In-progress Safety Investigation Statement

Ref. AAIU-2021-01-30-01
Issue date: 17 February 2023

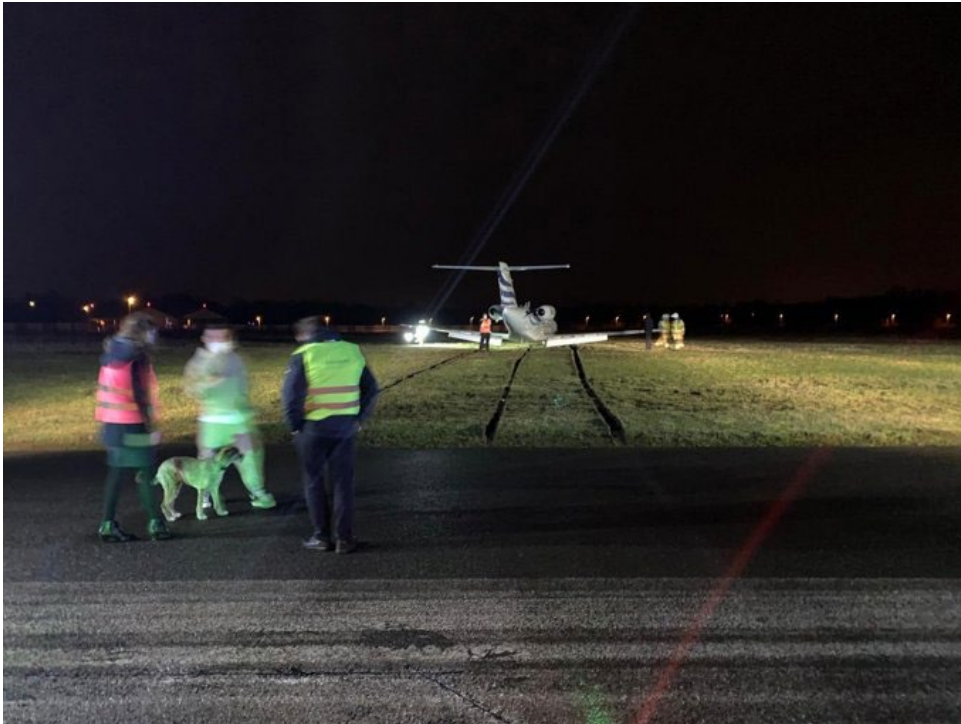
During a landing, at night and wintery conditions, the airplane overran runway 11 of Antwerp airport and stopped 40m behind the runway end

At the first application of the emergency brake the aircraft started to veer a bit to the left, but the captain corrected the path and applied even more force to the brakes trying to stop the aircraft before the end of the runway. The wheels blocked and the aircraft overran the runway 11 by 40 meters and came to a full stop on the runway strip.

All occupants exited the aircraft uninjured
