Air Accident Investigation Unit

FINAL REPORT ON THE ACCIDENT TO ULM POLARIS FK14B (OO-F37) IN HASSELT ON JUNE 30,2007

Ref. AAIU-2007-10
Issue date: 19 November 2007
Status: Final

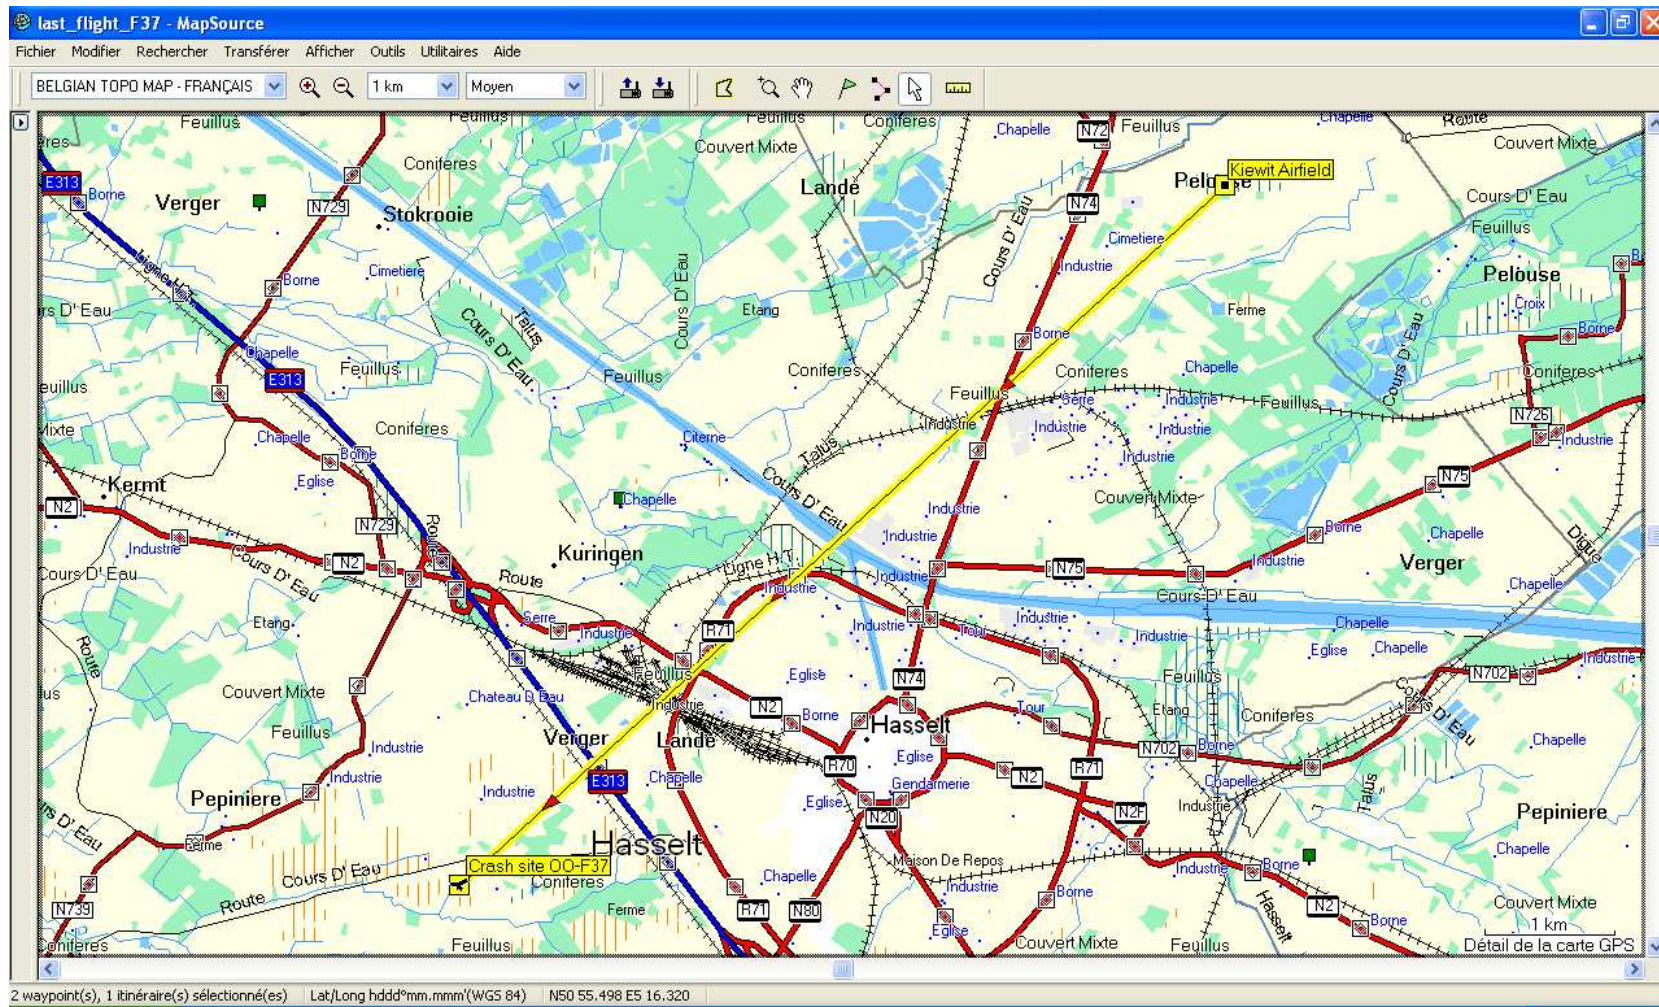
The Accident Flight

The aircraft then arrived above the crash zone, from the north-east. The aircraft went into steep climb of 60° incidence, with full power, then the aircraft leveled, in a shallow dive for 300m.

Then the pilot in command banked the aircraft for a hard bank turn to the right. The aircraft rolled (180°) to the right, and went into a high speed spin.

The aircraft recovered from the spin at an altitude of 50m, but seemingly having lost all forward speed.

The aircraft crashed vertically in the backyard of a residence on Wanbeekstraat, 3 Hasselt around 14.15.

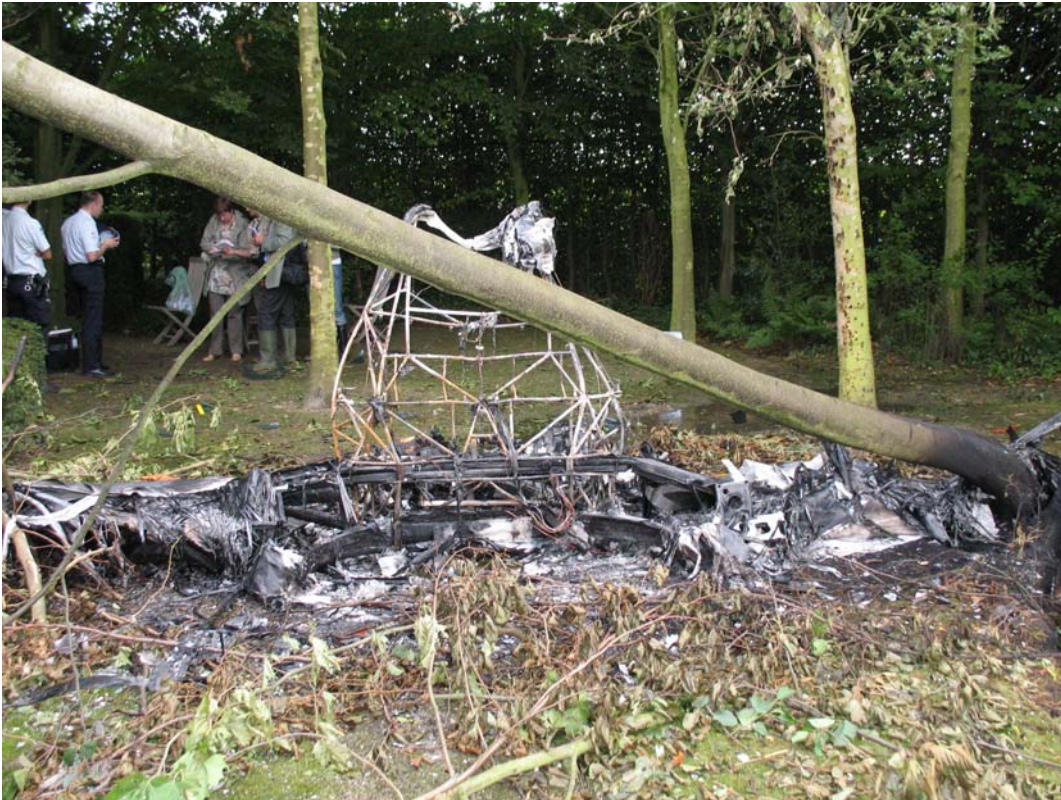
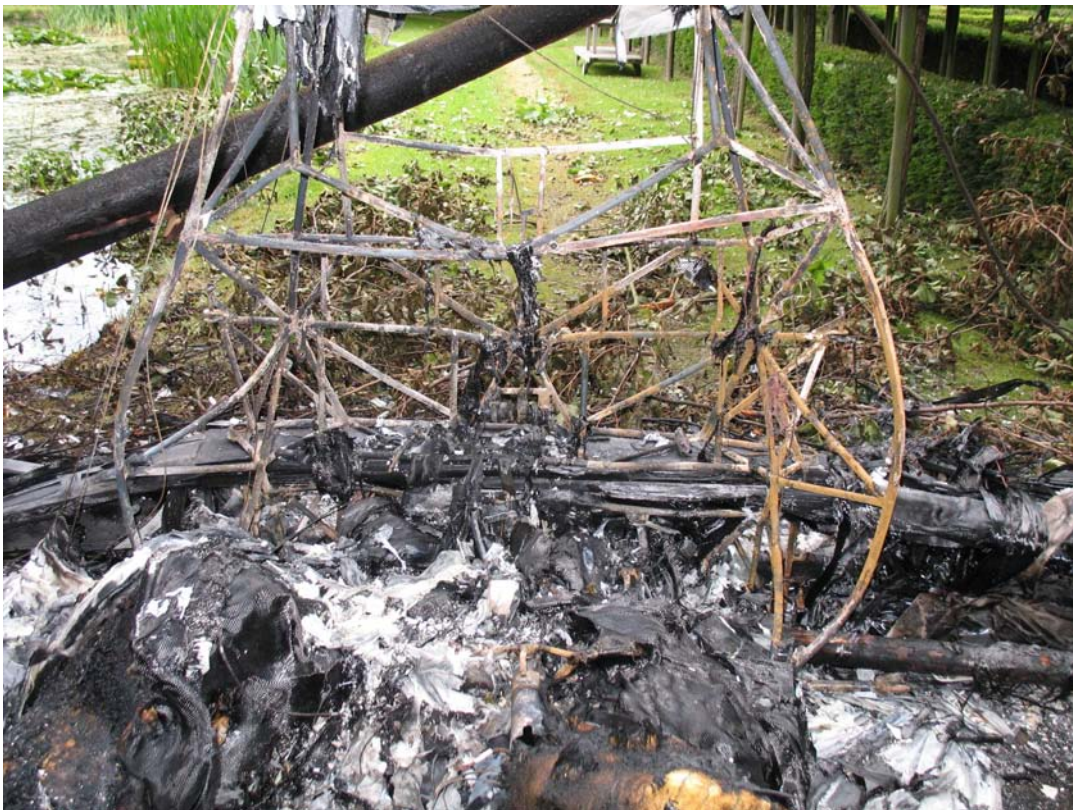
All the damage to the aircraft was consistent with the aircraft hitting the ground, and the subsequent fire.

The composite parts of the aircraft were all consumed by the fire, and only the metallic structure of the cabin was left. This structure shows deformations consistent with impact forces.

Continuity of the flight controls was established (up to the fixation bolts), and there was no evidence of a control restriction.

There was no sign of structural failure.

The Right wing showed some remains of composite parts, while the Left wing was totally consumed, indicating the fire started on the LH side.

The engine was not rotating upon impact; although broke into pieces, a part of the propeller tip was found close to the engine.

The rescue system operating handle was found, as well as elements of this system. The system was not used.

All instruments, computers, etc, were destroyed, burned beyond recognition.

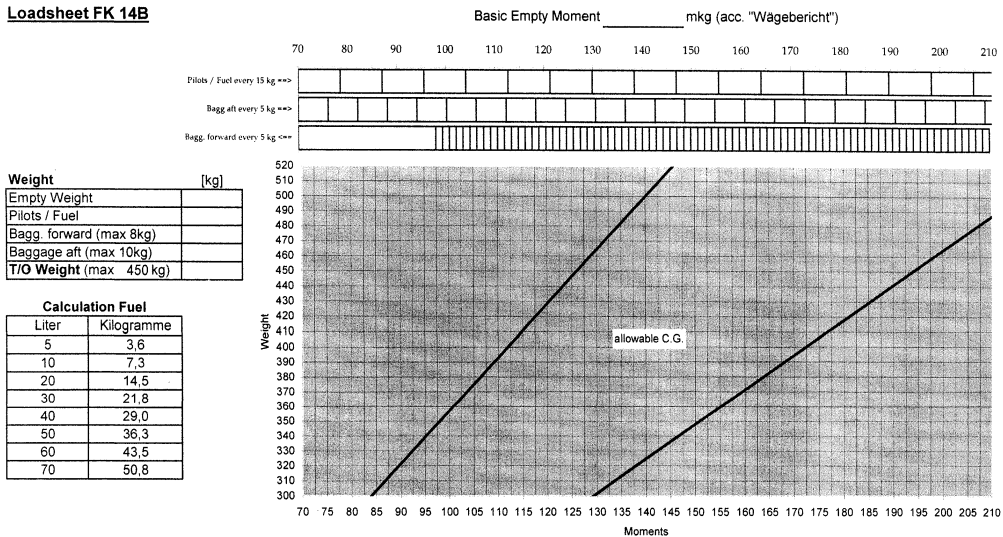
Loadsheet FK 14B

The weight of OO-F37, when taking off with the 2 persons on board, and 78 liters of fuel, was well above the certification figure of 450kg.

In normal circumstances, this would not have a negative impact on the position of the CG, as shown on the table; even with a weight of 520 kg, (of course, provided the weight be distributed normally), the CG would always be between limits.

Although the loading of the aircraft was exceeding limits, this would not have dramatically influenced the circumstances of the crash.

We suggest BCAA to consider an awareness campaign in order to outline the importance of the loading of aircraft and the technical and safety rationale behind the definition of the 450kg MTOW limit.
