**Federal Public Service
Mobility and Transport**
Belgian Civil Aviation Authority

Air Accident Investigation Unit

FINAL REPORT ON THE ACCIDENT TO HELICOPTER BELL TEXTRON B206 REGISTERED N678LW IN MERCHTEM ON 26 DECEMBER 2007

Ref. AAIU-2007-20
Issue date: 17 JAN 2009
Status: Final

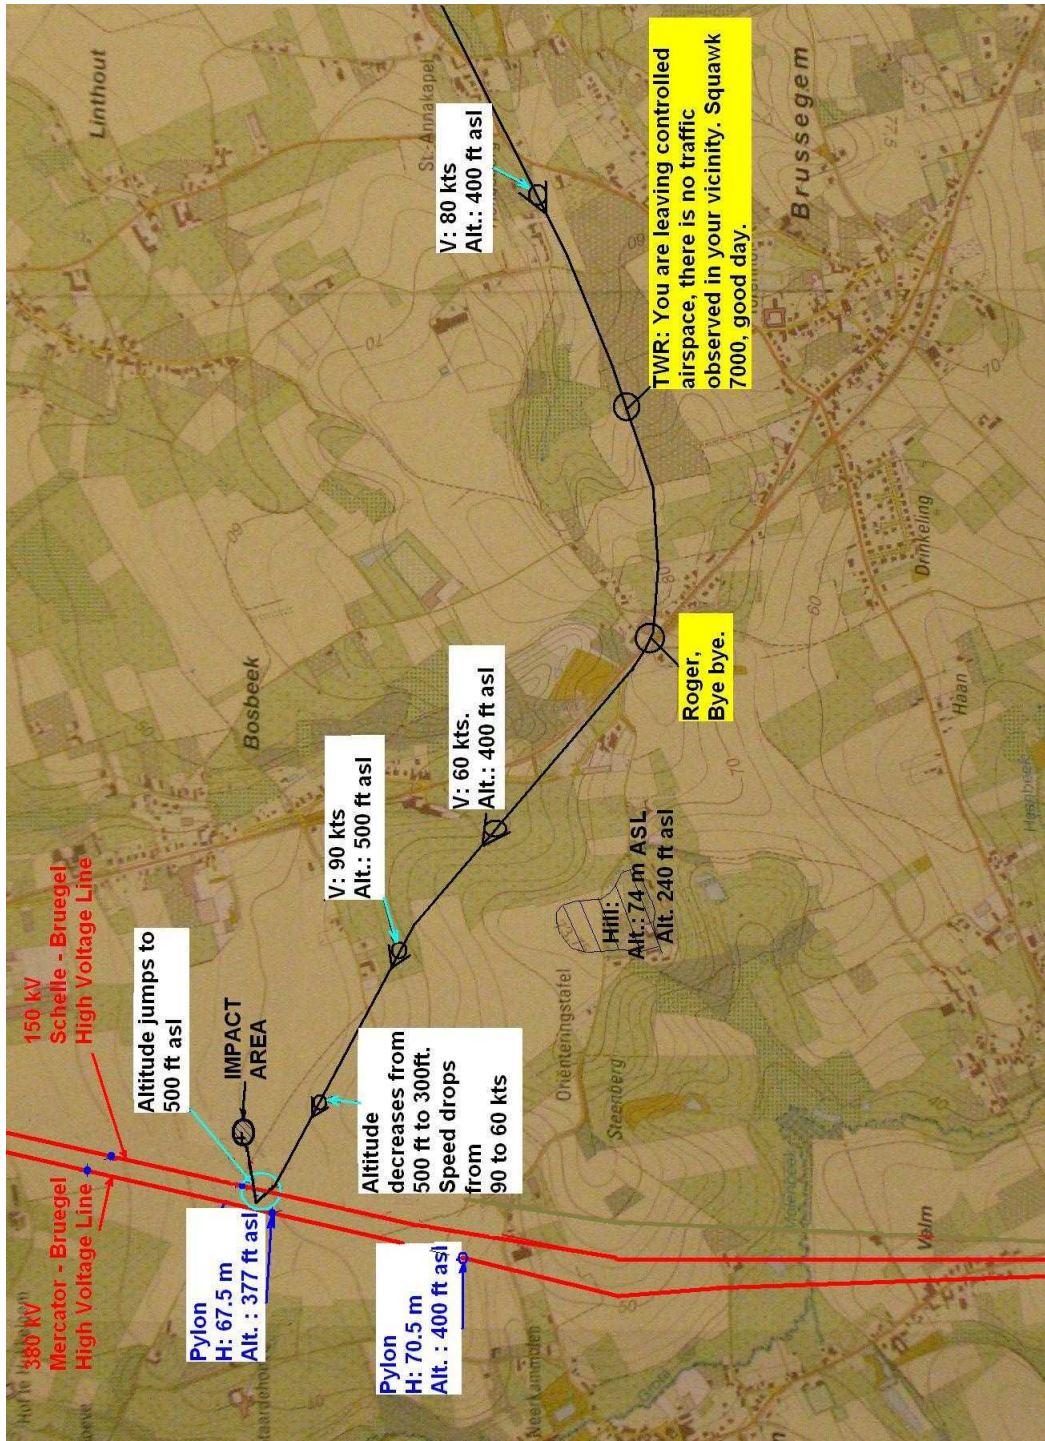
The helicopter turned to the North-West, following the terrain. The visibility conditions worsened, as mist was coming towards the helicopter flight path. the pilot lowered the altitude and reduced speed.

Upon reaching the high voltage line running from North to South (380kV – “Mercator – Bruegel” and 150 kV “Schelle – Bruegel”), the helicopter flew at an altitude of 300 ft and a speed of 60 kts. The electricity pylons of the 380 kV line culminates at 400 ft asl

The radar trace and the GPS data record show that the helicopter suddenly went up and turned around. This evasive maneuver was most probably induced by the pilot, surprised by the close vicinity of the high voltage line.

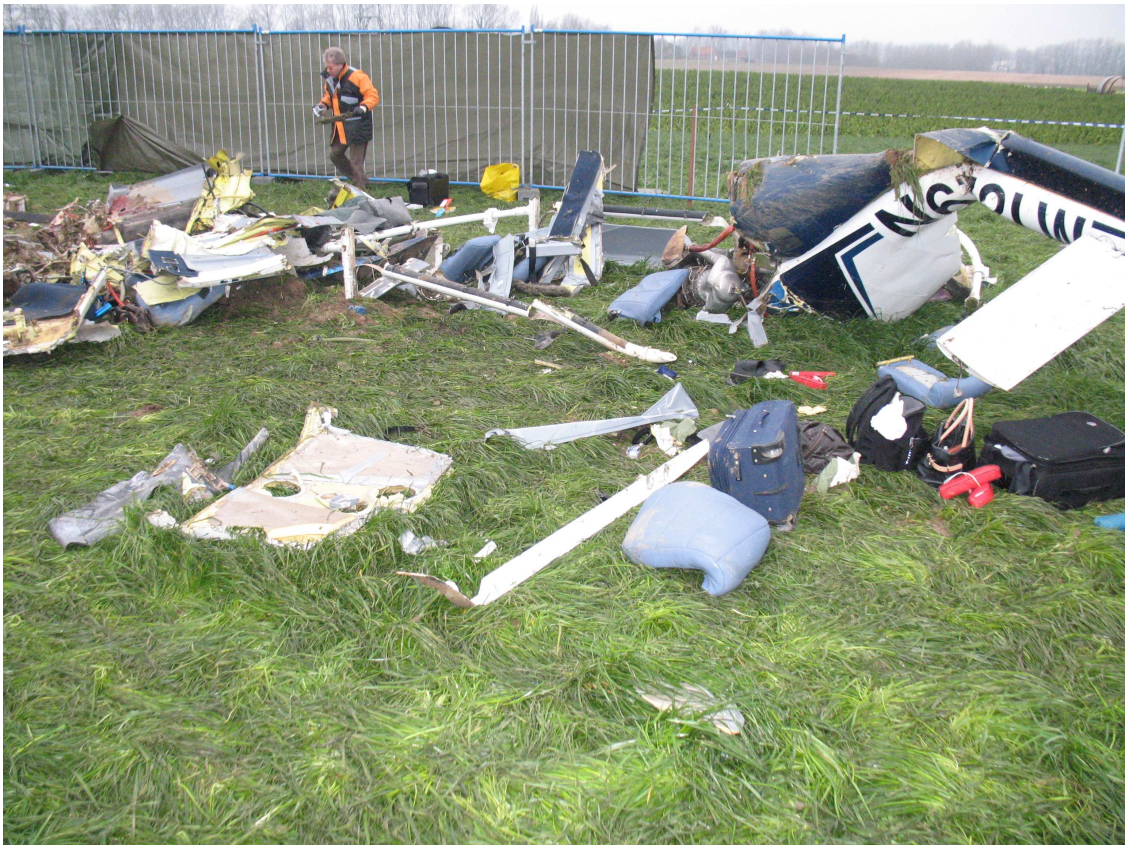
The helicopter is totally destroyed by impact force.

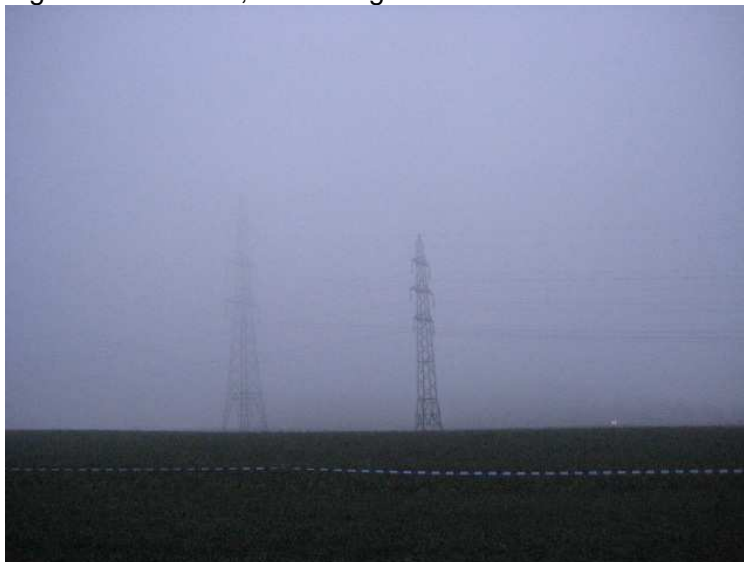
Picture taken from the crash scene (120 from the first HV line), shortly after the accident, showing the high Voltage line.
