**FINAL REPORT ON THE ACCIDENT
OCCURRED ON 10 MAY 2008 AT
HARVENG
ON A AVIAT HUSKY A-1 REGISTERED
OO-HUS**

**Ref. AAIU-2008-12
Issue date: 29 January 2009
Status: Final**

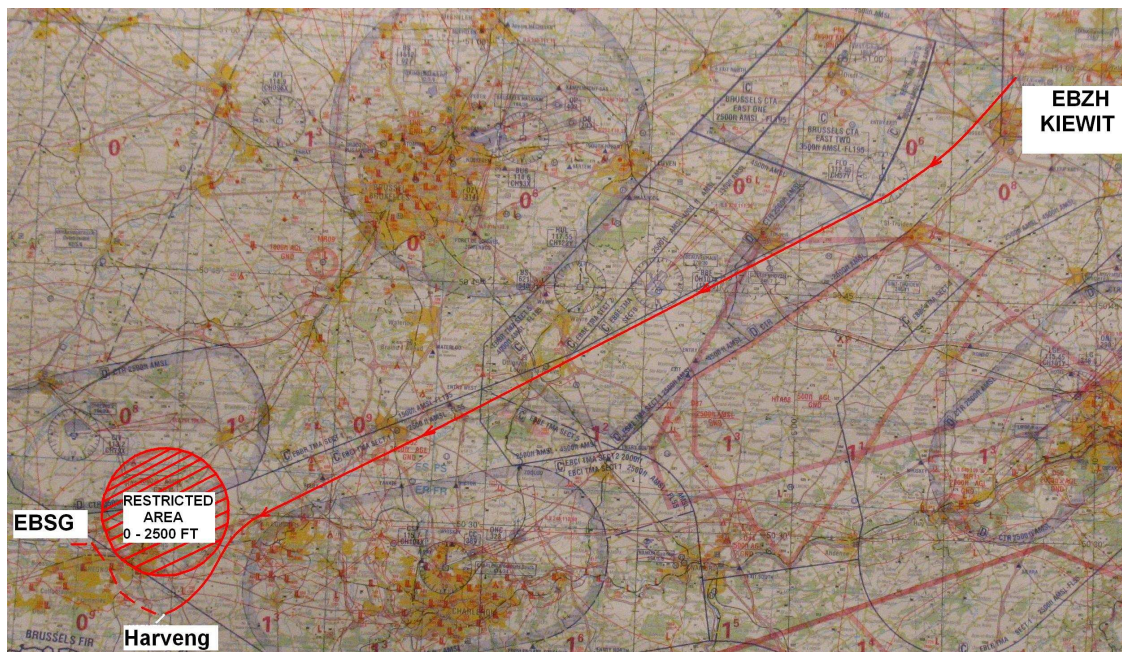
Estimated Flight Path.

The flight from EBZH to EBSG occurred in a nearly straight line, except that the zone around Casteau (SHAPE) is restricted. The airplane went south, and came in the vicinity of the villages of Harmignies and Harveng.

The airplane was seen by witnesses circling around the village center, first Harmignies, then Harveng. These people report the airplane flying at very low altitude, and performing “aerobatic” manoeuvres (sharp turns).

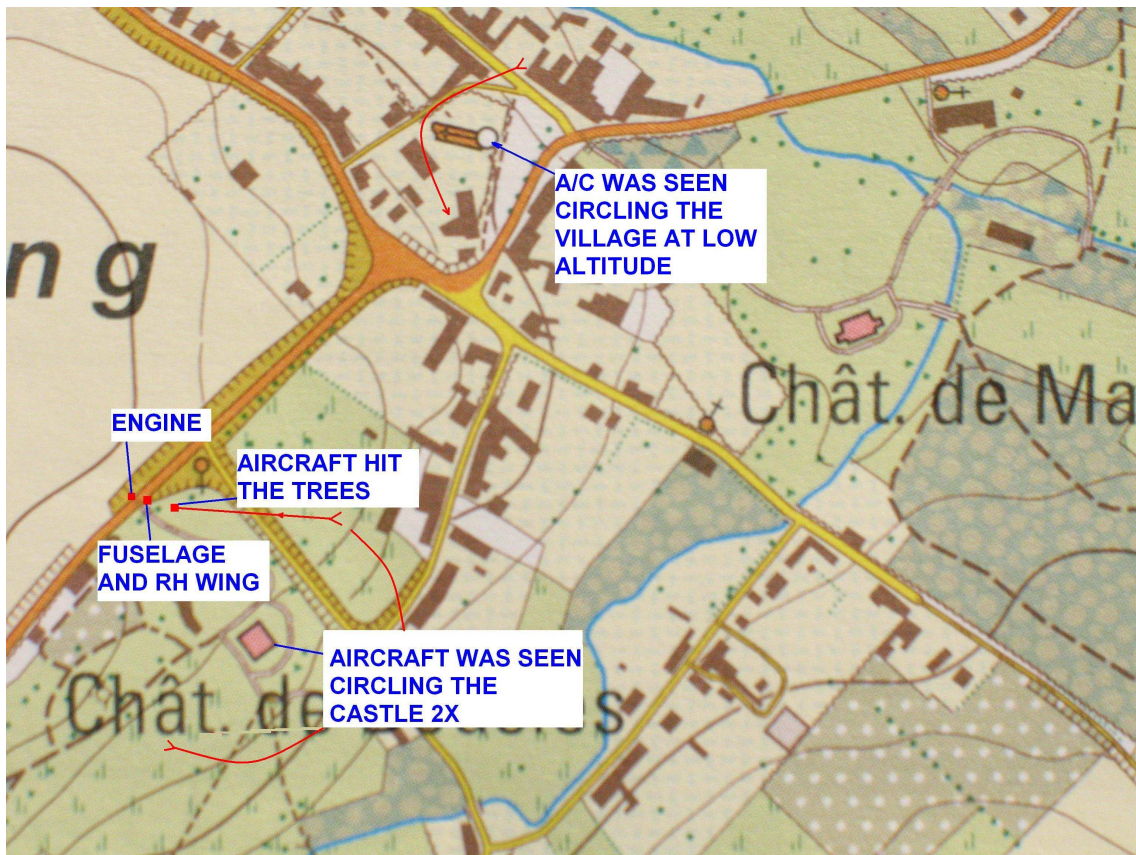
Crash Site

Finally, the airplane flew around Harveng’s castle, at tree top level. Upon completing the second circle, the airplane hit the tree bordering the main Harveng road (route Macadamisée).

The airplane hit a tree nose first; the crankshaft broke at the propeller flange, liberating the propeller. The left wing was severed by the impact, and remained caught in the tree, while the fuselage and right wing whirled down, and crashed before the gates of the castle.

The airplane was totally destroyed. There were also a couple of tree trunk severed by the impact.

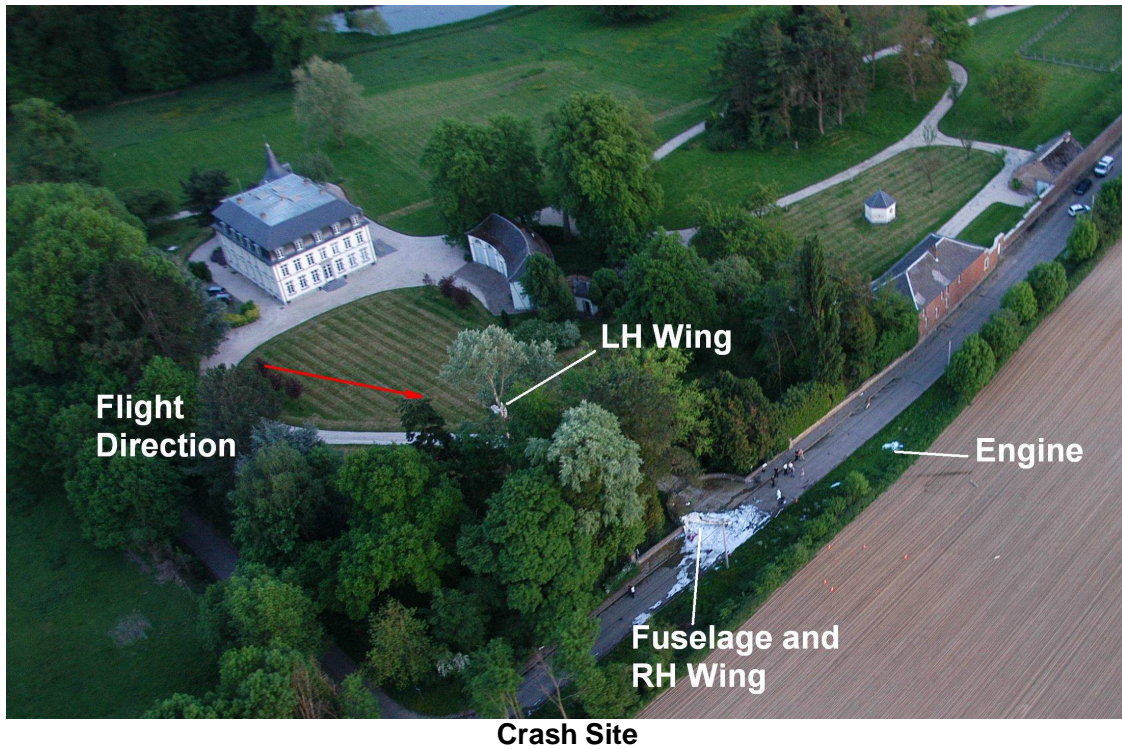
The airplane hit a tree nose first; the crankshaft broke at the propeller flange, liberating the propeller that fell inside the castle perimeter at the foot of a tree.

The left wing was severed by the impact, and remained caught in the tree.

The fuselage and right wing whirled down, and crashed before the gates of the castle.

The fuselage had the nose directed towards the castle, and the RH wing sat on top. The engine with the instrument board still attached was found at 9m from the fuselage, on the other side of the street.

The wheels were found inside the castle perimeter, close to the fence.

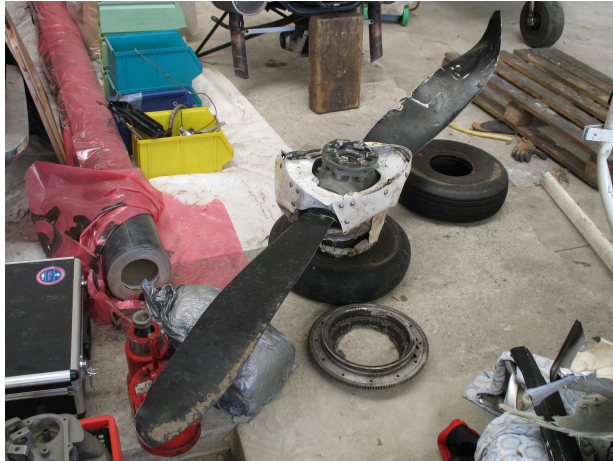
Propeller.

The propeller separated from the engine at an early stage of the shock; the propeller was found at the foot of a tree inside the castle perimeter, which was found unusual.

The propeller blade itself did not show catastrophic damage.

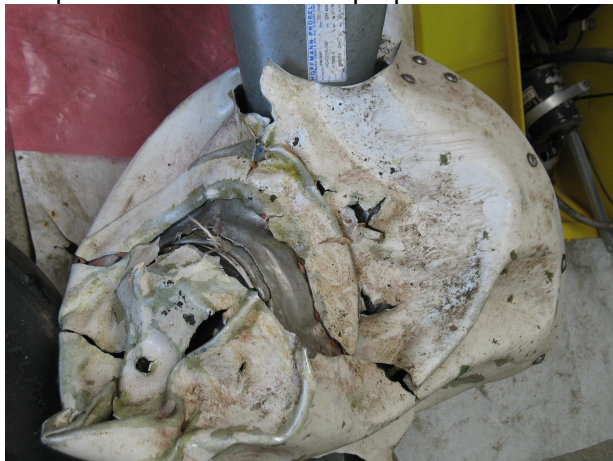
Spinner; front view

Deformations on the spinner indicate that the propeller took a near frontal shock

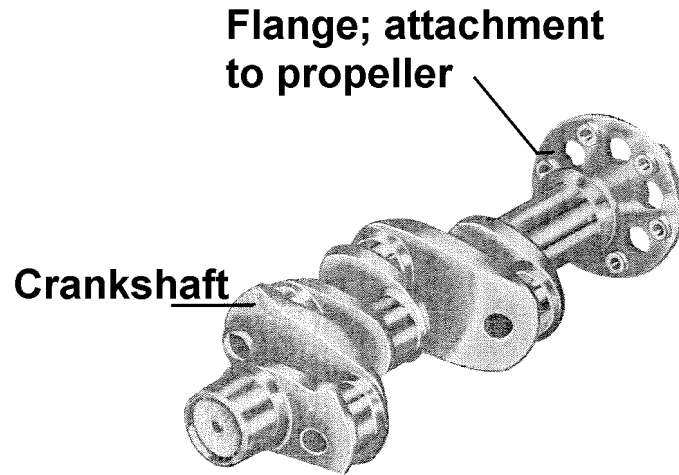
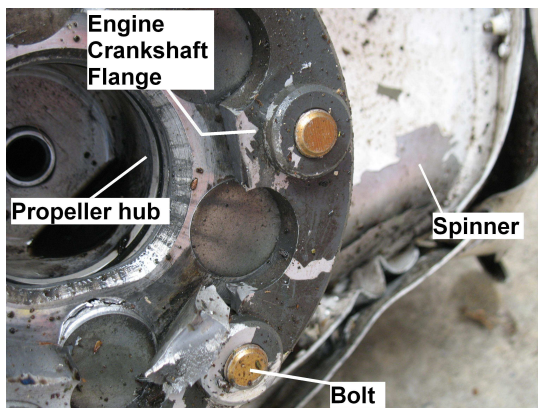
The crankshaft flange, the attachment point between the engine crankshaft and the propeller hub was found sheared off.

Propeller;
hub still bolted on the engine crankshaft flange

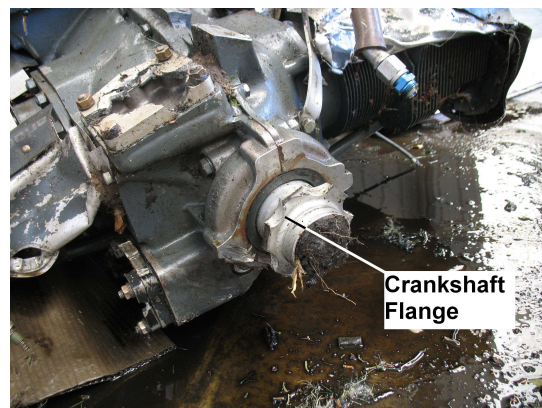
Engine:
Crankshaft flange.

The remains of the crankshaft and the propeller hub were scrutinized.

All fractures were found to be caused by shear stress due to the frontal impact of the airplane with a tree; There was no crack or corrosion prior to the shock visible. We can conclude that the engine was operating upon impact.

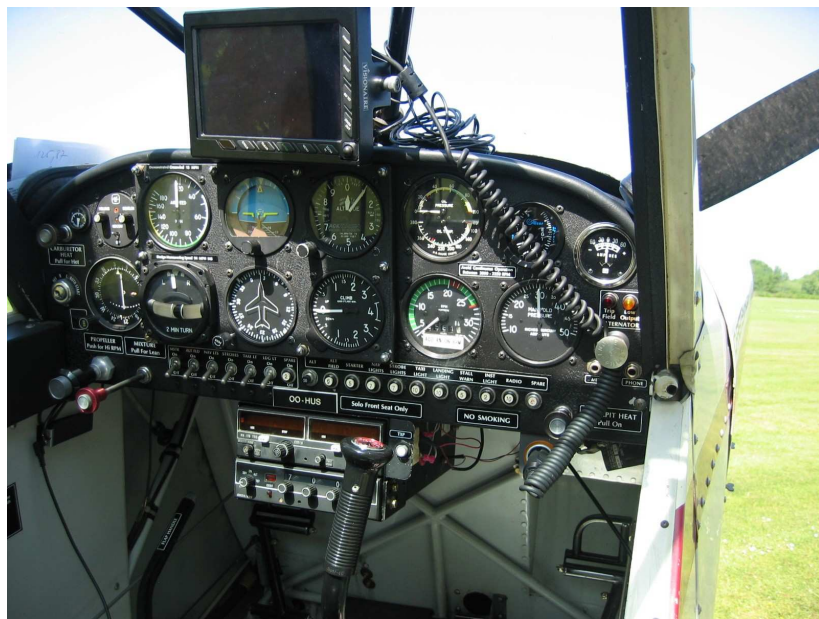
The pilot used a GPS – EKP-IV for navigation. This GPS features a 17.8 cm diagonal LCD screen. The screen was installed above the instrument panel, in the middle.

On this airplane; the GPS installation is not certified, therefore, the installation is not verified for adequacy.

On an aircraft such as the Husky (or similar Piper Cub), with such installation, the 1st pilot would be facing the LCD screen, and a large portion of its forward view would be obstructed.

A possible contributing factor to the accident could have been the forward view restriction by the GPS screen, in the event the 1st pilot was the pilot flying.

A possible contributing factor is the presence of a large GPS screen mounted on top of the instrument panel, that could have prevented the pilot to notice the presence of the trees on time (in the case the 1st pilot was the pilot flying).
