## Safety Investigation Report

# ACCIDENT TO THE ULM – RAINBOW AIRCRAFT REGISTERED OO-G29 IN HOEVENEN ON 11 DECEMBER 2011

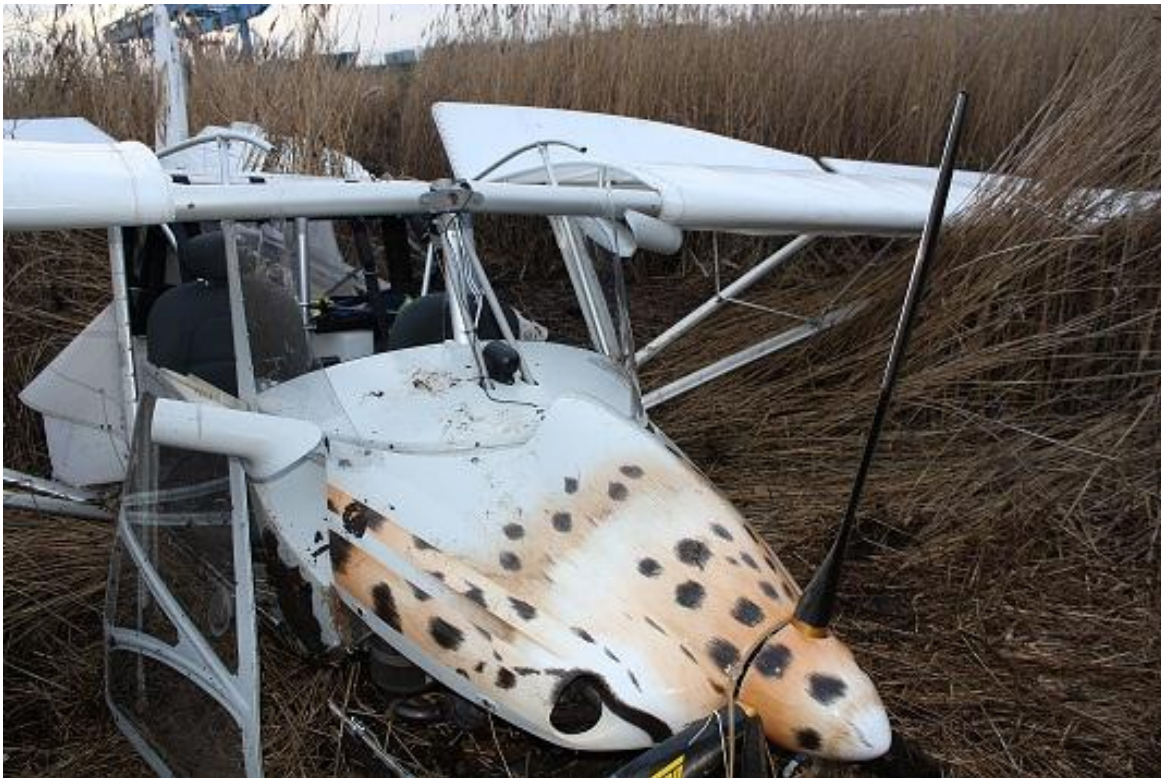
The airplane sustained heavy damage:

- Landing gear torn off (NLG and Main)
- Deformation on side braces
- Windscreen broken
- One propeller blade broken.

Fig. 4 crashed airplane

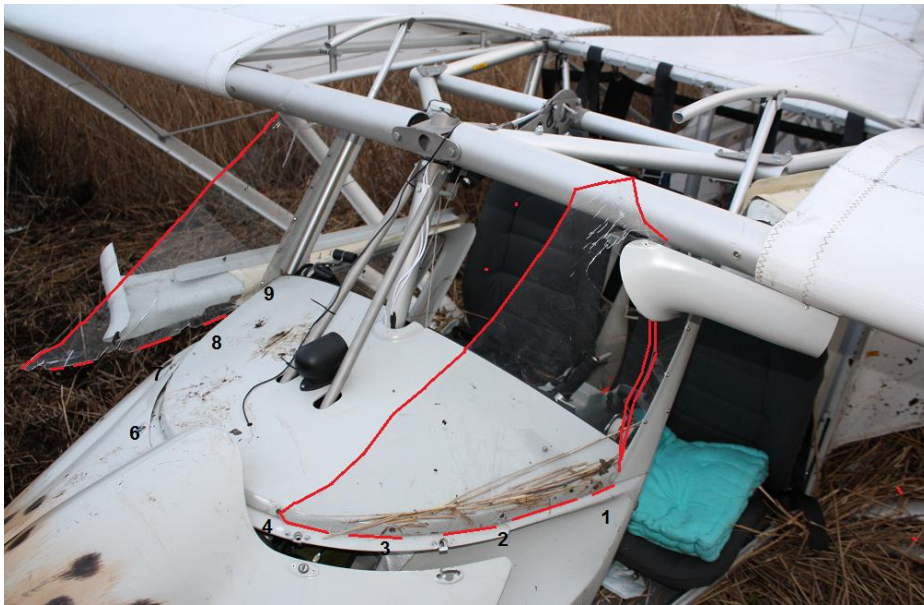
The windscreen was broken in 4 parts. All parts were found on the wreckage.

Fig. 6 Damaged Windscreen

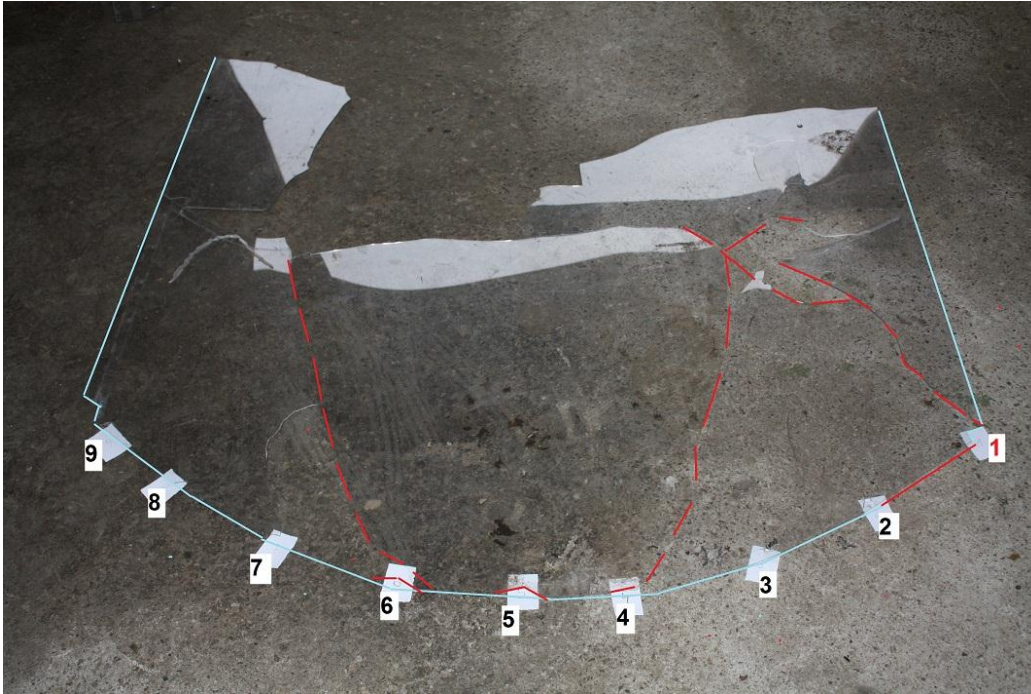
The central cracks were initiated from the attachment point 4 and a point between attachment 5 and 6.

Fig. 7 windscreen fractures

The windscreen failed in flight from cracks originating from attachment point 4 and cracks between attachment point 5 and 6.

The cracks at the attachment point and at the border of the windscreen were caused by a mechanical stress coming from the relative movements of the airplane structure and the windscreen (a visible sign of this movement is given by wear traces around attachment point 4). The installation of the windscreen was not complying with the manufacturer's requirements, as it omitted to place a rubber seal between the windscreen and the forward fairing, that would normally act as a stress dampener.

AAIU(Be) recommends Rainbow aircraft to amend the current assembly manual of the Cheetah to incorporate a caution note about the importance to install the rubber seal when installing the windscreen.

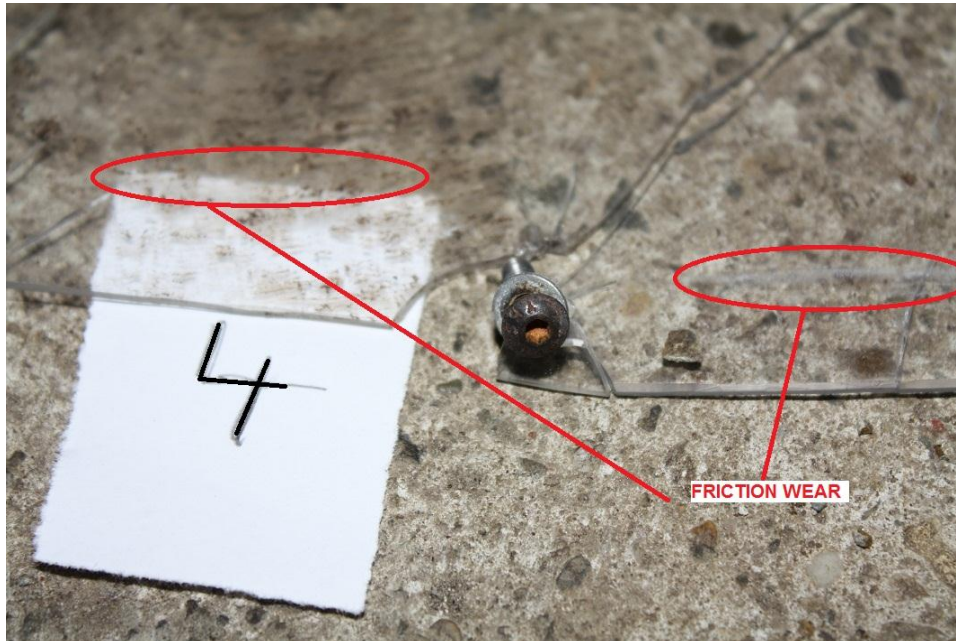
Fig 8. Attachment point 4

The area shows friction wear from both sides of the attachment.

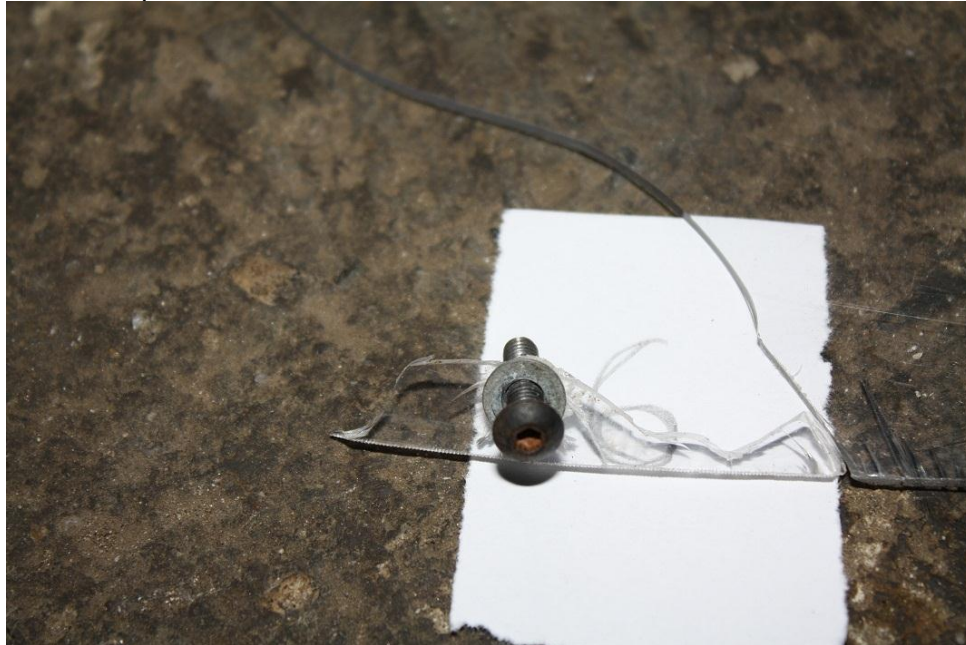
Fig. 9 Second fracture point

Crack initiations are visible left and right of the fracture.

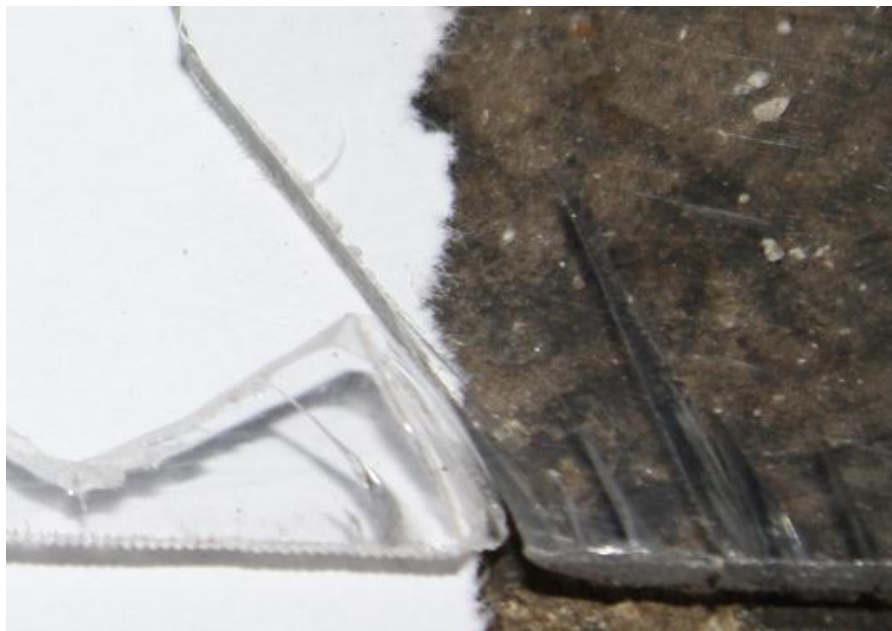
Fig 10 cracks in the windscreen

Reportedly, the windscreen showed on 30 September 2011 already some light cracks around the windscreen attachment point. The cracks did not evolve from that time.

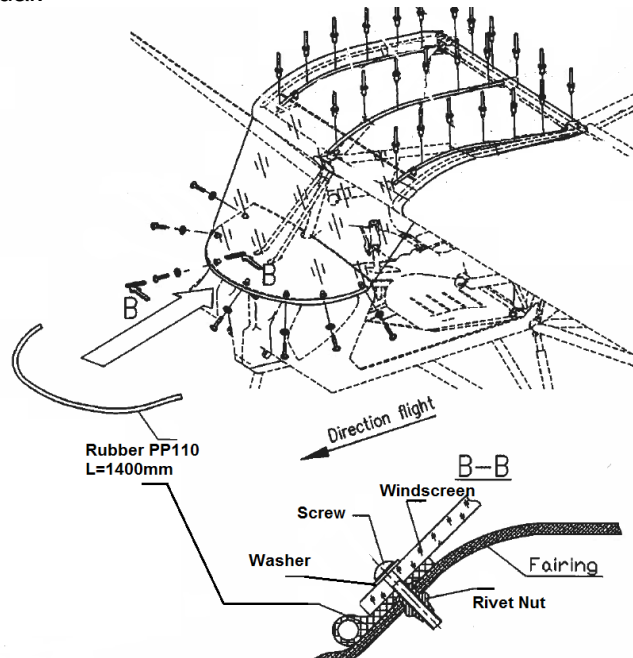
The windscreen is attached to the airplane forward fairing by rivet nuts and separated from the fairing by a rubber seal (see fig 11 hereabove)  
On OO-G29, the inspection of the windscreen revealed that the Rubber seal PP110 was not installed. A silicone sealing was added.
