Safety Investigation Report

ACCIDENT TO
THE PZL-BIELSKO SZD-55-1
REGISTERED D-5****
IN EBNM
ON 18 MAY 2011

Ref. AAIU-2011-15-EBNM
Issue date: 10 August 2012
Status: Final

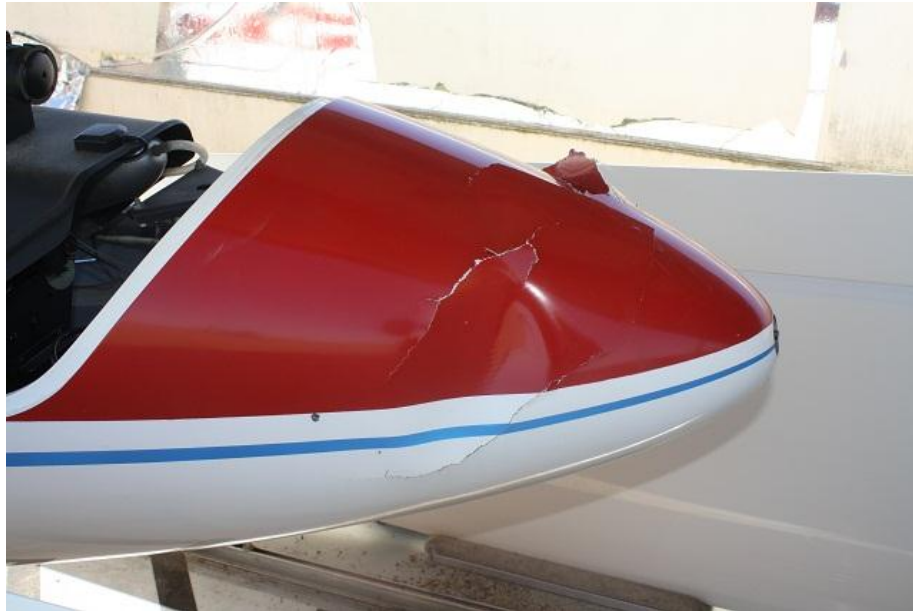
The sailplane rotated around the extremity of the LH wing, and the nose crashed into the ground, and fell back on its tail, rupturing the tail boom.

Fig. 1 Damage to the nose of the sailplane

The nose plowed into the ground. The sailplane came to a brutal stop, and fell back on its tail, causing the aft fuselage to break.

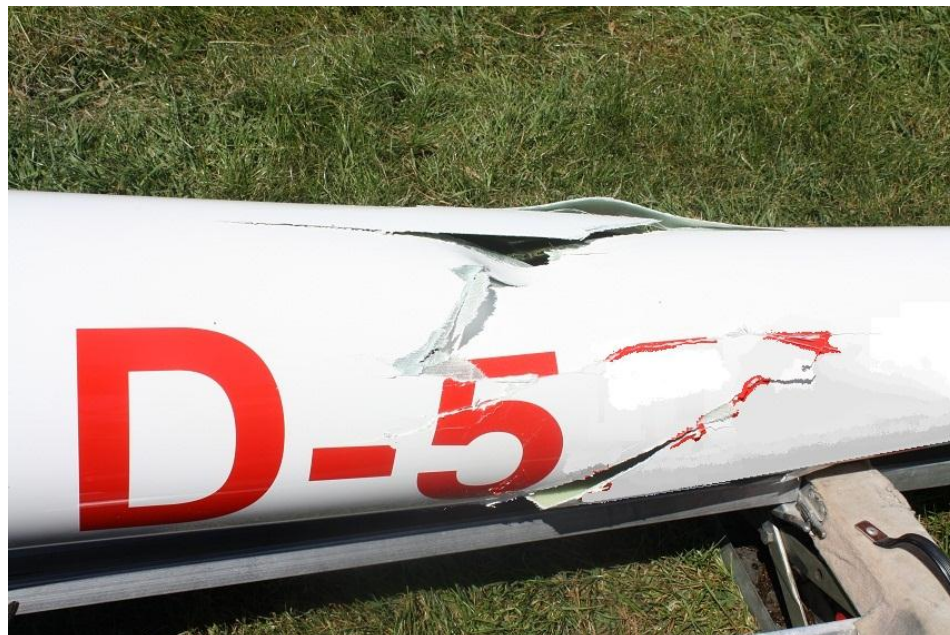
Fig. 2 Damage to the fuselage

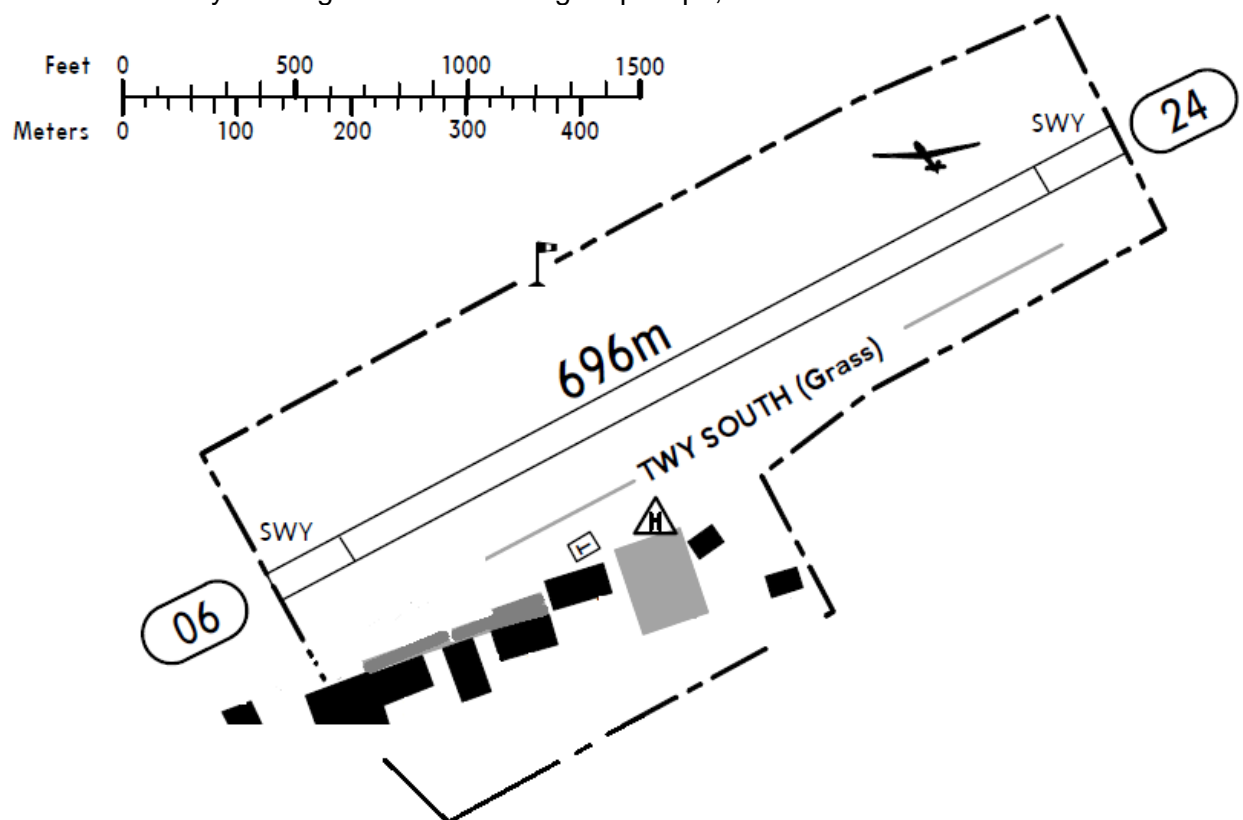
Runway 24 for gliders shows a slight up slope, and is somewhat uneven.

Fig.4 EBNM Airfield

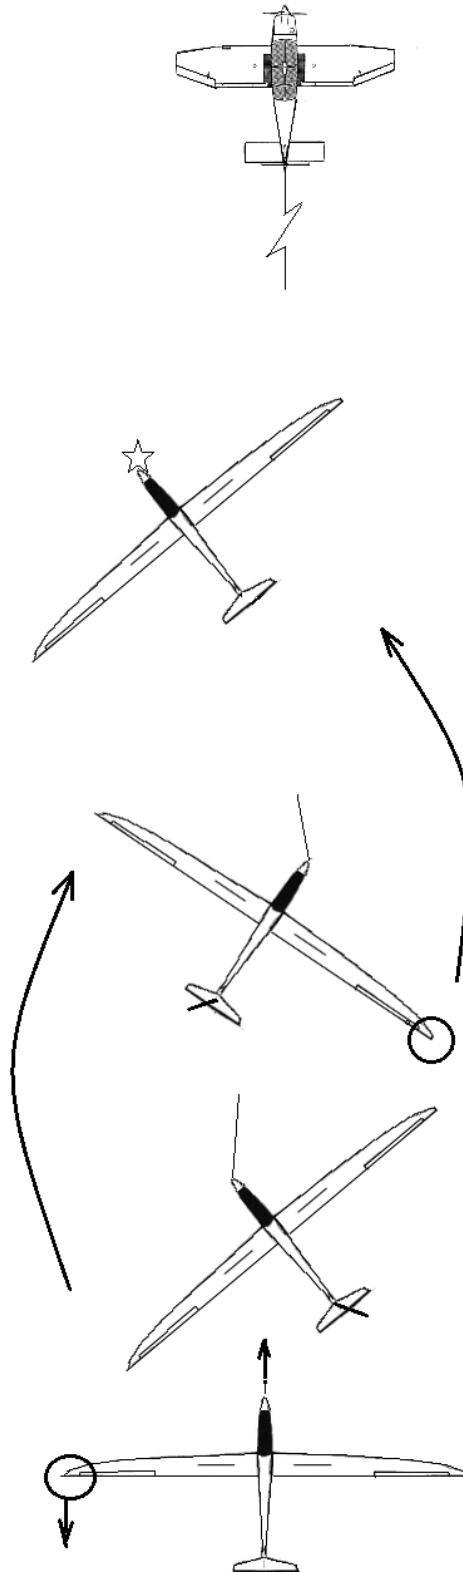
When the launching crew let the wing go, the LH wing tip fell on the ground. The pilot reacted immediately with RH aileron and rudder, but the reaction of the sailplane was slow, and the (unusually) tall grass caused a yawing effect to the left due to the friction forces.

The sailplane was pointing 40° to the left of the towing airplane, the pilot directed the sailplane to the right, in order to align with the towing airplane. At some point, the left wing went up, causing the right wing tip to contact the ground. The pilot reacted by applying LH aileron and rudder, and the sailplane turned again to the left, but the LH wing tip hit the ground.

The RH side of the sailplane left the ground and the sailplane quickly rotated around the LH wing tip, in a nose dive.

Fig.6 The flight
