Safety Investigation Report

ACCIDENT TO VAN'S AIRCRAFT RV-8A REGISTERED OY-L** AT GRIMBERGEN ON 30 APRIL 2011

Ref. AAIU-2011-6-Grimbergen-OY-L**
Issue date: 10 July 2012
Status: Final

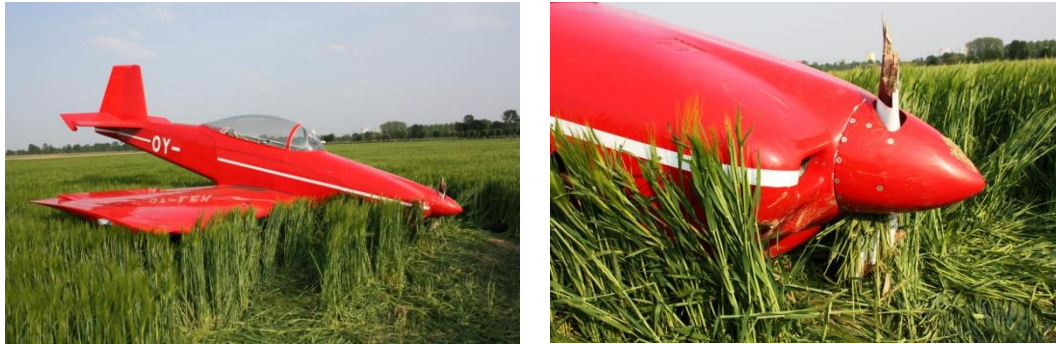
Figure 1: General view of the A/C and damages to the propeller.

The propeller blades were destroyed and both wing leading edges were crushed near the wing tips by impact with the ground.

At first sight, the possibility existed to perform a soft forced landing. However, as seen on the above pictures (Figures 1 and 2) the airplane suffered a loss of control close to the ground causing significant damage to the airplane (Nose landing gear, wing leading edges, propeller ...). Both propeller blades were broken. First investigation on the crash site showed that there was enough fuel inside both fuel tanks.

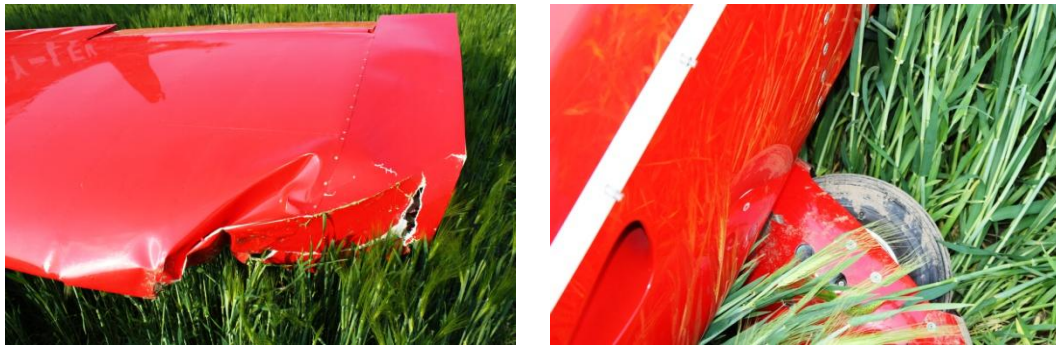
Figure 2: L/H wing leading edge and view of the nose wheel under the engine cowling.

As seen on the above picture the damage is serious and is consistent with a hard landing on a soft field.

The nose landing gear was bent backwards upon impact.

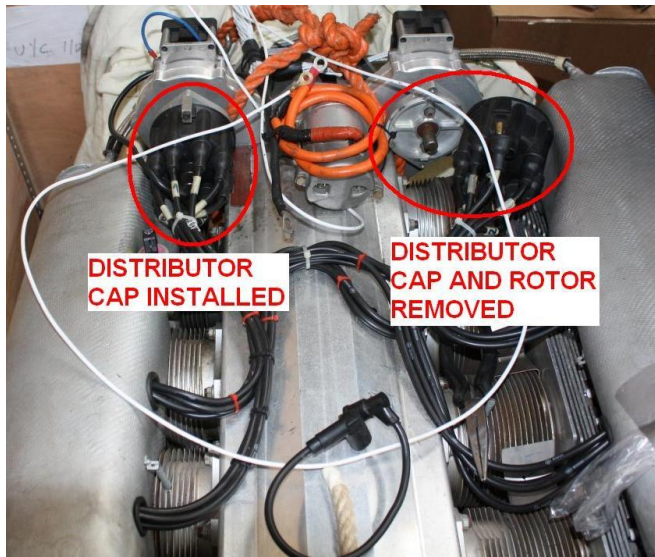
We removed both distributor caps and we found that there was no clearance between the new rotors and the distributor caps.

Figure 3: view of the high tension distributors

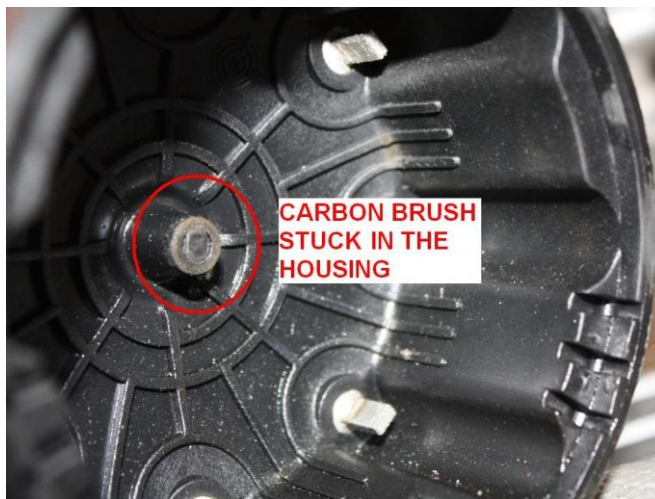
Consequently, the rotors were damaged and the carbon brush of each distributor was blocked inside its housing due to the friction (see figures 4 and 5).

Despite the damage, the distributor caps and the rotors were yet functional and could not explain a sudden and complete engine failure. However, it is likely that sooner rather than later this would have result in a partial or complete failure of the ignition system.

Figure 4: Inside of a High Tension distributor cap

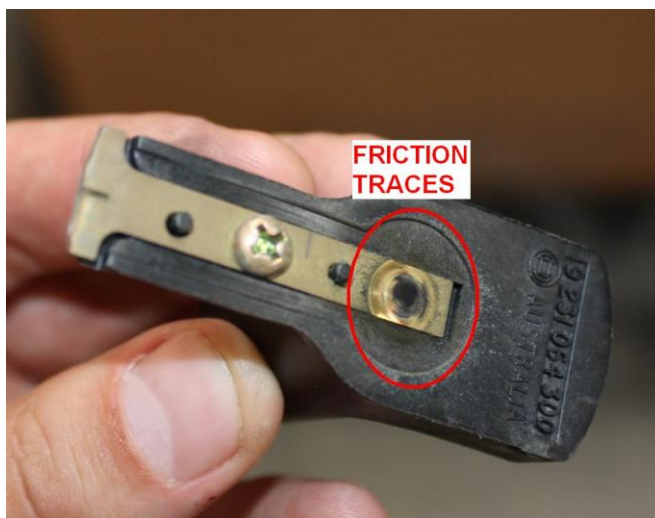
This anomaly was probably not the cause of the engine failure and therefore we didn't investigate the actual cause of the inadequate positioning of the rotors.

Figure 5: Friction traces on a practically new rotor

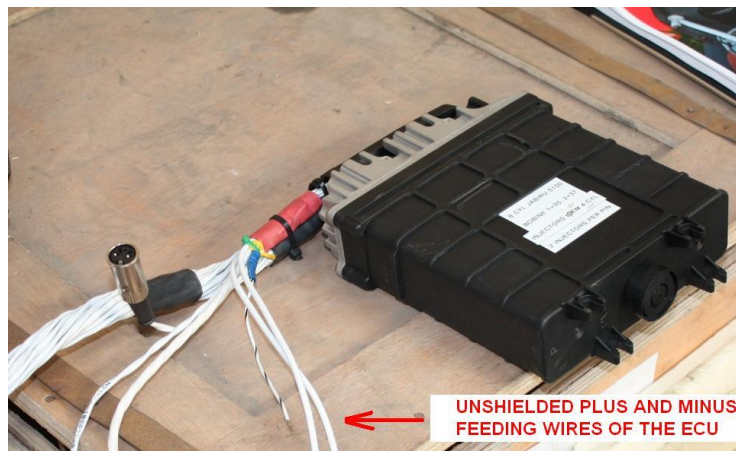
By looking in detail at the ECU loom of OY-L**, we noticed that the both plus and minus feeding wires of the ECU were not shielded.

Figure 4: ECU box and loom

Therefore the possibility exists that the unshielded wires of the ECU worked as antennas, picking up electrical interference, causing the ECU to trip.
