FINAL REPORT ON THE ACCIDENT TO PIPER PA-28 REGISTERED OO-TMI AT EBZH ON 08 FEBRUARI 2011

Ref. AAIU-2011-01
Issue date: 08 April 2011
Status: FINAL

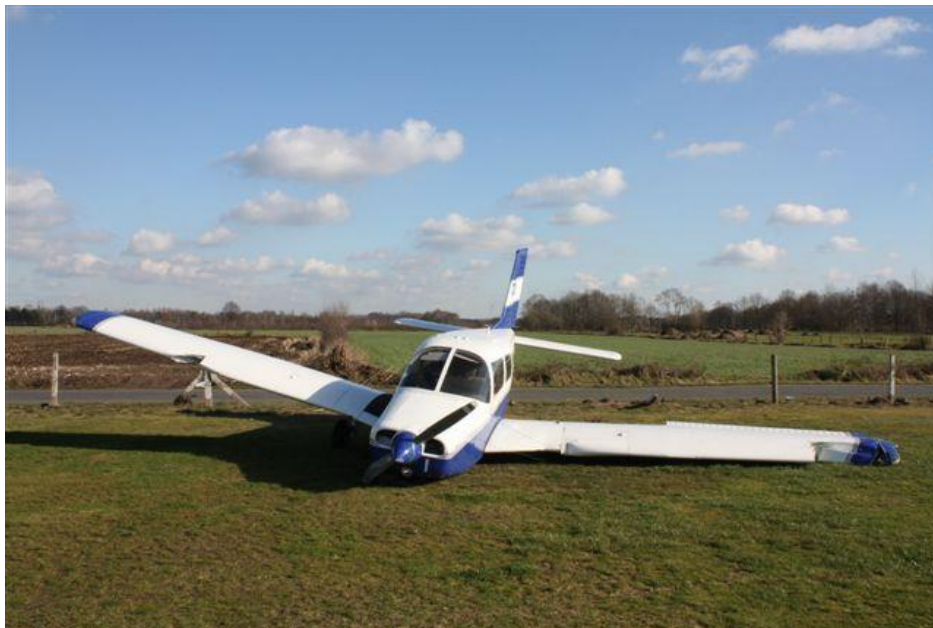
The airplane sustained heavy damages to ;

- The Nose Landing Gear (broken)
- The LH Main Landing Gear (broken)
- The propeller was bent (mostly on one blade)
- The fire wall was slightly bent
- Impact damage on both wings.

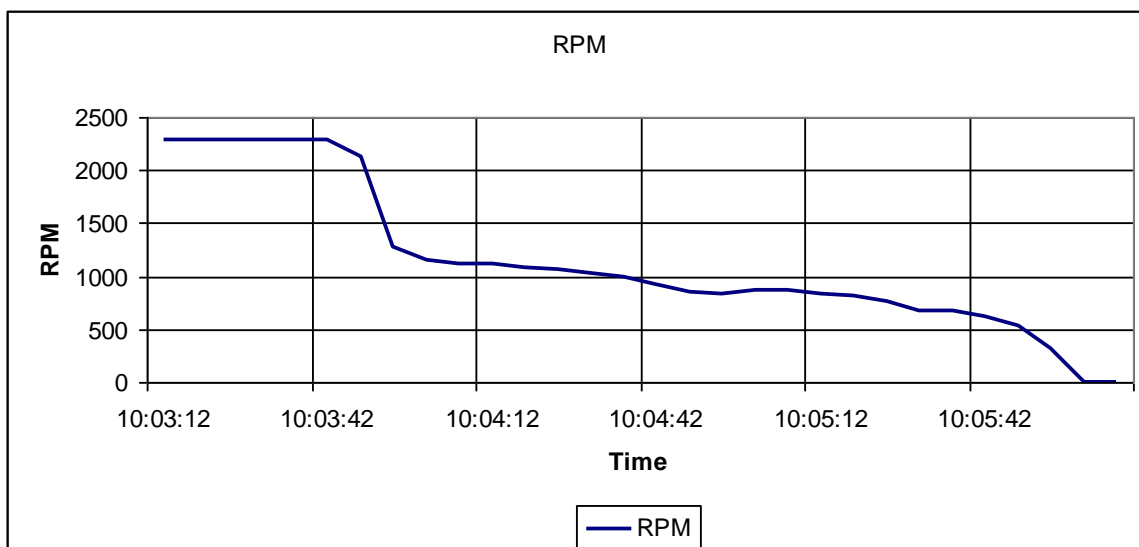
1.11.3. Engine RPM.

The engine RPM is generated by a tachometer installed on the engine. The parameter shows that the engine started to decelerate between 10:03:42 and 10:03:48. The evolution shows a gradual decrease, until the RPM drops abruptly to zero at 10:06:00.

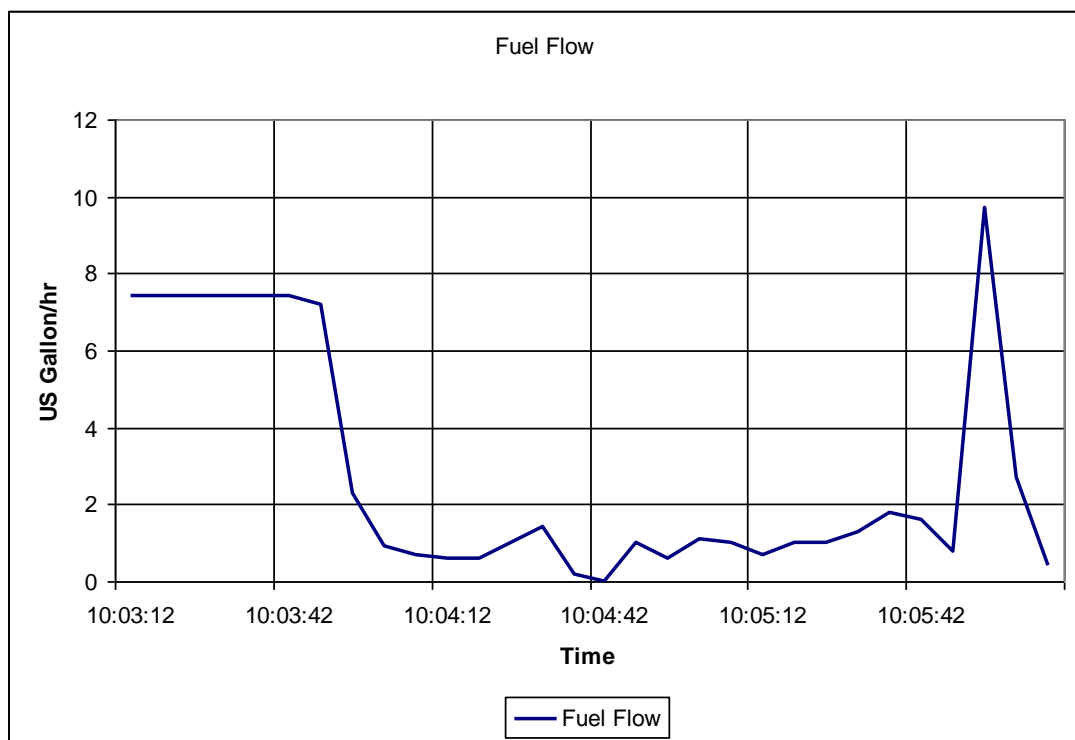
1.11.4. Fuel Flow.

The evolution shows a drop in value at the same time the RPM starts to decelerate (between 10:03:42 and 10:03:48). It shows also 2 consecutive very low value around 10:04:42, and a peak at 10:05:54.

The Fuel flow measured during the emergency landing simulation (between 10:04:00 and 10:05:48) is on average 0.79 US Gal/hr, with values ranging from 0 to 1.4 US Gal/hr.

The fuel flow measured by the fuel flow transmitter during the two minutes preceding the impact shows an average value significantly lower than the value usually encountered during engine power loss in flight exercise.

The value is even dropping to zero for 12 seconds, meaning that something was blocking totally either the airflow or the fuel flow. This obstruction caused the combustion to stop shortly after the power reduction and the engine started windmilling.

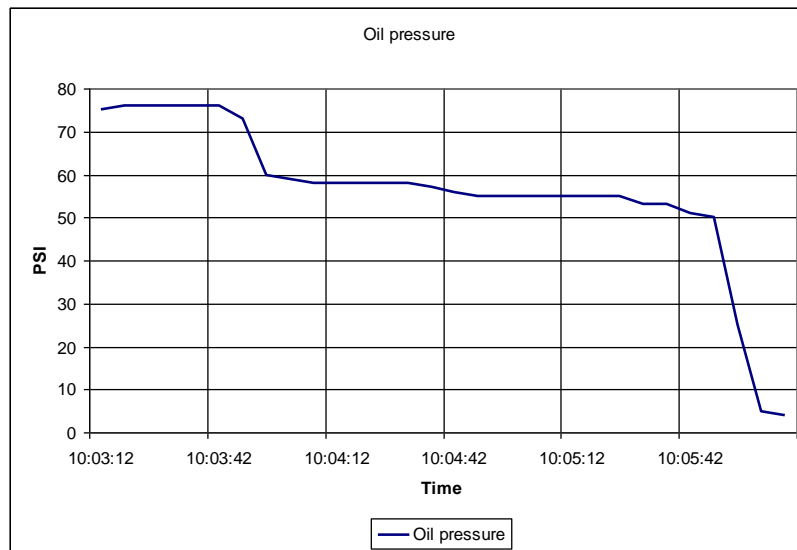
1.11.5. Oil Pressure.

The evolution shows a drop in value, at the same time the engine starts to decelerate, until 10:05:48, when the pressure decreases abruptly towards lower values.

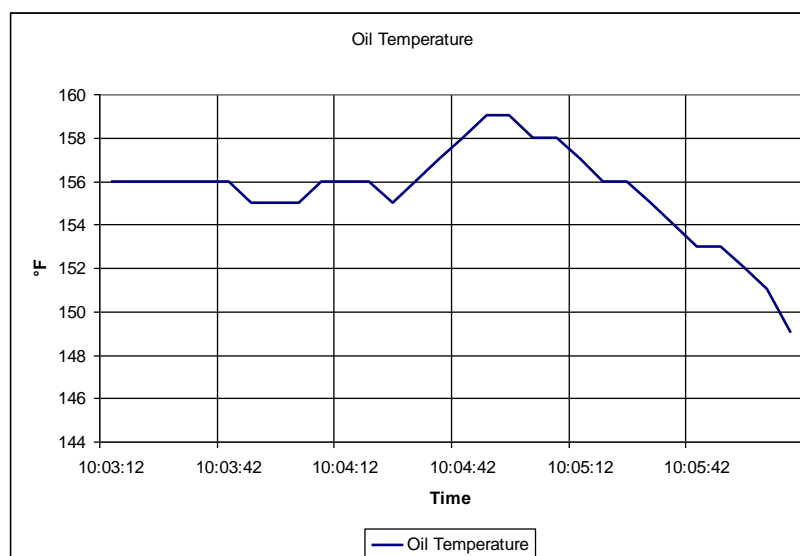
1.11.6. Oil Temperature.

The Oil temperature shows no changes upon the engine rpm changes, then the temperature increases somewhat before decreasing steadily.

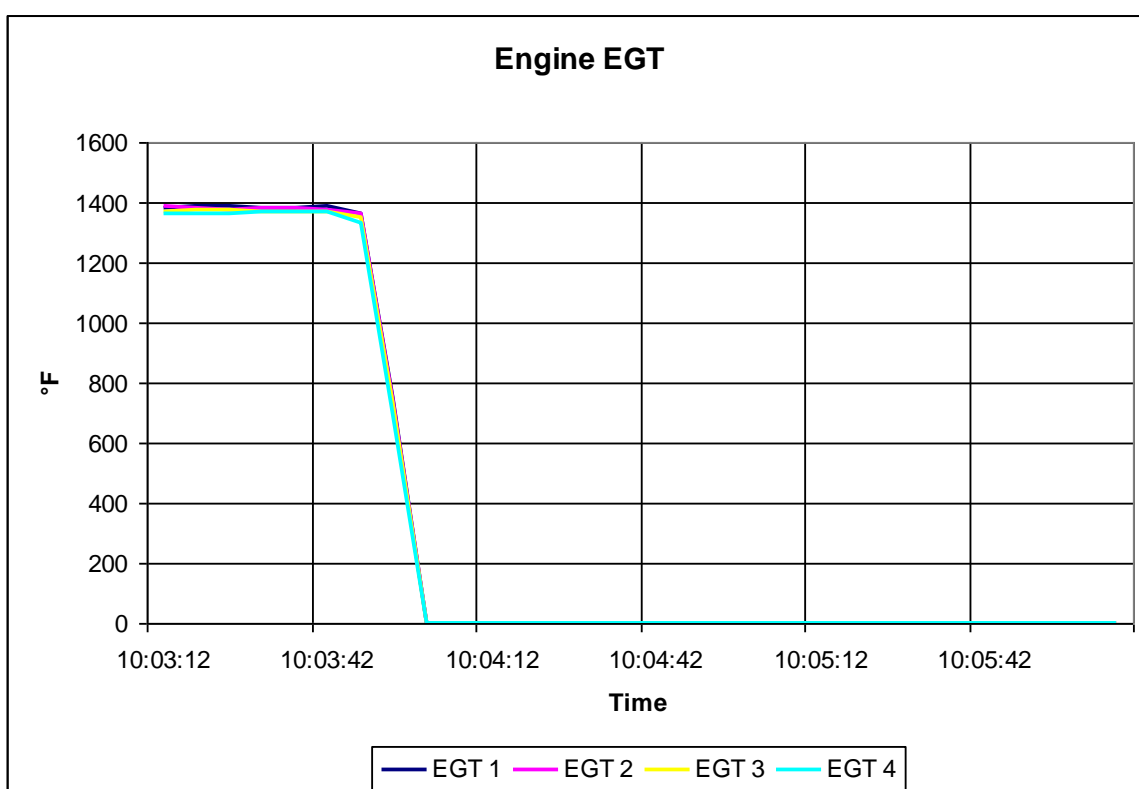
1.11.7. Engine EGT.

The evolution shows a decrease towards 0 in 12 seconds (at 10:04:00, all 4 parameters reads 0).

Temperature below 600 °F are not measured by the EGT instrument, and therefore read 0.

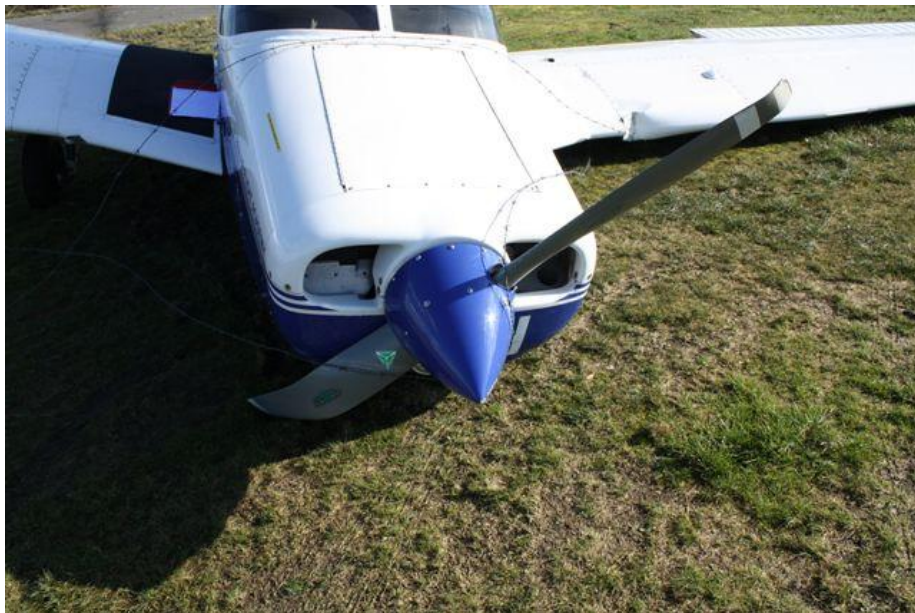
Both propeller blades were bent backwards, one blade showing more damage than the other.

The damage to the propeller show the engine was not producing power at the time of impact

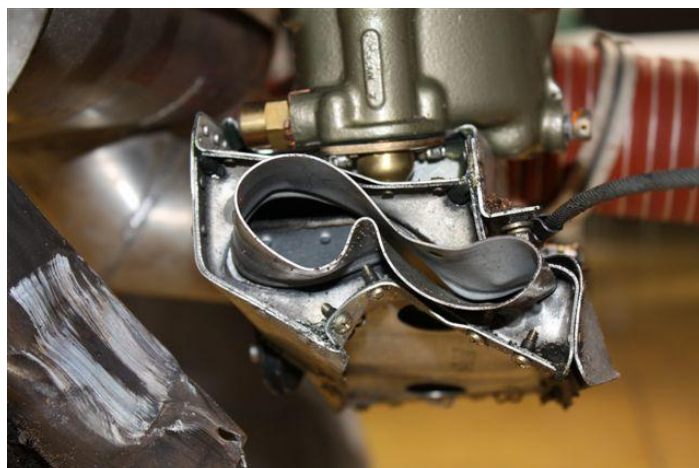
The carburetor heat box was found crushed by impact; the valve was found 2/3 in the 'cold' position.

The carburetor valve was found almost in the 'cold' position, but this position was obviously influenced by the impact.

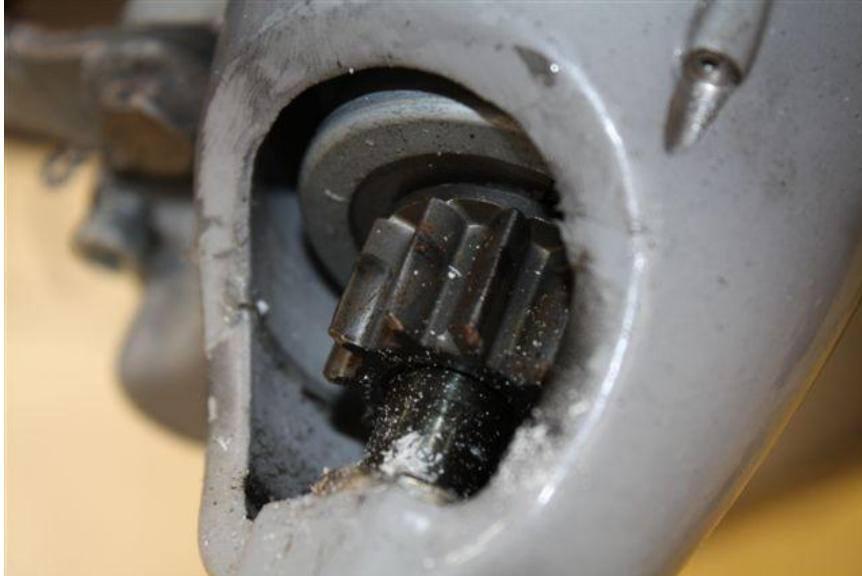
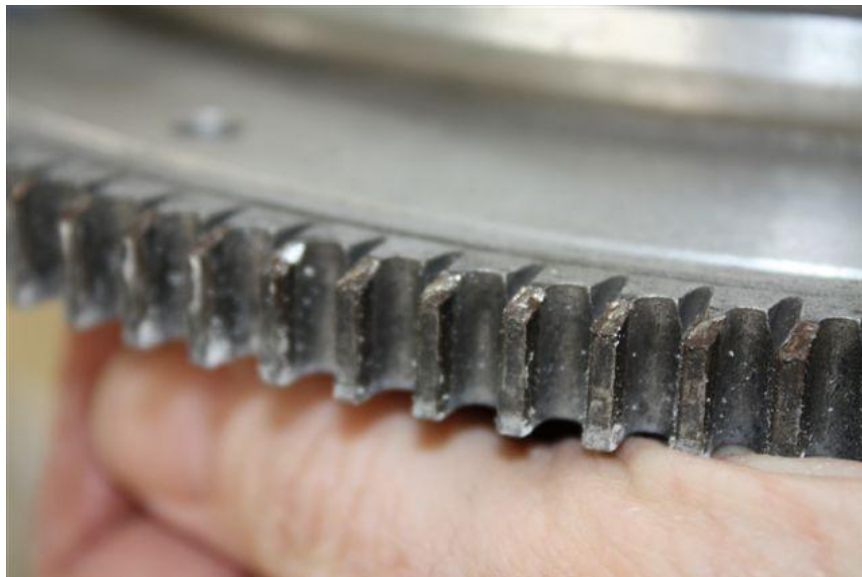
The starter clutch was inspected, and the gear still showed traces of the in-flight attempt to restart the engine.

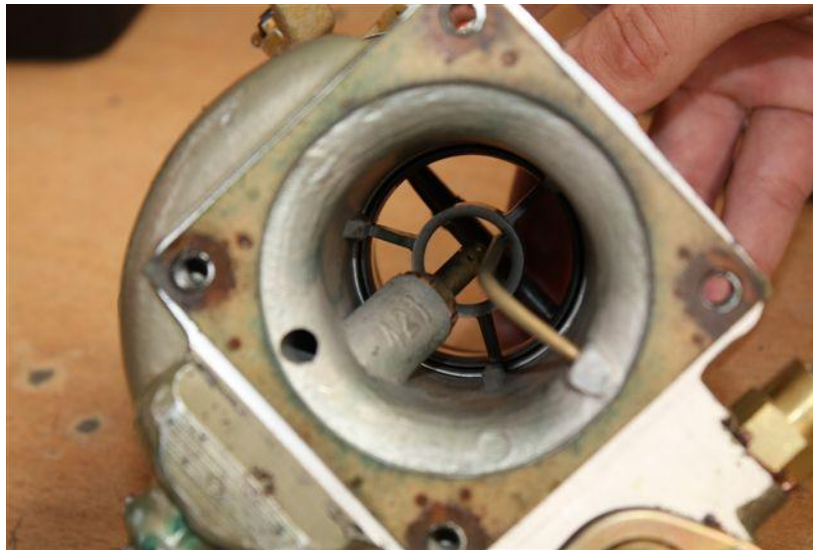
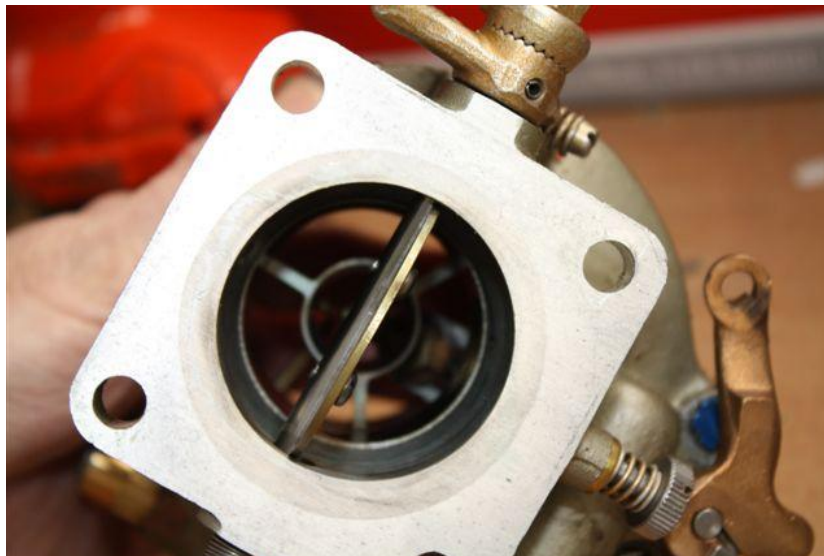
The carburetor (type LW-15986-70, Model MA-4SPA, pn 10-5217, sn CK817940) was removed and inspected. The acceleration pump was tested using the fuel remaining in the pump housing.

The carburetor bowl was clean and no contamination was found.

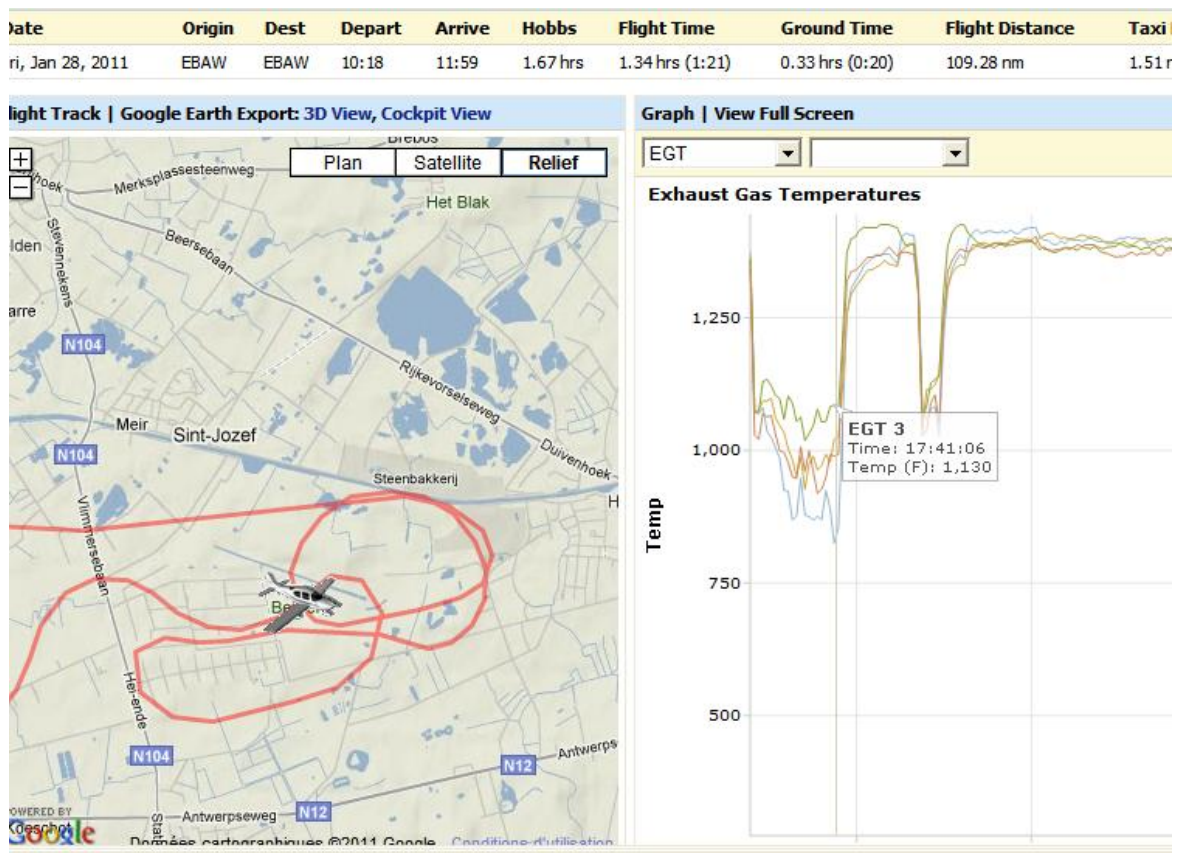
Example of EGT data for a PFL exercise.

At least 4 previous flights showed exercises of Practised Forced Landings, with flight and engine parameters similar to the ones pertaining to the accident. All these flights showed that the EGT stabilized around 1000 °F.

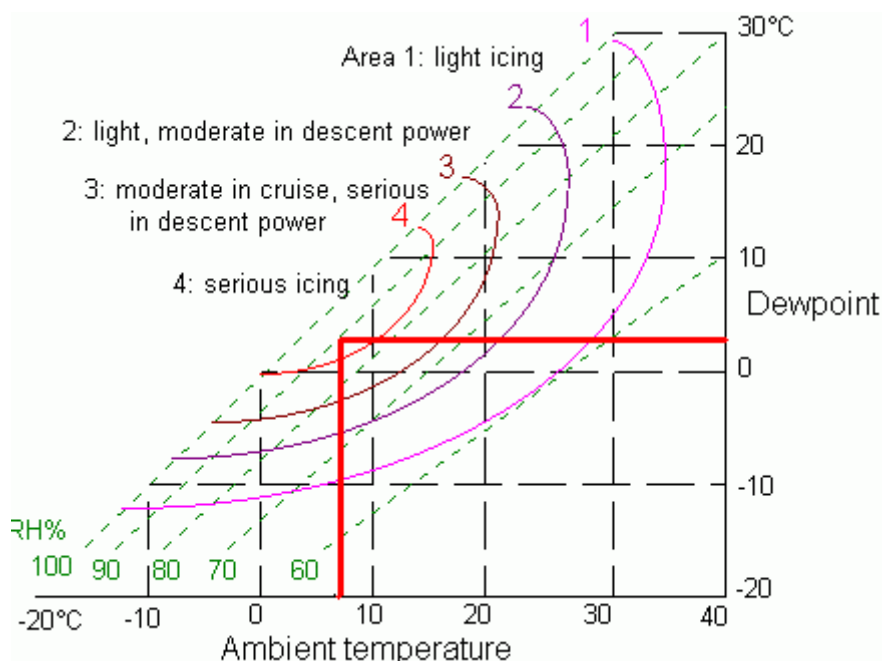
METAR in EBBR and EBLG indicate an outside air temperature of 6°C with a dew point of 3°C. The OAT measured by the airplane indicates an OAT on ground of 4°C.

These values indicate conditions that were conducive to carburetor icing.

AAIU(Be) recommends BAFA to study the possibility to equip their fleet of PA-28 with the optional carburetor ice detector, or similar device.
