Federal Public Service
Mobility and Transport
Air Accident Investigation Unit

Safety Investigation Report

ACCIDENT TO PIPER PA-18-95 SUPER CUB REGISTERED OO-KKK IN THEUX ON 16 OCTOBER 2011

Ref. AAIU-2011-25
Issue date: 2012
Status: Final R1

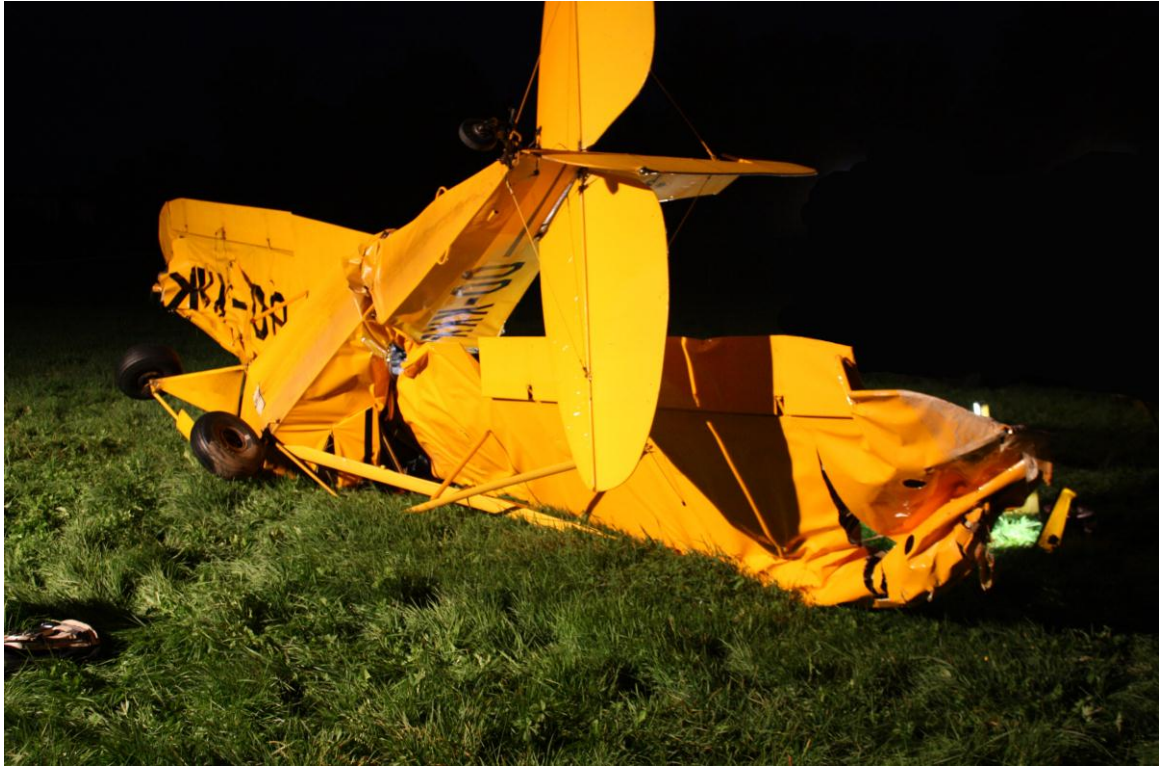
Figure 2: The crashed airplane

The aircraft was totally destroyed

The cockpit was crushed and both wings had been partially torn from the fuselage. The whole tail had been broken off with a swing to the right. The propeller blades were completely bended.

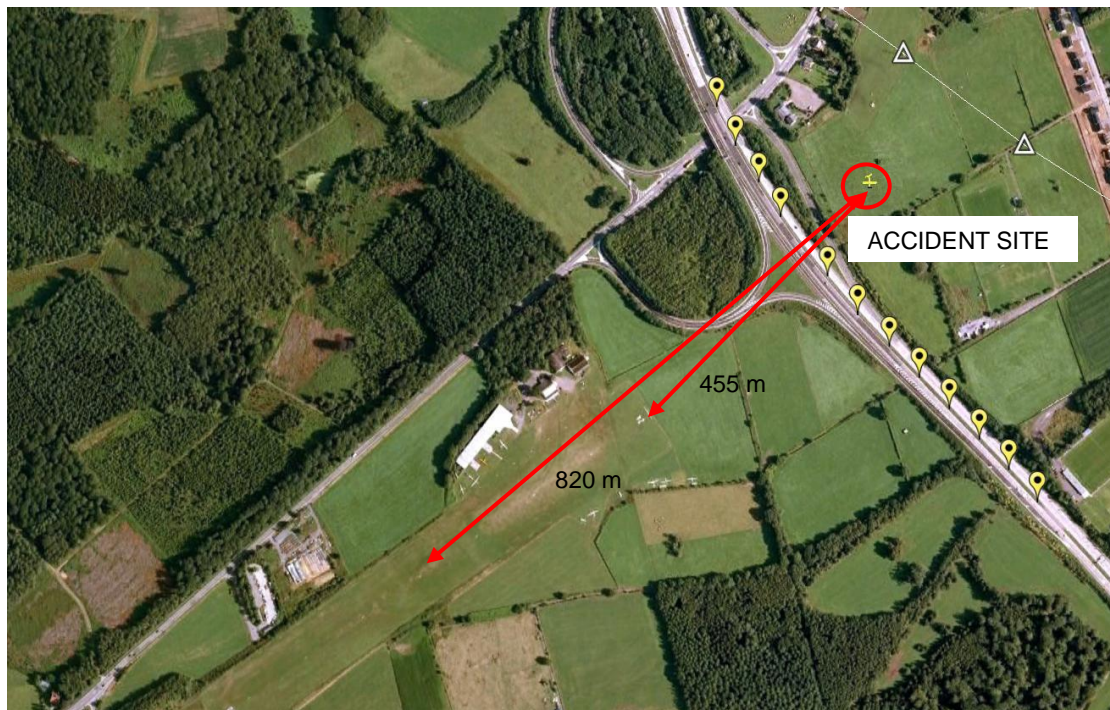
Figure 11: Accident site (with simulation of crashed aircraft)

The aircraft impacted the ground with a pitch angle of 60° relative to the horizontal with its nose toward the south.

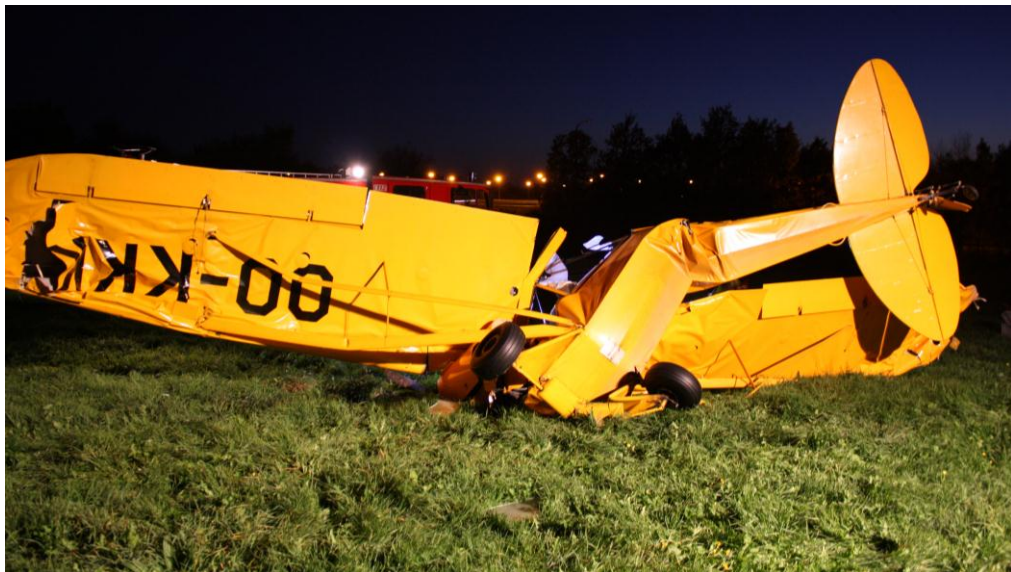
Figure 12: Wreckage

Both fuel tanks were still intact and contained fuel.

Fractures were inspected and it was determined that there was no pre-impact break-up.

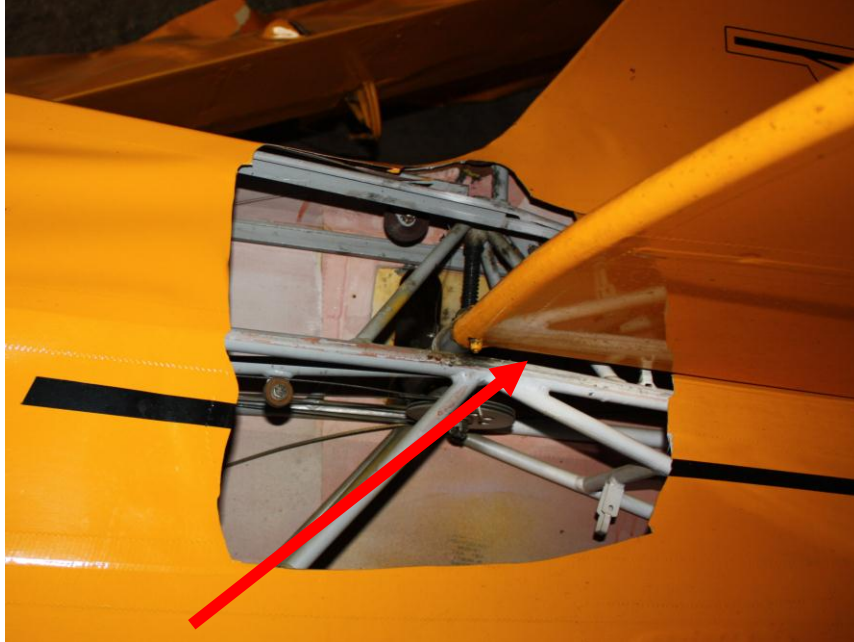
Figure 13: End position of trim jack screw

The stabiliser trim jack screw was found in the full nose up position (leading edge of stabilizer down).

- No pre-impact anomalies on the engine were found.
- The aircraft had a very high pitch during lift-off.
- The stabilizer trim was found in the full nose up position, however for take-off and climb it is recommended to put the control in the neutral position.

The cause of the accident is the improper take-off setting (stabilizer trim in full nose up position) generating a too high initial pitch of the aircraft, which caused a stall during initial climb.

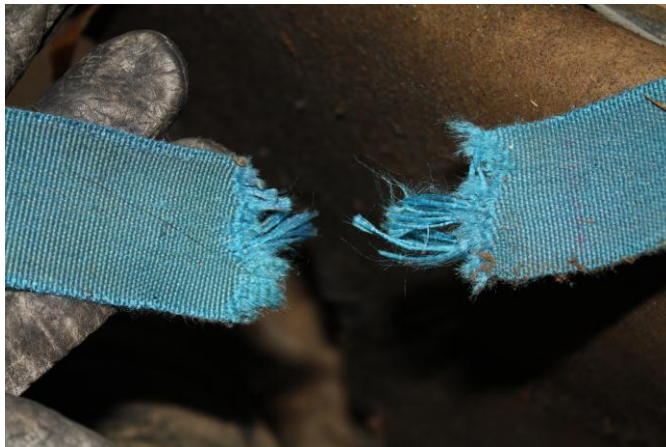
Figure 14: Torn seat-belt of passenger

The pilot and the passenger both wore their ventral safety belt. A harness was not installed nor was it required. The safety belt of the pilot withstood the crash, but that of the passenger didn't. It was torn in two between the fuselage attachment point and the buckle.

For the pilot the accident was not survivable because he was crushed between the dashboard and his seat. However, the passenger's seat stayed on its place. The passenger was smashed forward causing its belt to tear. A harness could have increased his survival chances.

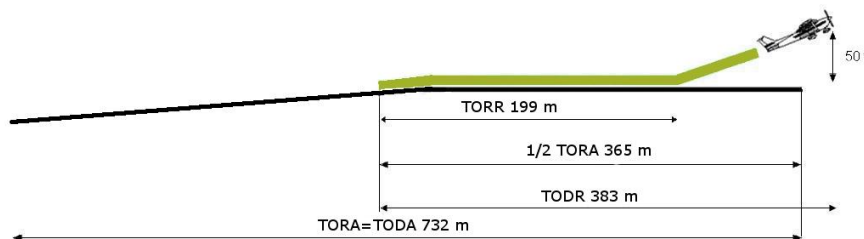
Figure 15: Take-off lengths

The calculated required take-off distances (see 1.16.1) were:

- Take-off run: 652 ft (199 m)
- Take-off distance over 50 ft barrier: 1255 ft (383 m)

The available runway length was thus more than sufficient, the used runway length was sufficient to do the take-off run, but on the limit for the take-off distance over 50 ft barrier.
