Safety Investigation Report

FINAL REPORT ON THE SERIOUS INCIDENT TO APEX AIRCRAFT DR400/120 REGISTERED OO-C AT POTTES ON 2 AUGUST 2011**

Ref. AAIU-2011-20-Pottes-OO-C**

Issue date: 7 September 2012

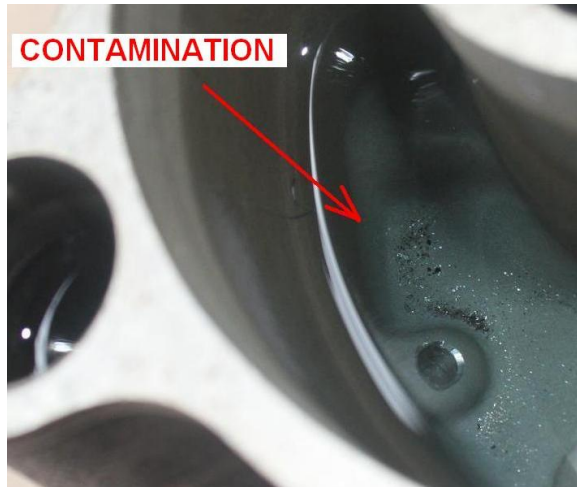
Then the carburettor was disassembled and contamination deposits of small metallic non magnetic particles and black undetermined particles were found on the bottom of the float chamber). However, it was determined that those small metallic particles did not affect the carburettor's working.

Figure 1: contamination particles

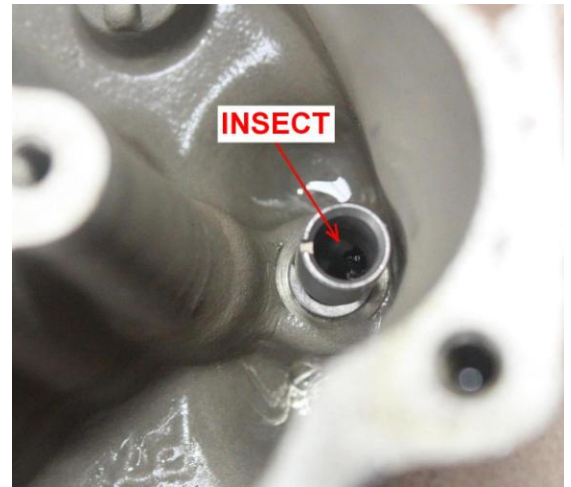
Figure 2: insect contamination

Further inspection found a small dead insect inside the fuel feed tube (housing the metering valve), at its bottom, leading to the main fuel nozzle. The insect was blocking the fuel flow to the main fuel nozzle.

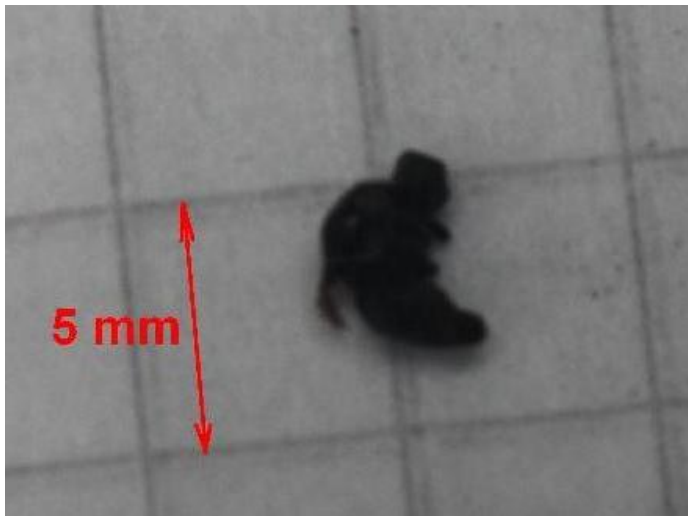
Figure 3: picture of the insect

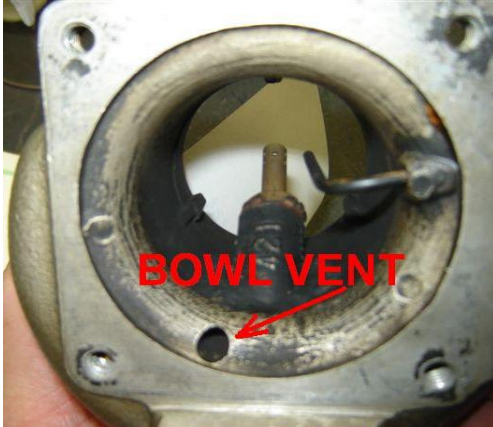
As the fuel inlet strainer was found uncontaminated and in good condition, the way the insect (fly-like) entered the carburettor float chamber was investigated and it was determined that the insect arrived in the carburettor through the bowl vent.

Figure 5: vent view carburettor intake side

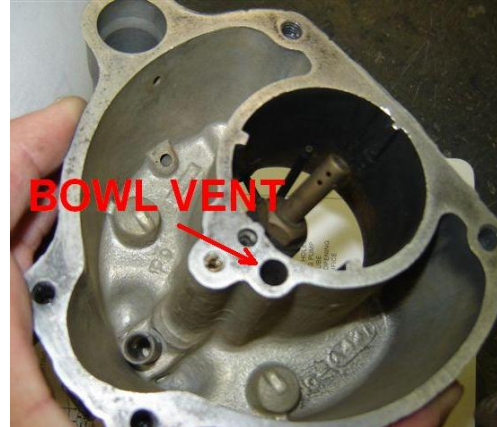
Figure 6: vent view float chamber side

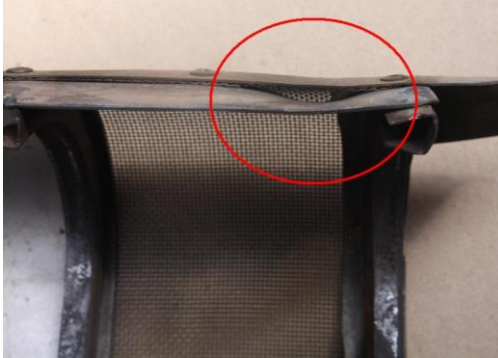
The metal strip attachments of the wire mesh of the exhaust shroud showed a deformation in two different places (Figure 7).

One rivet of the shroud was completely loose showing a significant oval hole. The two U profiles of the carburettor heater section of the shroud showed significant wear (Figure 7 and 9).

Figure 7: example of mesh wire support damage

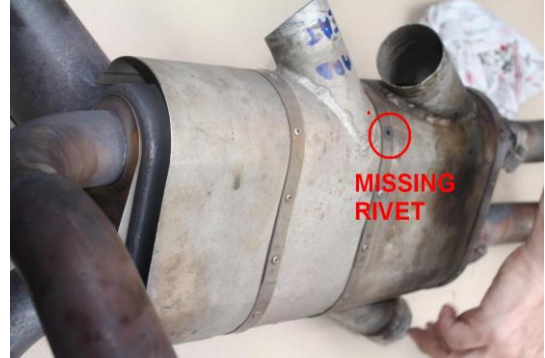
One rivet of the shroud attachment was missing (Figure 8).

Figure 8: missing rivet on carburettor heater shroud

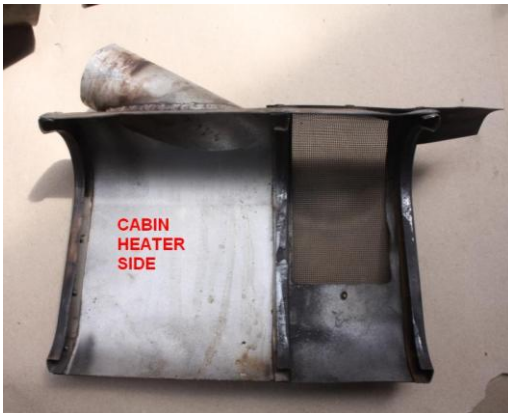
Due to the dynamic air pressure of the cabin heat side of the heater, the air stream has transferred particles from this pressurised side to the carburettor heat side. That was shown by black deposits (Figure 9) coming from the friction between the shroud and the muffler, which were only visible on the internal surface of the carburettor heater side (and not on the cabin heat side).

Figure 9: View of black deposits located inside the shroud, only on carburettor heat side

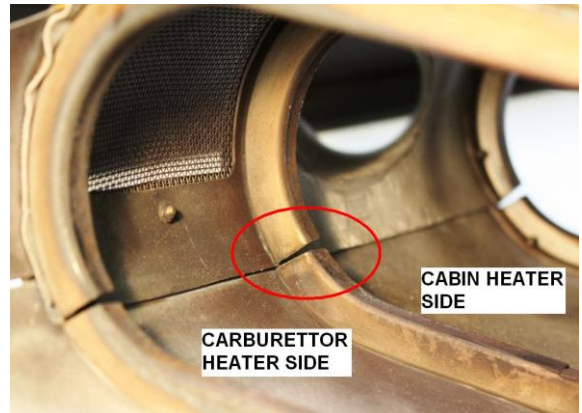
Figure 10: View of passages between carburettor heat and cabin heat chambers

The insect contamination was caused by the clearance between the cabin heat and the carburettor heat chambers of the exhaust shroud.

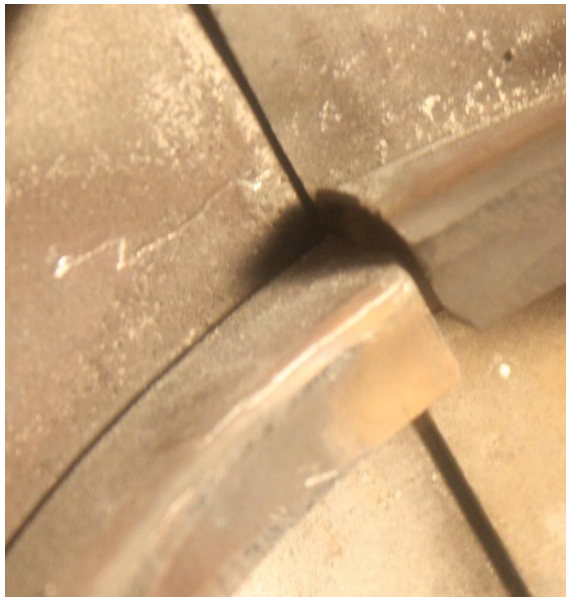
Figure 11: View of misaligned central ribs located between carburettor heat and cabin heat chambers

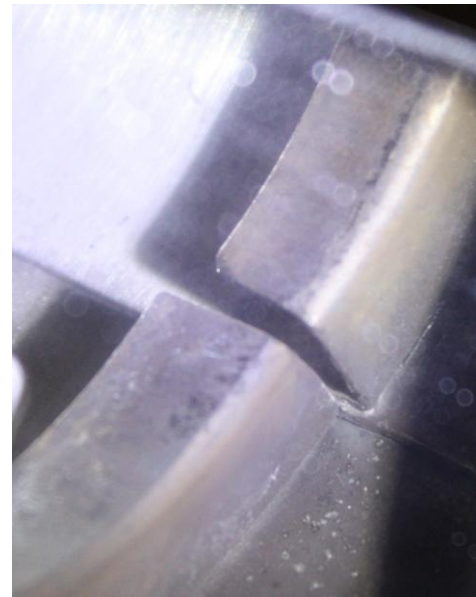
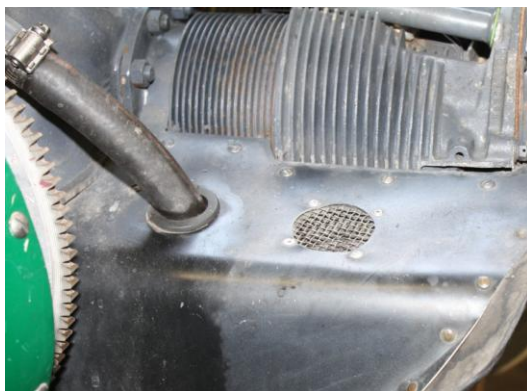
Figure 12: View of the cabin heat air intake screen featuring square openings significantly larger than the wire mesh of the carburettor heat shroud.

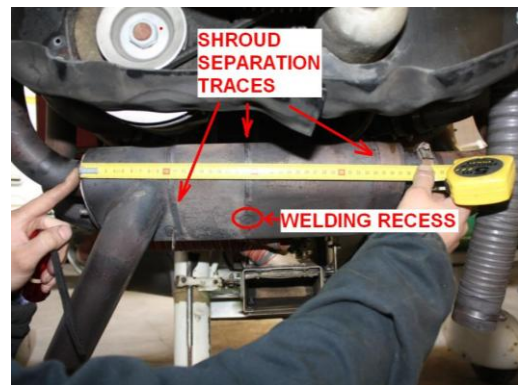
The external structure of exhaust muffler showed two deformations (welding recesses) located precisely at the separation of the cabin heat section and the carburettor air heater section of the exhaust shroud.

Figure 13: Traces of the shroud ribs onto the muffler + welding recess

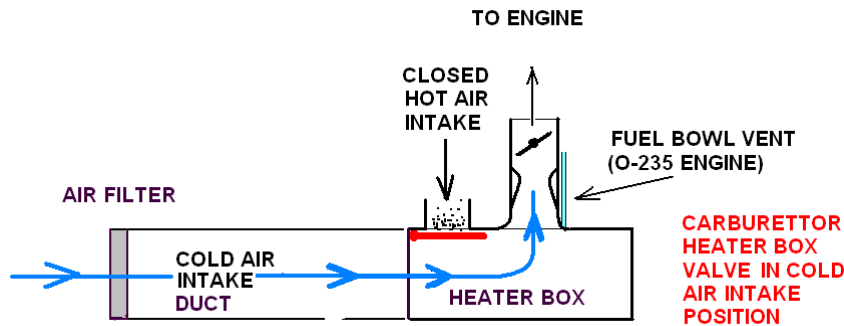
In the current design of the CEAPR pre-heater device, ventilation and cooling are only achieved by natural convection, allowing the evacuation of hot air through the wire mesh of the shroud.

Figure 15: CEAPR carburettor heater box

As seen on the above drawing, the CEAPR carburettor box valve is an open/close valve, which remains in the closed position as long as the carburettor heater is not selected by the pilot. This system is likely to capture contaminants during the entire flight and may later release them when the pilot uses the carburettor heater system.

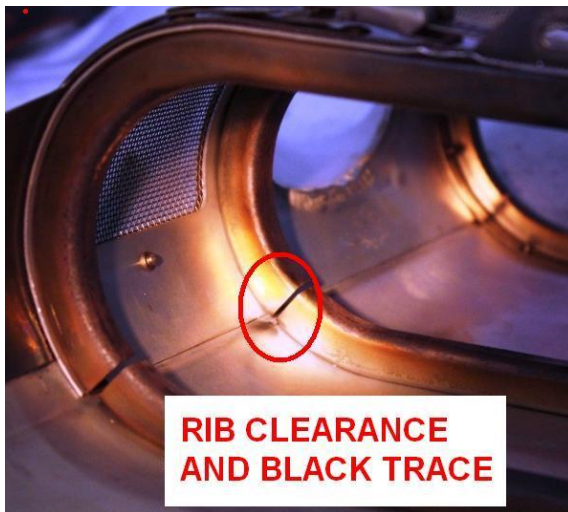
Figure 18: Newly installed shroud

We found that the newly installed shroud showed approximately the same configuration as the old one, as a consequence a clearance at the junction of the ribs was present.
