Safety Investigation Report

ACCIDENT TO RANS S-6ES COYOTE II AT EBBZ ON 21 OCTOBER 2012

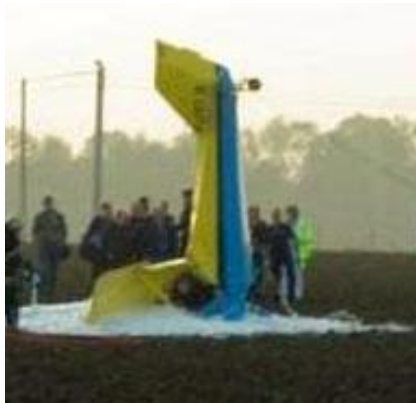
The airplane collided with the ground vertically and remained in vertical position after the crash until the rescue services cut the wing rear attachment in order to gain access to the victims.

When the investigators arrived on the crash scene, the fuselage had been moved down but the engine and the wings were left in the original position of the crash.

After removal of the fire extinguishing foam surrounding the wreckage, it could be determined that there was only one impact area in the ground, proving that the airplane collided with the ground almost vertically.

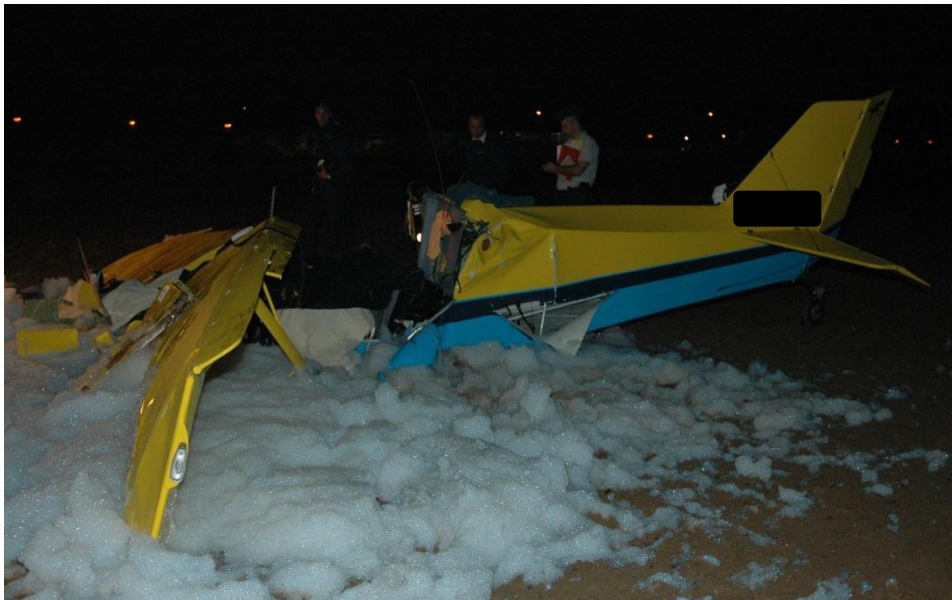
The wreckage was oriented with the nose pointing south and the tail pointing north, toward the threshold of runway 34. Both wing chords made an angle of

around 80° with the ground and the leading edges were in contact with the ground. The engine was partially buried in the soft ground and partially pushed inside the lower front part of the fuselage. The propeller showed two undamaged blades while the third blade was broken at the root and was buried in the ground.

The BRS parachute had not been activated and its control cable had been deactivated by the rescue services for safety.

First investigation on the crash site showed that the wreckage was complete and did not reveal any obvious pre impact structural failure.

Both fuel tanks were filled up to their filler cap, taking into account the position of the wings as seen on the above picture.

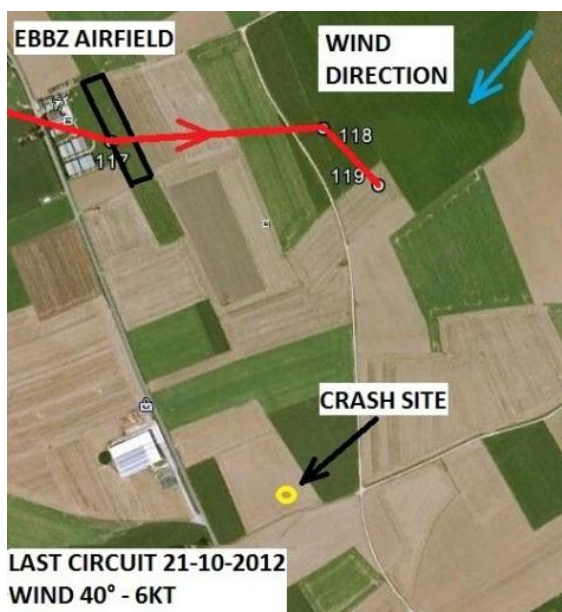
The GPS data of the last flight was found incomplete, ending in the middle of the downwind landing pattern.

The last missing part of the flight could have been caused by the buffering that occurs within the application software combined with the time required to write the data to the SD card.

The crash occurred 640 meters South South-East of the threshold of runway 34 in the runway prolongation (Axis).

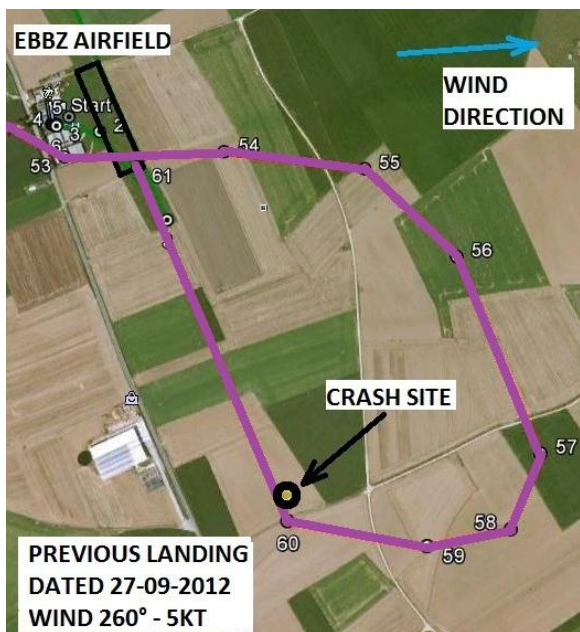
The hereby enclosed picture shows a turn made when a 5KTS wind was coming from 260°.

The GPS picture shows a relatively constant 180° turn.

The pilot had obviously no difficulty to align the airplane on the final leg.

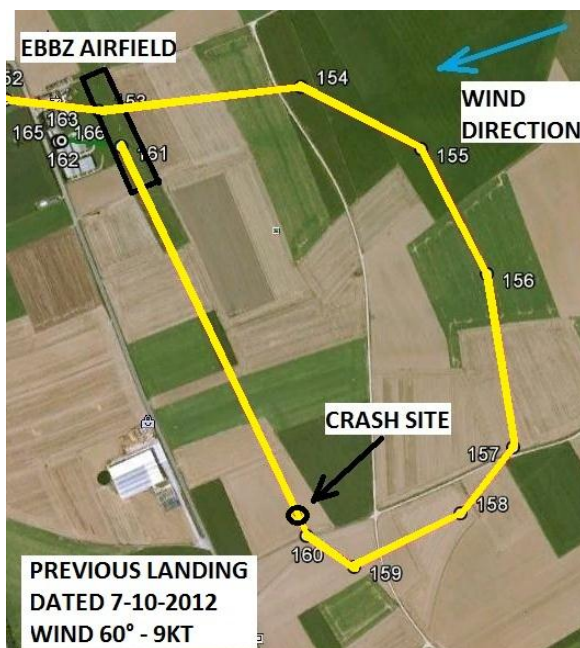
A landing performed on 7 October 2012, a few days before the accident, gives an idea of what could have been the fatal last turn.

The wind speed and direction on the day of the accident (40°- 6KTS) and the 60°- 9KTS wind speed and direction of 7 October 2012 would have caused almost the same difficulty to align on the final leg.

Reportedly, the last turn to align in final is more difficult to handle when the wind is coming from east. However, a 9 KTS wind coming from 60° would be acceptable for a properly trained pilot.

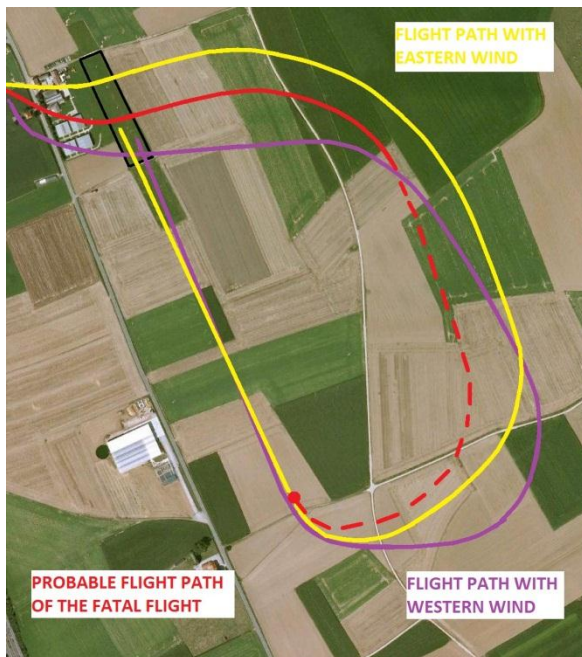
The pink flight path shows a landing circuit performed with a western wind having as consequence a large radius of the last turn to align on final leg.

By contrast, the yellow flight path of a landing circuit in an eastern wind shows a smaller radius of the last turn.

The red flight pattern is a simulation of the probable flight path of the fatal flight, illustrating the difficulties the pilot likely encountered to align the airplane on the runway axis.
