Safety Investigation Report

Ref. AAIU-2013-16
Issue date: 1st April 2016
Status: Final

Classification:	Accident
Level of investigation:	Standard
Date and time:	Sunday 02 June 2013 at 13:59 UTC
Aeroplane:	Apex aircraft DR 400/140 B (former Robin). The aircraft was registered in Belgium and held a Certificate of Airworthiness and a valid Airworthiness Review Certificate (ARC).
Owner:	Noordzee Vliegclub VZW, a flying club based in EBOS
Total flight time:	1255:20 FH
Engine:	One Thielert TAE 125-02-99 SN: 02-02-03166
Accident location:	Ostend airport (ICAO: EBOS)
Type of flight:	General Aviation - Cross-country
Phase:	Landing
Persons on board:	4
Injuries:	None

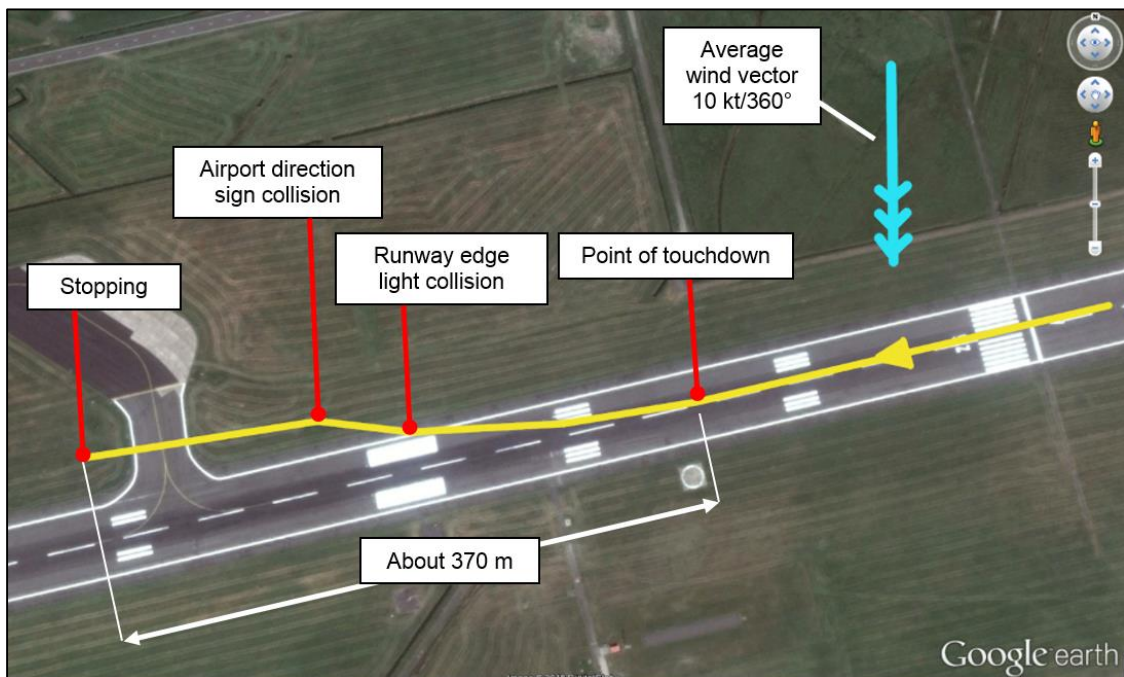
Figure 1: rolling path reconstruction

As seen on Figure 1, the different phases of the runway excursion were reconstructed based on records from the action camera that the pilot installed on board for this flight. The rolling distance between the touchdown point and the position where the aeroplane came to a full stop has been determined to be about 370 m.

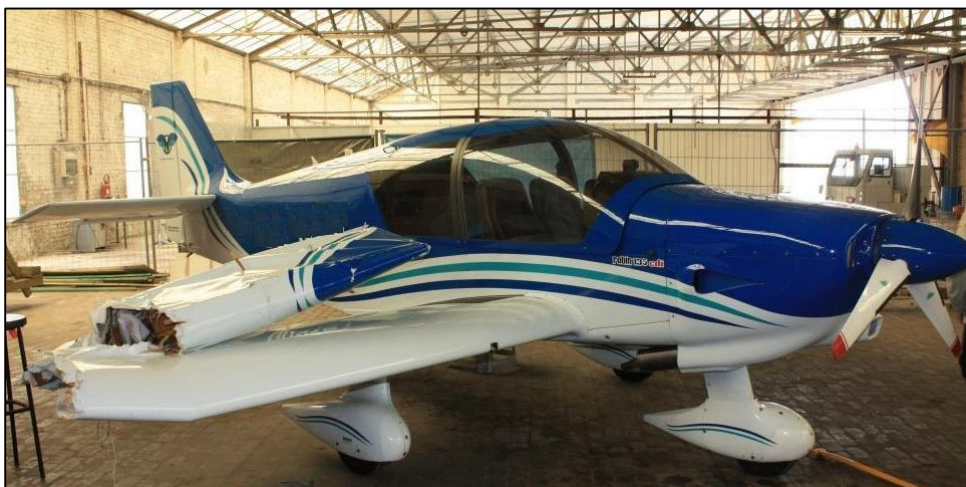
Figure 2: general view of the damage

The aeroplane suffered extensive structural damage to the right wing. The outboard part from the tip to the dihedral change was torn off. The fairing of the left landing wheel was destroyed and the fairing of the nose wheel was damaged on its left side.

The aeroplane was disassembled at Oostende and transported to a maintenance organization located at EHMZ. The wing was thereafter repaired by “CEAPR Maintenance”, a specialized repair station belonging to the aeroplane’s manufacturer. Thereafter, during the reassembly of the repaired wing and the repair of other damages caused by the accident, a 6 years inspection was carried out.

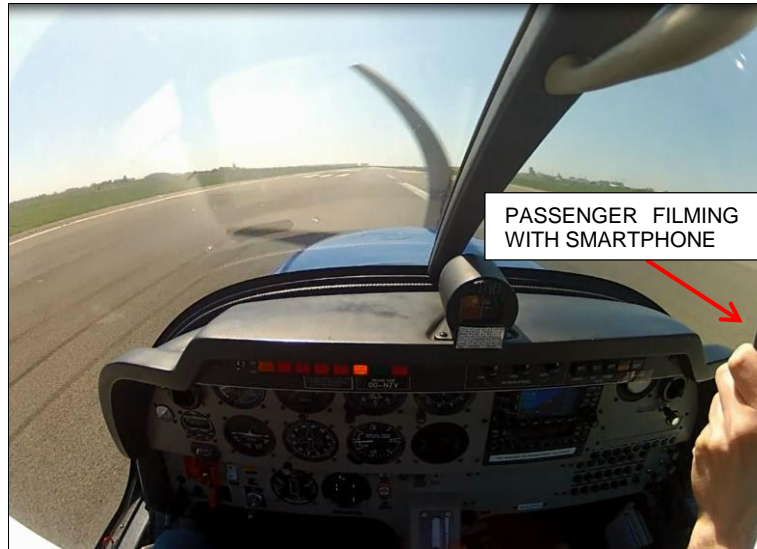
Figure 4: Touchdown – reference time: 0 – Airspeed about 62 kt

- The touchdown airspeed was determined to be about 62 KIAS, which is above the maximum recommended touchdown speed of $1.15 V_{SO}$ (54 KIAS)
- The aeroplane started to deviate just after the touchdown. However, the almost simultaneous touchdown on the main and nose landing gear made it impossible to verify the pilot's statement that the aeroplane started to deviate when the nose landing gear contacted the runway.

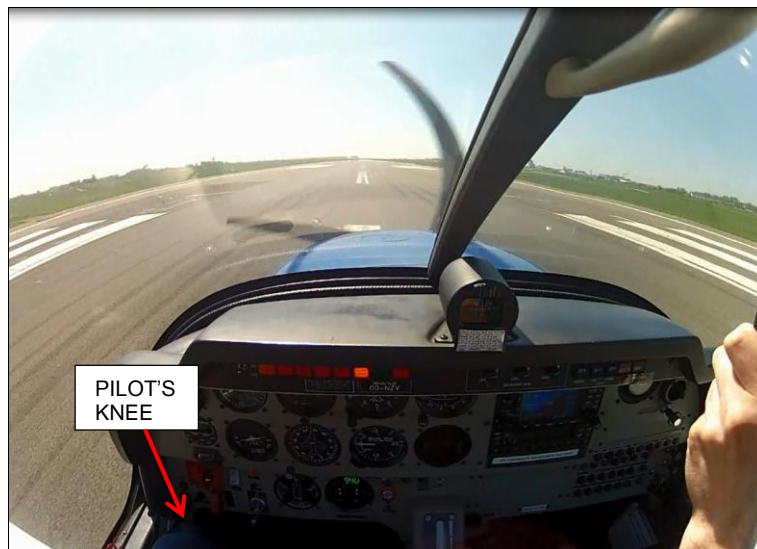
Figure 5: The A/C begins to deviate to the right
Time: 2 seconds after touchdown - Airspeed about 61 kt

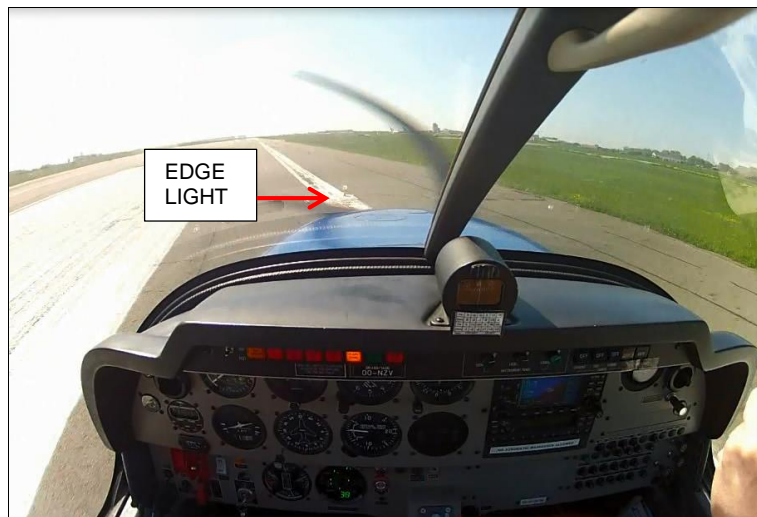
Figure 6: Just before hitting the edge light with the left wheel fairing
Time 6 seconds after touchdown – Airspeed 52 kt

- From the images, it was impossible to determine the stick movement during the landing and subsequent roll out.
- A runway edge light was hit by the left or by the nose landing gear.

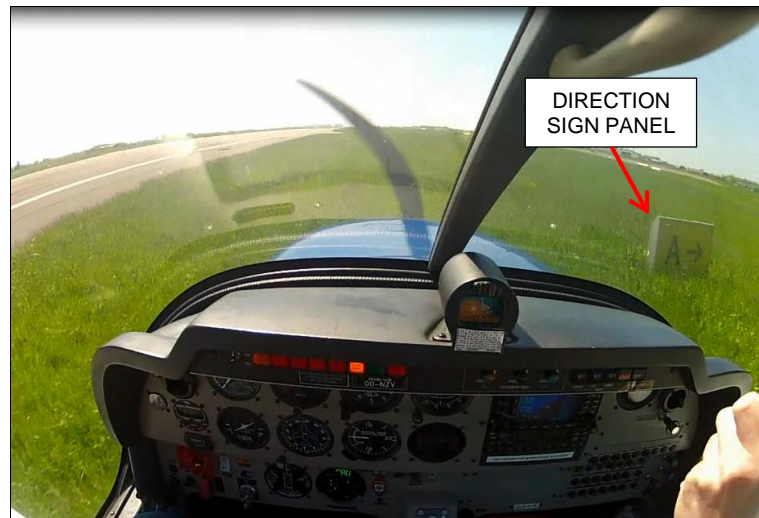
Figure 7: Just before colliding with the direction sign panel
Time 9 seconds after touchdown - Airspeed 45 kt (Edge of the white arc)

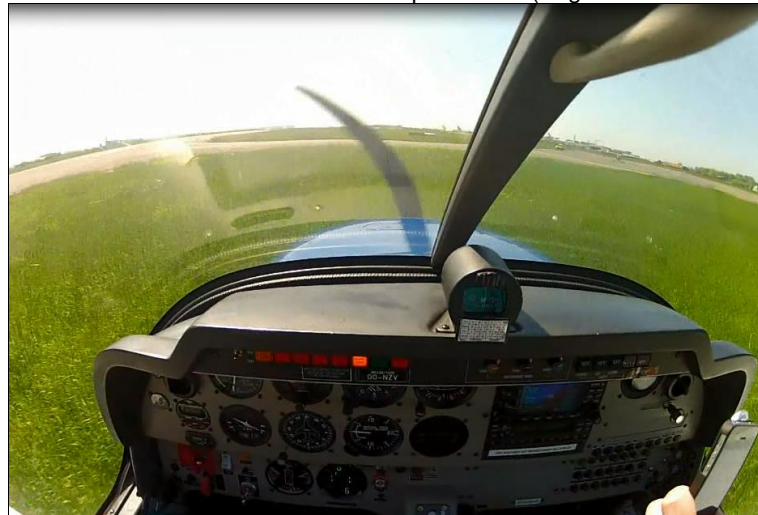
Figure 8: Time 12 seconds after touchdown – Airspeed 35 kt

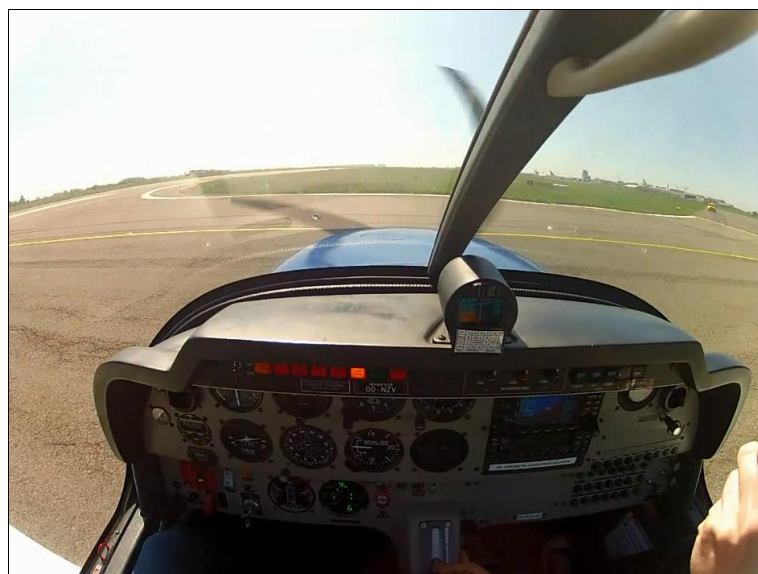
Figure 9: Time 15 seconds after touchdown – Airspeed needle close to the stop

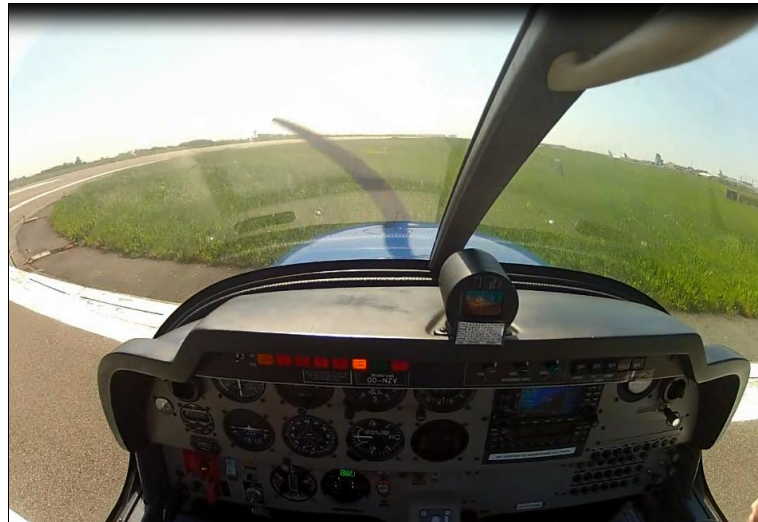
Figure 10: Time 19 seconds after touchdown, just before stopping
Airspeed needle on the stop

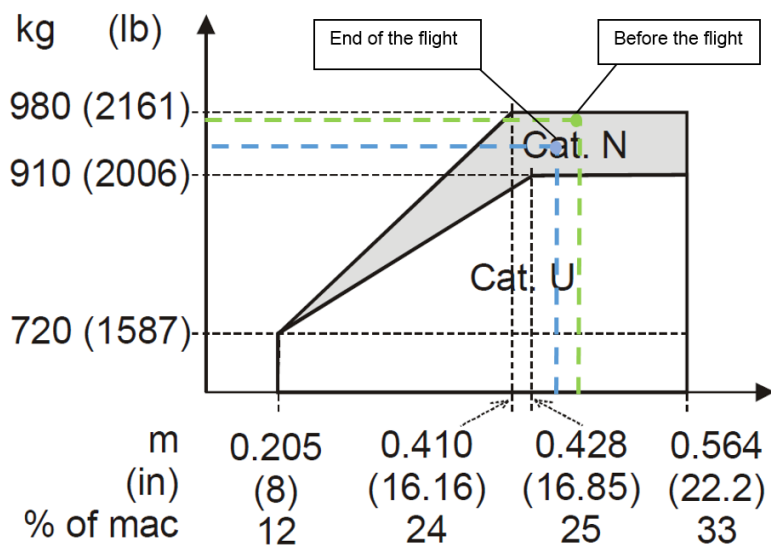
Figure 17: CG positions before and at the end of the flight

As can be seen on figureFigure 17, the weight and balance was within limitations.

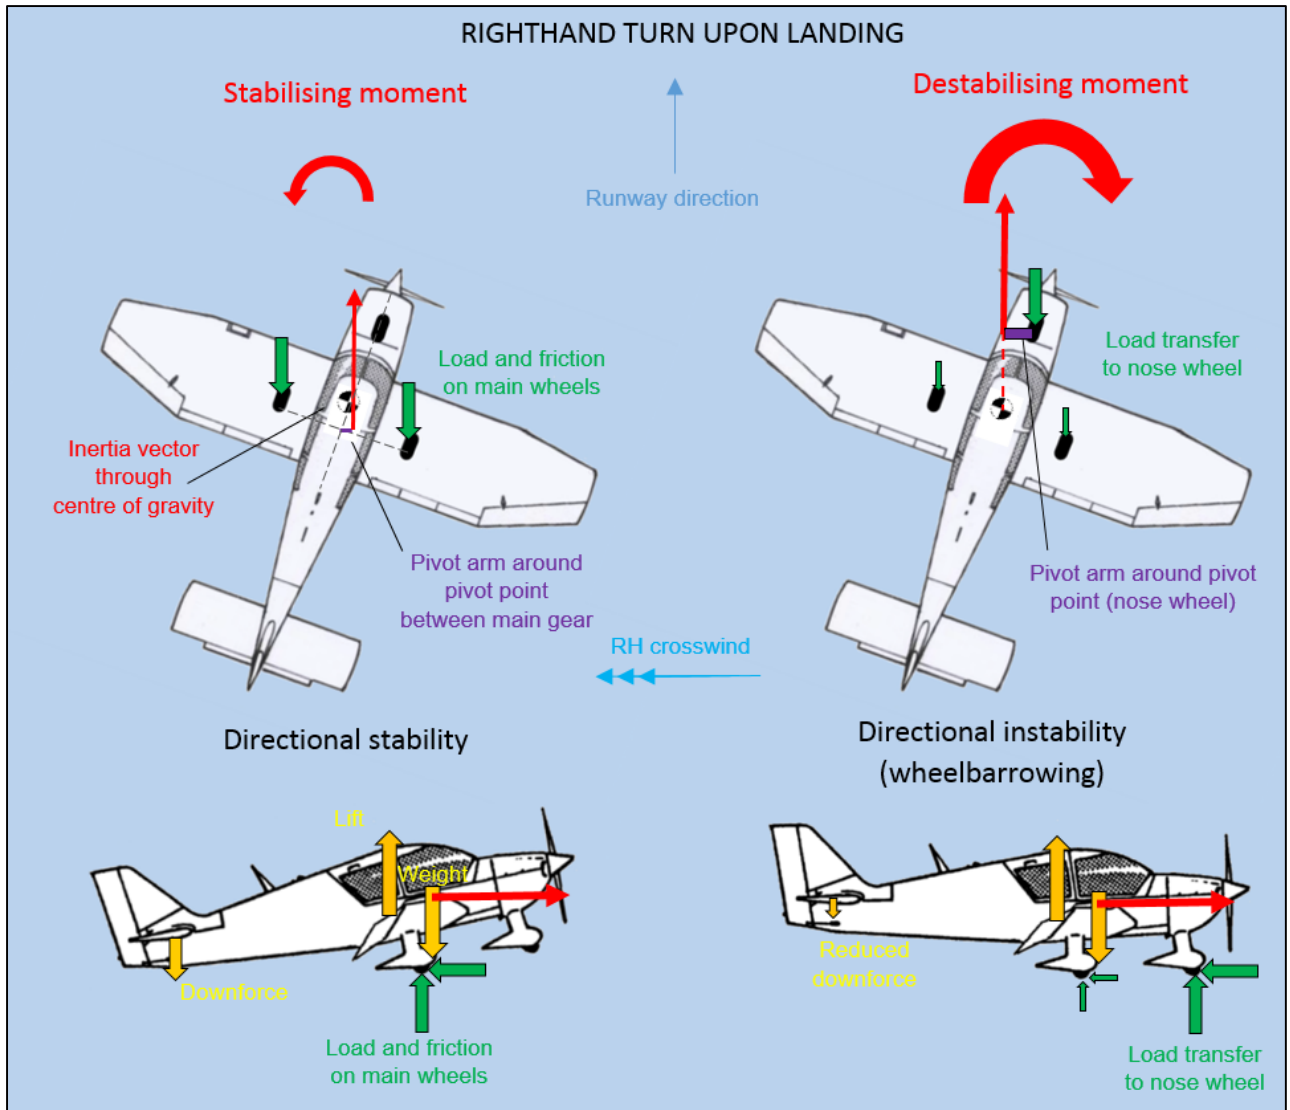
Figure 23: Wheelbarrowing effect with right hand crosswind

Furthermore, when the weight of the aeroplane becomes concentrated on the nose wheel due to not applying adequate back pressure when landing with full flaps at excessive airspeed, the above phenomenon is aggravated. This condition is called 'wheelbarrowing'. The aeroplane will then tend to turn around the nose gear instead of the main gear. Because in that case the centre of gravity is lying behind the pivot point (like a taildragger), the aircraft will get directionally unstable, which will be hard to counteract without releasing the load on the nose gear.

It is advised that, using this report, instructors emphasize the need for proper attitude and airspeed control during approach and landing, particularly in crosswind conditions, and also instruct how to recover from the phenomenon 'wheelbarrowing' if it is ever experienced.
