Safety Investigation Report

Ref. AAIU-2013-01-EBHN

Aircraft: Robinson R-22 Beta II, msn 4133. The helicopter was registered in Belgium and held a Certificate of Airworthiness and a valid Airworthiness Review Certificate (ARC)

Accident location: On EBHN airfield

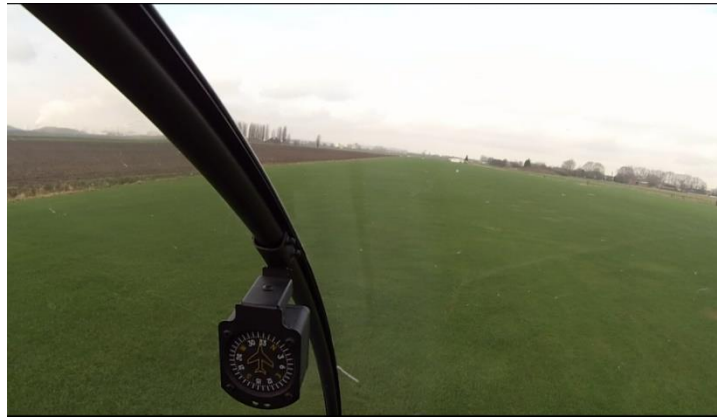
Fig. 3: Hover taxi towards the EBHN hangars.

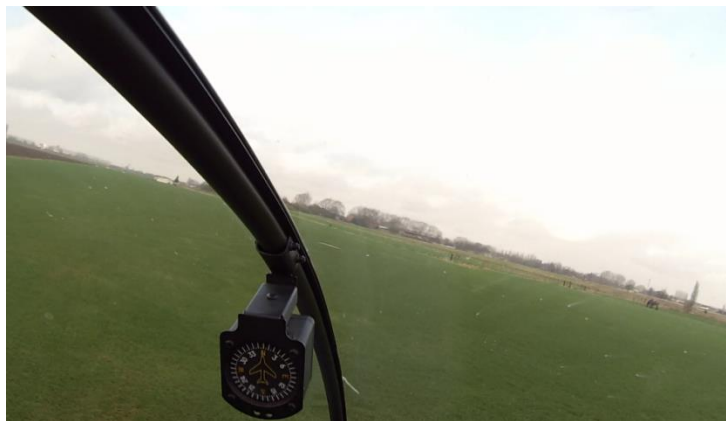
Fig.4: 09 min 37secs: nose deviates to the right.

On the day of the accident, when the helicopter was hover taxiing along the runway, on a heading of 333° the wind was blowing from the left (240°). The student let the helicopter nose to turn right and thereafter tried to correct with left cyclic. The helicopter banked to the left, allowing the rear of the left skid to contact the ground.

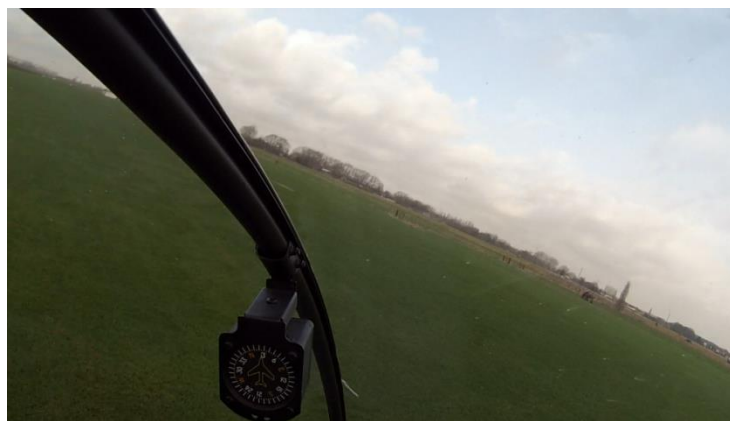
Fig. 5: 09min 38secs: LH skid touches the ground

The impact traces on the ground and inspection of the left skid show the rear of the skid contacted the ground. The traces show further the impact of the rotor blades with the ground.

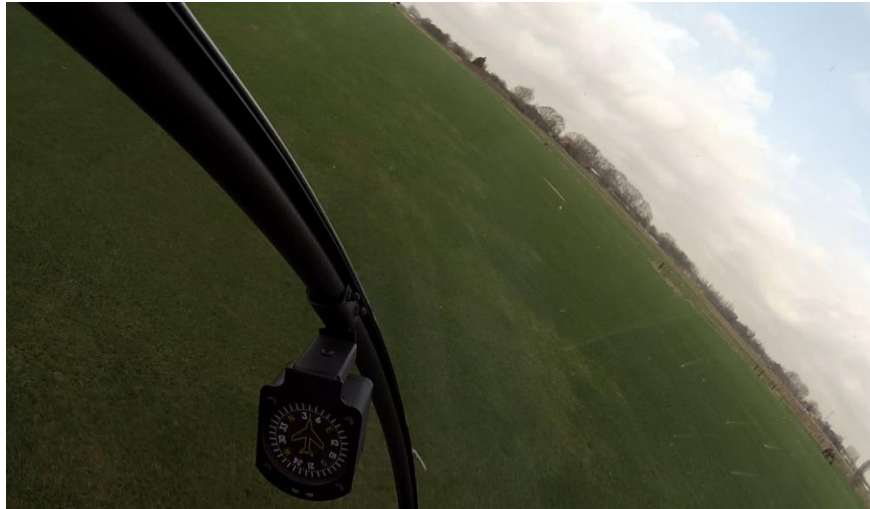
Fig. 6: 09min 39 secs: dynamic rollover

The instructor reacted by pulling the cyclic to the right but too late to avoid the dynamic rollover.

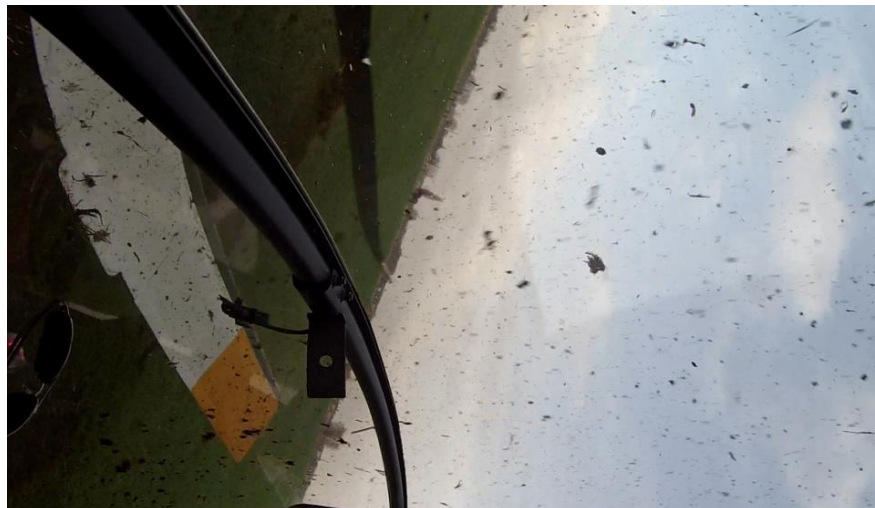
Fig. 7: 09min 40secs: Helicopter rolls over.

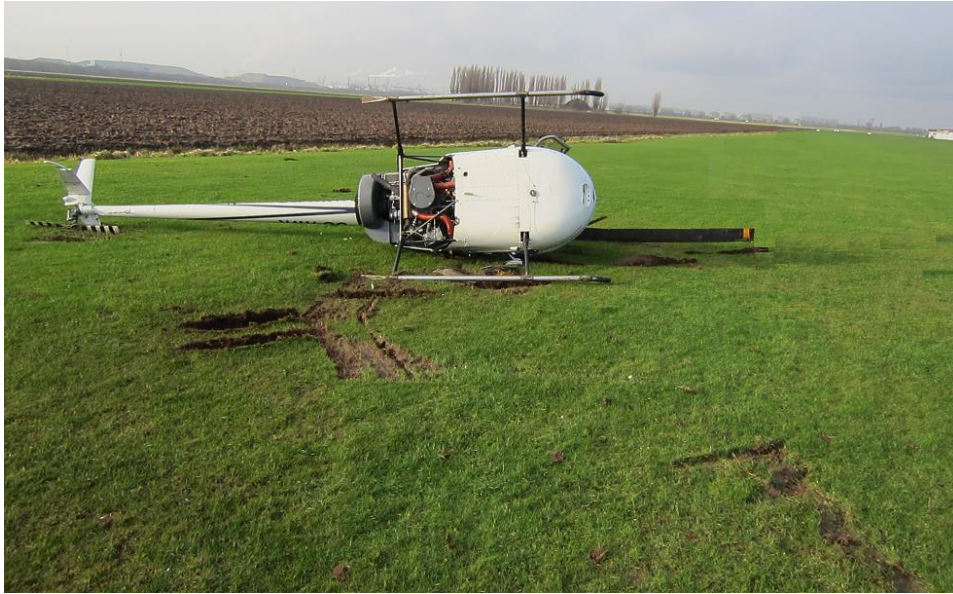
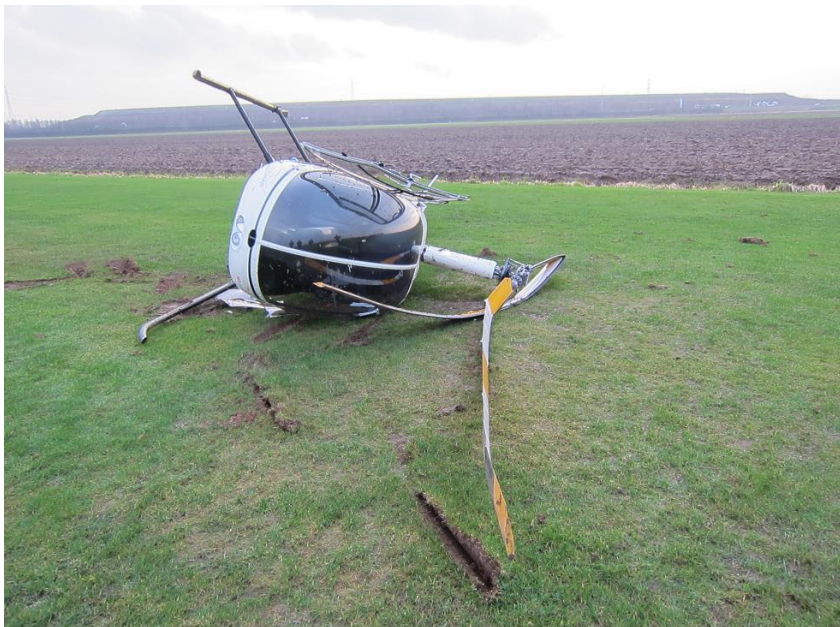
One main rotor blade is broken.

Damage to the helicopter structure; Vertical firewall deformed. Tail boom deformed on both ends. LH door window broken.

The wreckage was inspected on the day after the accident. All damage found are consistent with a dynamic rollover.
