## Safety Investigation Report

# RUNWAY INCURSIONS AT BRUSSELS AIRPORT - EBBR

Ref. AAIU-2014-EBBR-RI  
Issue date: 22 August 2014  
Status: Final

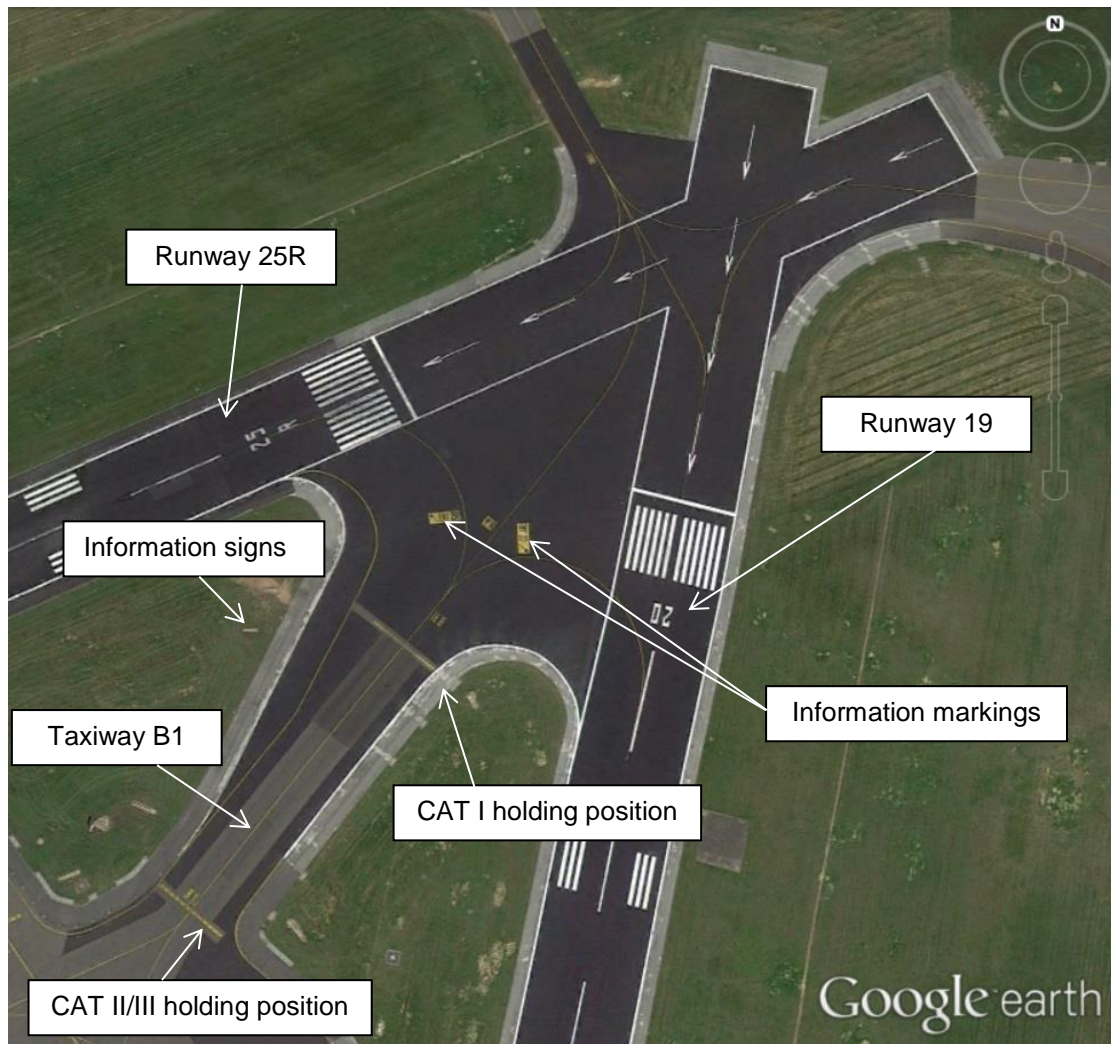
RWY 25R and RWY 19 are intersecting runways in a V-shaped configuration. This is a geometry where two runway ends commence from the same location but proceed in different directions. There is one common taxiway B1 to enter both runways. This taxiway has two holding positions;

Figure 1: Aerial view taken on 7 July 2013. Runway 20 has become runway 19 as from 19 September 2013

There's no doubt that the layout of the runway entry where one taxiway leads to two runway ends is the root cause of the occurrences. ICAO Doc 9870 also mentions that an important factor in preventing runway incursions is to limit the physical possibility for pilots and vehicle drivers to mistakenly enter runways.

AAIU(Be) strongly recommends that the Brussels Airport Company undertakes a study to redesign and reconstruct the entry of the concerned runways by splitting the end of taxiway B1 into two individual taxiways, leading respectively to runway 25R and runway 19 and each provided with stop bar lights to clearly indicate the inactive runway. All this to mitigate both the risk that flight crew enter the wrong runway after having passed the holding position sign and the risk that flight crew enter the protected area of the other runway by making their entry turn to wide. This study should finally lead to a concrete proposal of redesign to the BCAA.

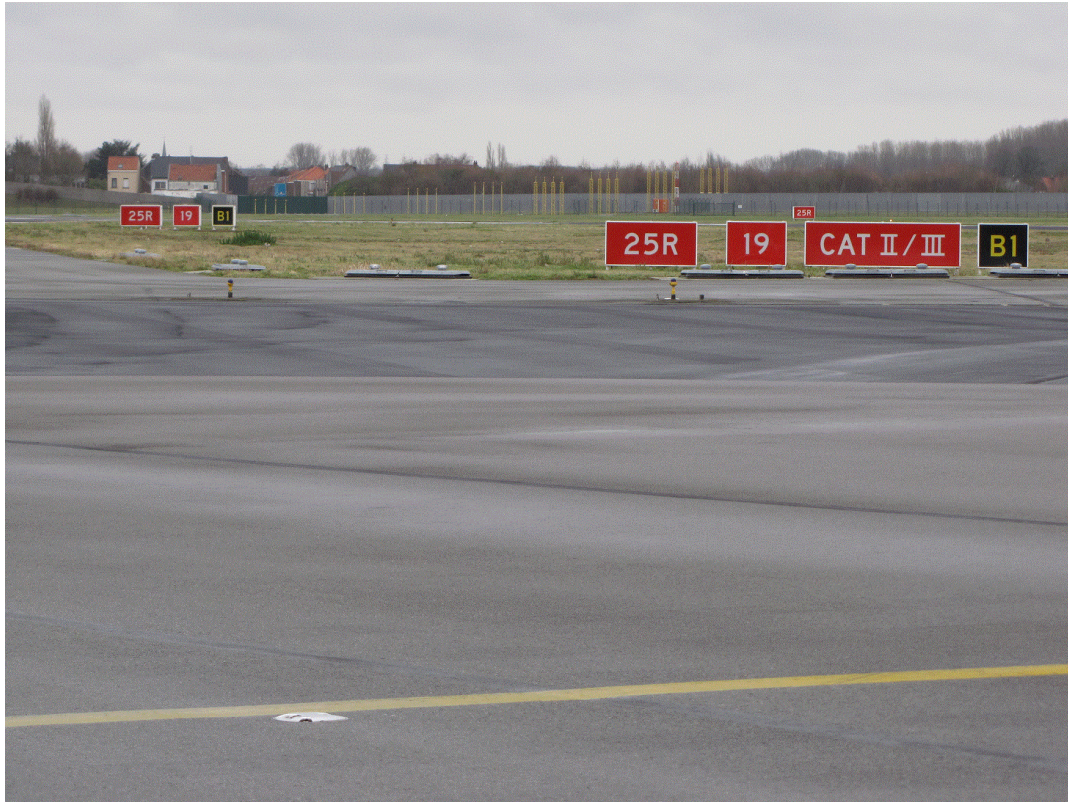
Figure 2: Holding point signs right-hand side at taxiway B1

Mandatory instruction (red boards) signs are located on both sides of the taxiway; they do not show arrows, only the reference of the runway. Information boards, are also located on both sides of the runway, and they do feature arrows.

Considering that crew are looking primarily to red boards they may discard valuable information – such as the arrows on the yellow (information) boards.

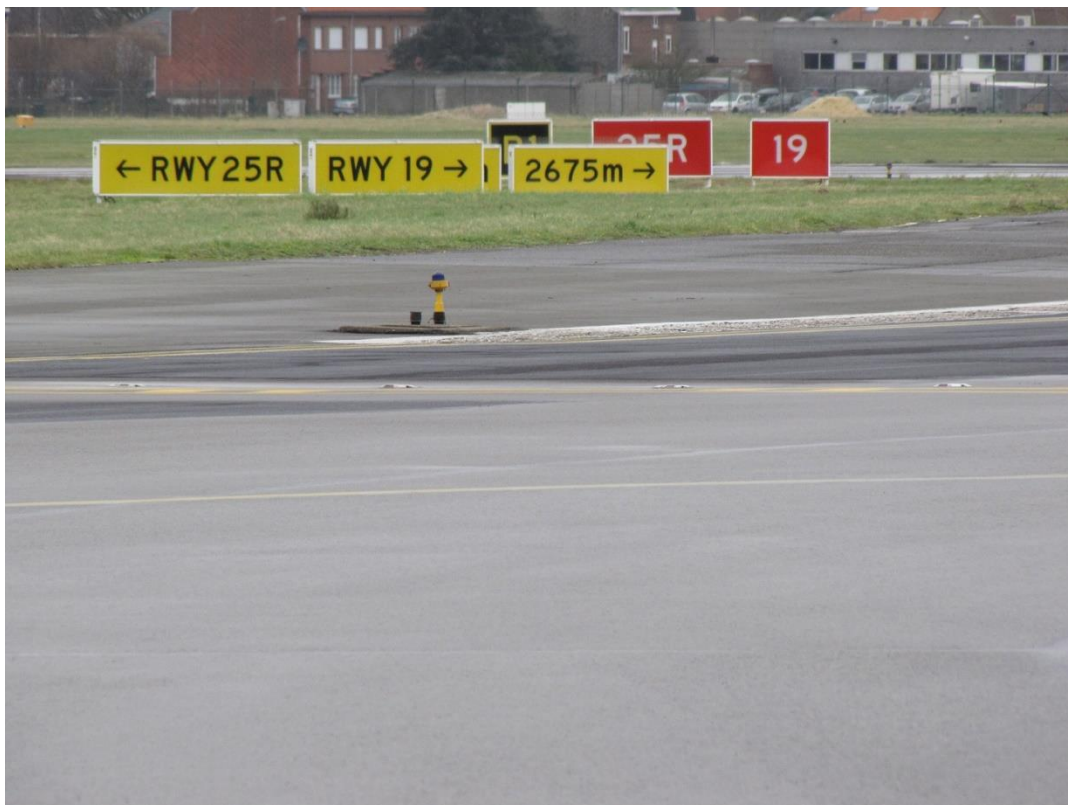
Figure 3: Holding position signs and information signs left-hand side at taxiway B1

All mandatory instructions signs and markings are in compliance with ICAO standard practices. On the left hand side of TWY B1, information signs give the direction of both runways 25R and 19.

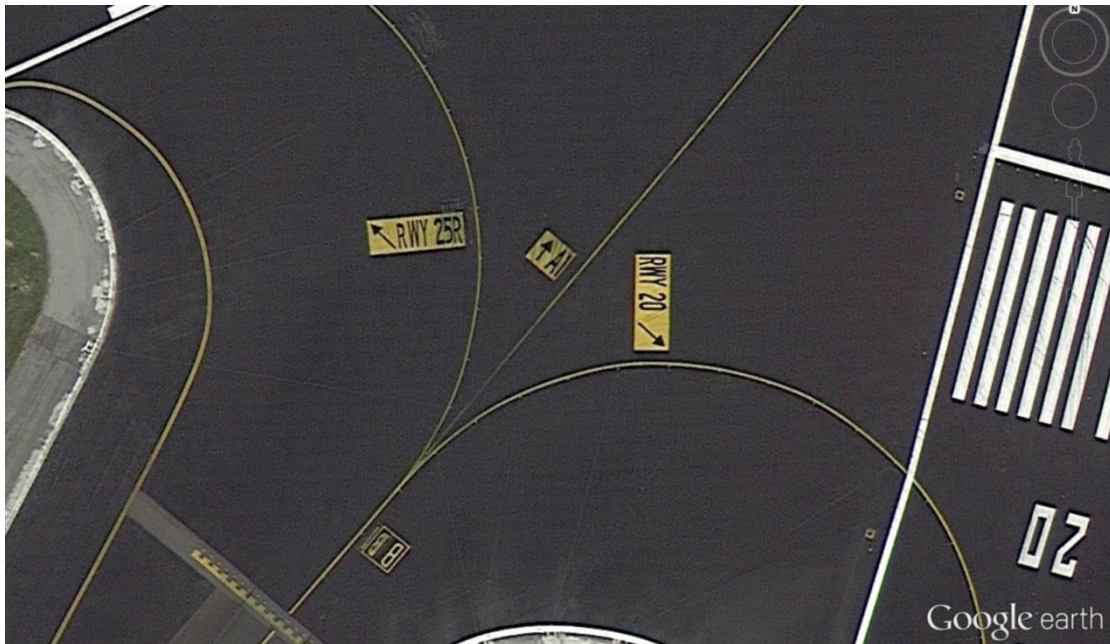
Figure 4: Zoom on the instruction markings at TWYB1

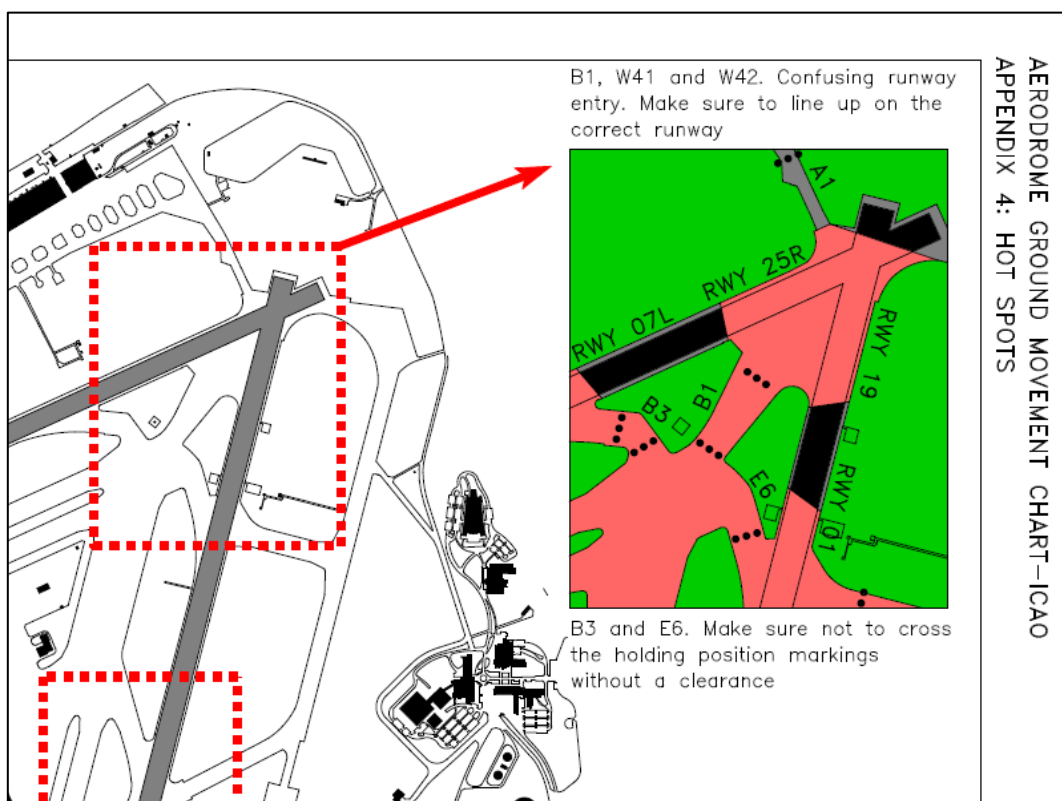
*“B1, W41 and W42. Confusing runway entry. Make sure to line up on the correct runway”*

Figure 5: Zoom of AGMC chart, published in the AIP

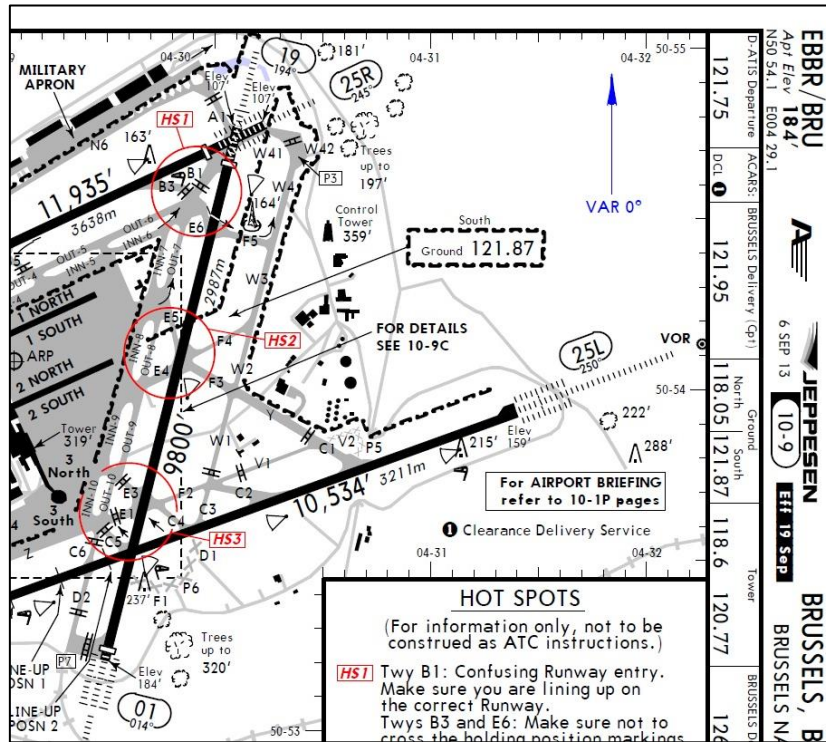
Figure 6: Hot spot indication on Jeppesen chart

None of the flight crew involved in the 5 incidents used the official chart of the AIP to prepare the taxiing. However the hot spot was indicated on the charts that were used. Although the explanation was not written next to the hot spot, it could be found on the charts.

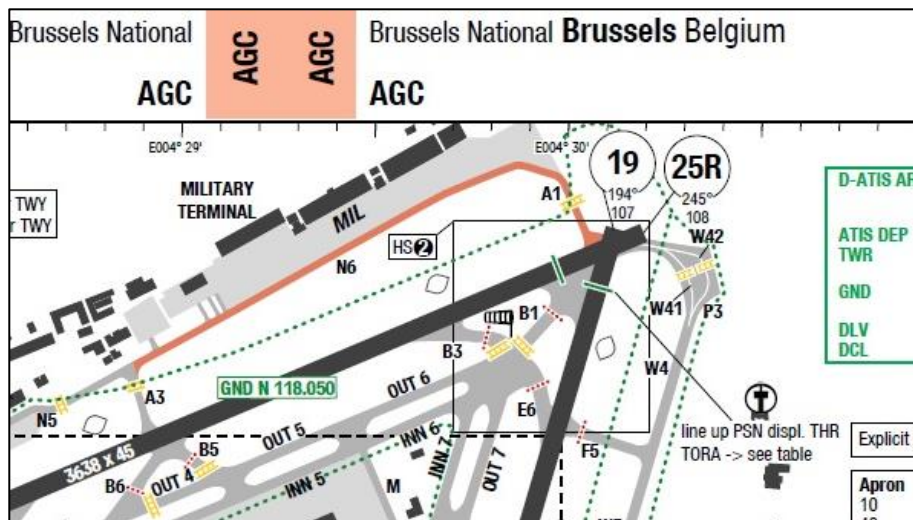
Figure 7: Zoom on hot spot indication on Lido chart (text is below on the map)

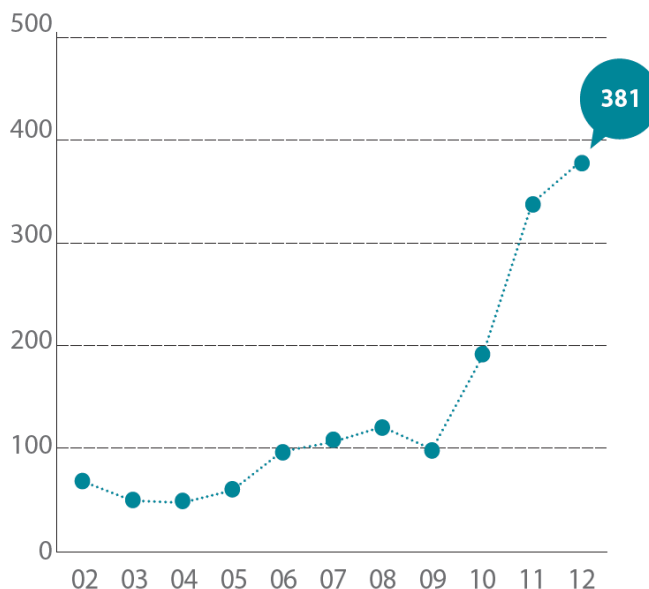
Figure 8: Evolution of number of all occurrences reported by AT controllers in Belgium

Most of the runway incursion occurrences are reported by ATC (Belgocontrol). The number of all occurrence (not only runway incursion) reports has seriously increased over the last years, mostly further to an improvement in awareness for the need of reporting all incidents. Also as from April 2013, the Belgocontrol internal incident reporting procedures were simplified. This may explain the sudden rise of similar runway incursion reports at Brussels Airport.

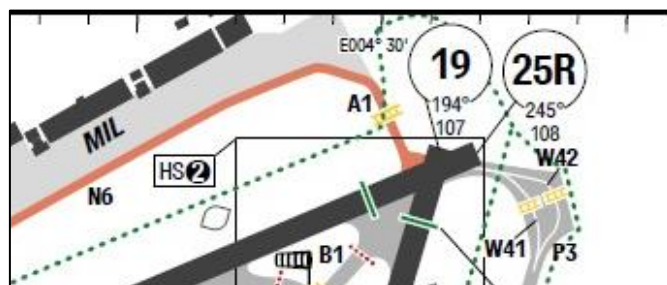
The indications of the runways on the Lido chart are not aligned with the centrelines and could contribute to the confusion.

Figure 9: Runway indications on Lido chart

Both the LRST and Turkish Airlines advised Lido to improve their ground movement chart by aligning the runway numbers with the centrelines of the runways.

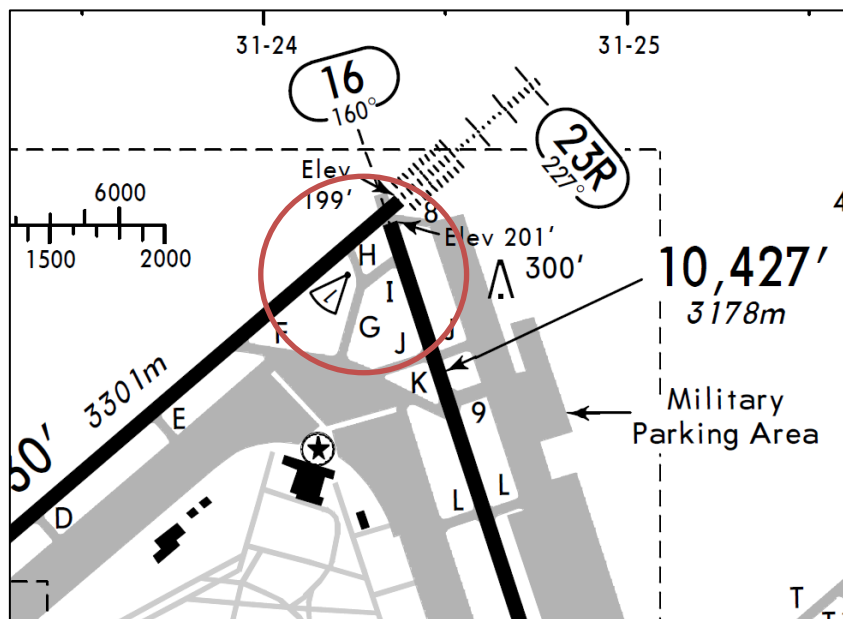
When splitting taxiway B1 into two individual taxiways leading respectively to runway 25R and runway 19 and each provided with stop bar lights at their holding position sign, then the physical possibility to enter the wrong runway will be excluded. As an example, Cairo International Airport has a similar taxiway design.

Figure 10: Taxiway design at Cairo as an example
