Safety Investigation Report

ACCIDENT JMB AIRCRAFT / AVEKO VL3-B AT VELAINES (CELLES) ON 8 SEPTEMBER 2015

Ref.:
AAIU-2015-AII-10

Issue date:
17 November 2016

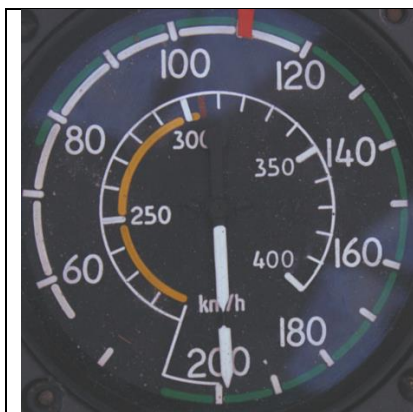
Figure 3 : Accident aeroplane airspeed indicator

- The airspeed is indicated in kilometres per hour (km/h).
- The outer diameter circle starts at 60 km/h up to 210 km/h and then continues on the inner circular arc ending at 400 km/h.
- The white arc starts at 55 km/h (Stall speed in landing configuration, V_{so}), ending at 120 km/h (V_{fe}).
- The green arc starts at 75 km/h up to 210 km/h (Max structural cruising speed, V_{no}).
- The yellow arc extend from 210 km/h up to 305 km/h where a red radial segment indicates the V_{ne} .

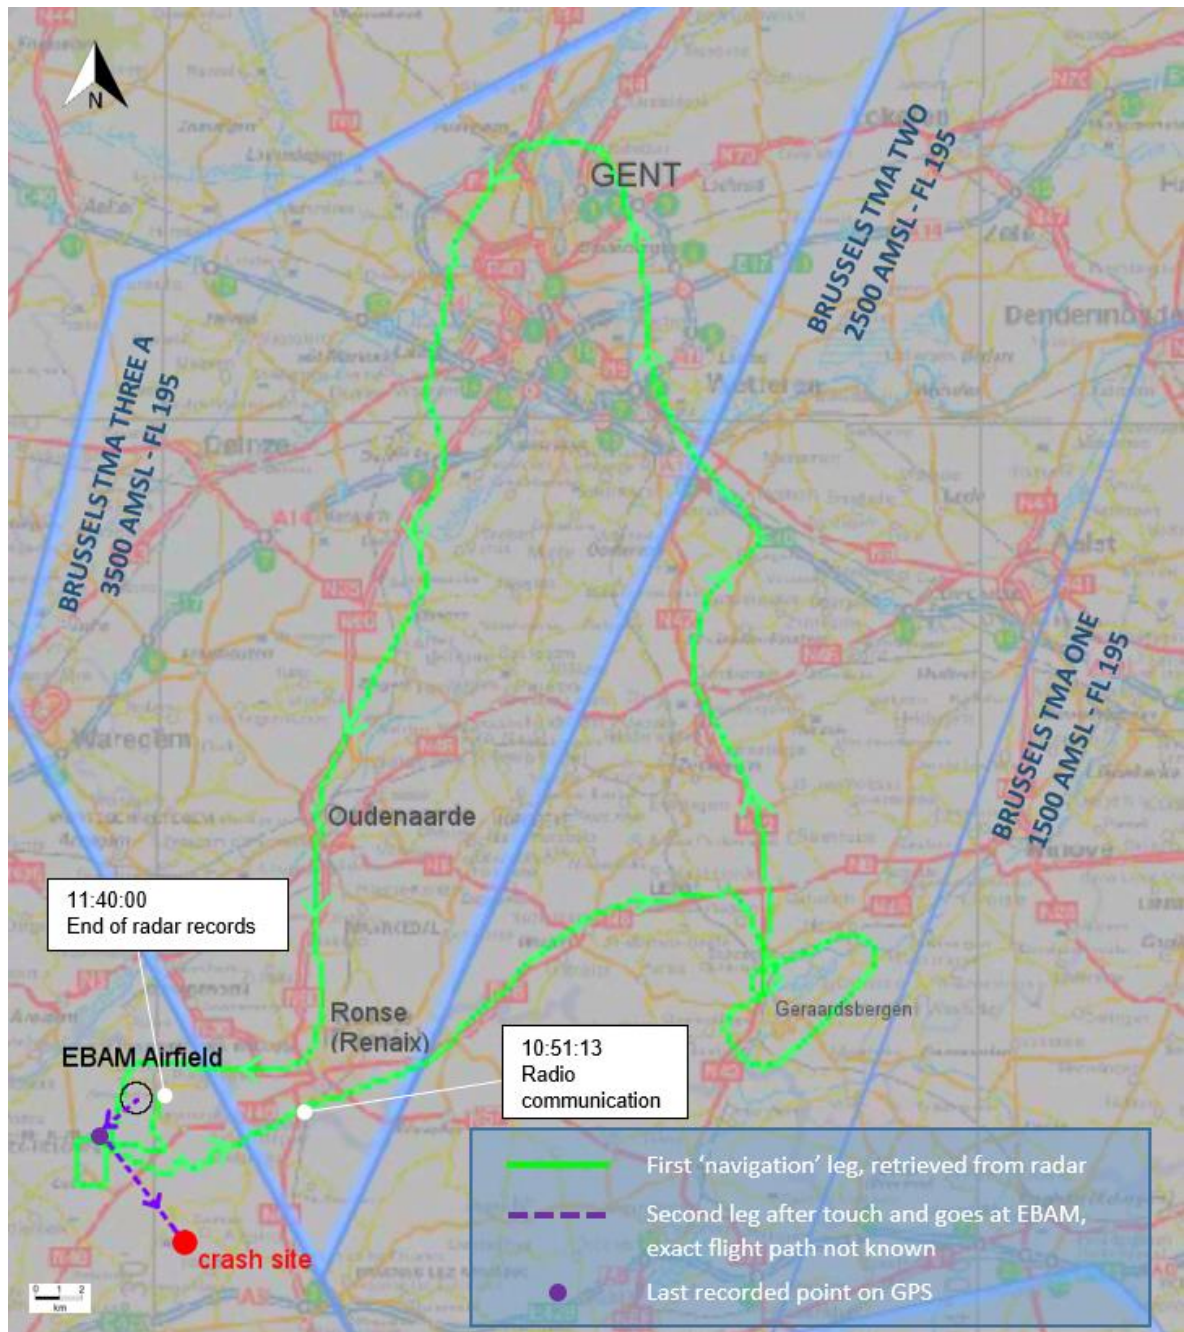
Figure 5 : Approximate navigation flight path

At about 11:40, meaning approximately 20 minutes before the crash, the aeroplane disappeared from the secondary surveillance radar (SSR) when flying at 600 ft in the vicinity of the airfield. For the remainder of the flight, no radar information was available.

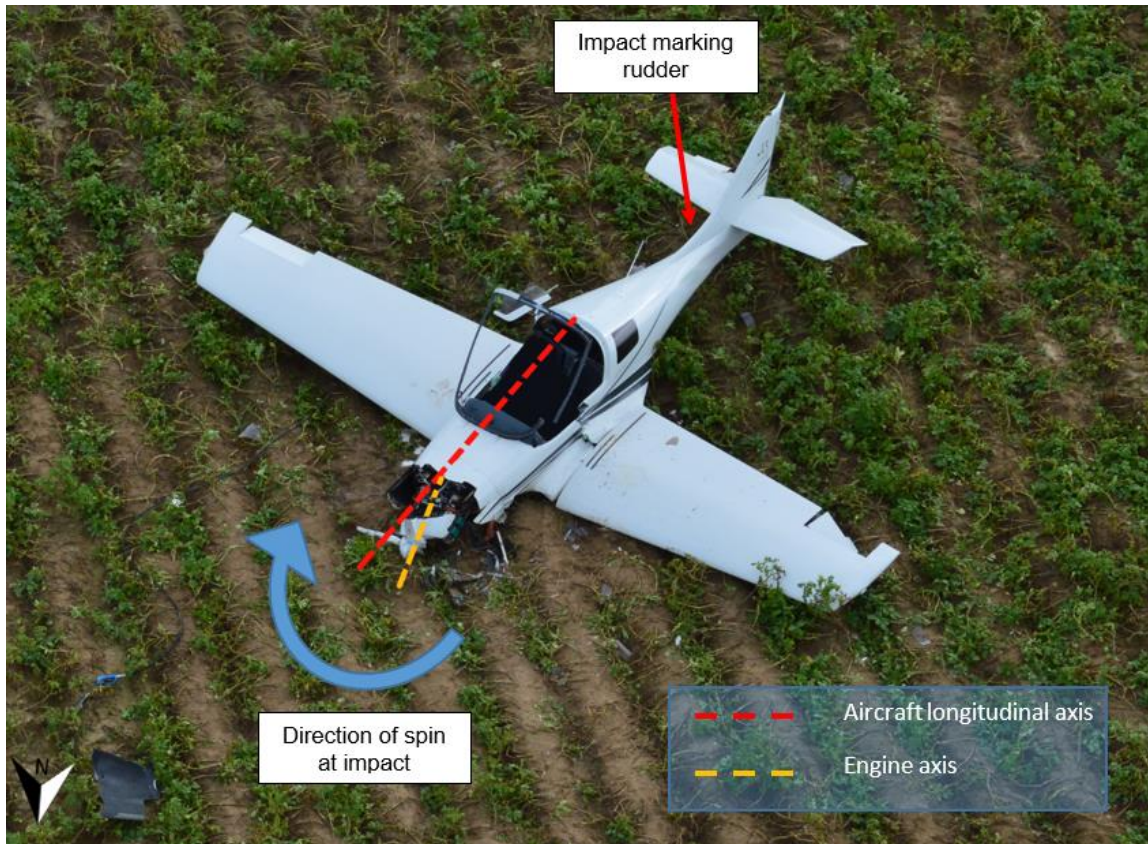
Figure 6: Aerial view

Examination of the damage could determine that the aeroplane was destroyed essentially by a high vertical speed impact combined with a limited forward speed. Notwithstanding the shock, the wreckage did not disintegrate showing few separated parts excluding fragments of the canopy and of the engine cowling, the whole thing found in a circle of less than a 10 m diameter.

The impact left no trace of sliding on the ground, not even on the foliage of potato plants. The wreckage was found pointing NNE. The wings were in horizontal position. Because of the direction of the impact forces and the subsequent damage to the engine mount, the longitudinal axle of the engine was pointing slightly to the left with respect to the fuselage. The underside of the rudder was covered with soil and a corresponding impact with the ground was visible about 30 cm right of the rest position of the rudder. These 2 observations indicate that the fuselage turned further clockwise after the first impact and that the aircraft was in a right-hand spin. See Figure 6: Aerial view.

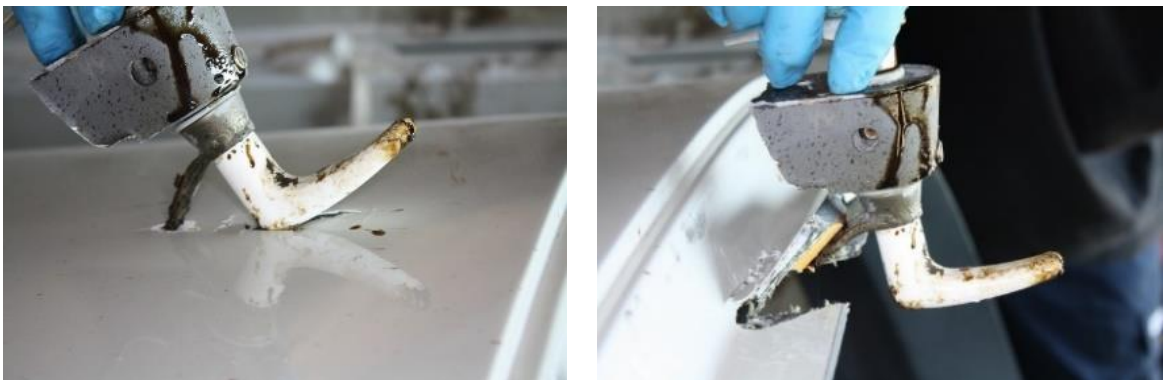
Figure 7: damage caused by the canopy locking latch

Examination of the fuselage frame at the receptacle of the canopy locking latch showed that the structure was ripped off at this place and that the latch and the handle had struck the roof of the fuselage about 15 cm rear of the frame.

Examination of the wreckage shows that the fuselage failed in compression causing the vertical ruptures at both sides of the fuselage. The pull-out of the canopy locking latch and its impact with the roof of the fuselage about 15 cm rear of its normal position is also proof that the structure of the cockpit (on which the canopy rests) deformed and bent at impact. This shows a significant temporary deformation of the fuselage at impact after which the cockpit structure recovered almost its normal shape when resting on the ground.

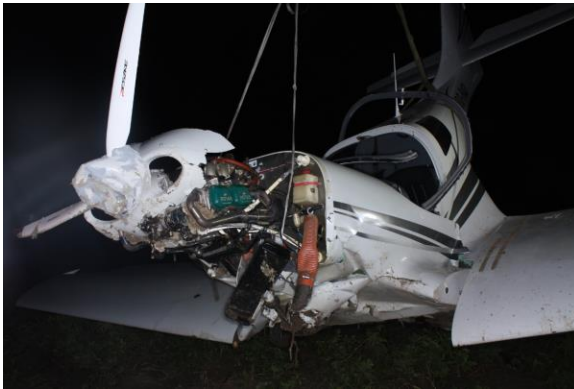
Figure 8 : damage to the underside of the fuselage

Both fuselage sides show a vertical fracture starting approximately in the middle of the wing roots and ending at the opening of the canopy.

Lifting of the wreckage using a crane in order to facilitate the removal of the wing allowed the compression damage to be seen on the forwards front underside fuselage and also that the fuselage had lost all rigidity due to the both side vertical cracks.

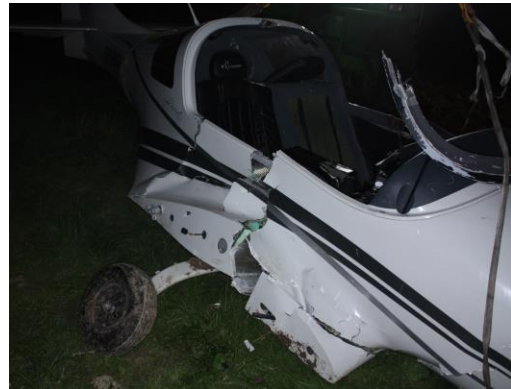
Figure 9 : damage to the right side

After the removal of the wings, the observation of both fuselage side fractures showed that the fuselage had almost broken in two parts.

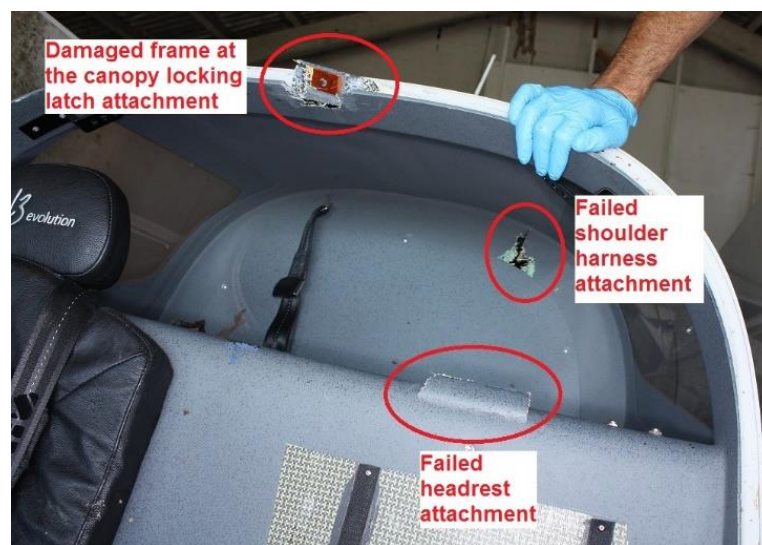
Figure 10: failed shoulder harness and headrest attachment

When arriving at the crash site, the police and the rescue services found the two occupants still sitting inside the wreckage, secured by their safety belts except that the attachment of the left seat shoulder harness at the structure had been ripped off at the cabin rear bulkhead. The left seat headrest attachment also failed during the accident.

The rupture of the pilot's shoulder harness was likely caused by the load exercised by the pilot's upper body inertia, directed forward in relation to a normal flight direction.

- The airframe was extensively damaged. Amongst others, the airframe ruptured at the pilot’s shoulder harness attachment at a place where the structure is systematically reinforced in the current JMB production of VL3. No information was released recommending a retrofit of the AVEKO production.

Recommendation: BE-2016-0009:

It is recommended that 'JMB Aircraft s.r.o', the current production company publishes an information bulletin to inform the owners of the earlier production of VL3 (up to SN: 100) about the possibility of reinforcing the shoulder harness attachment structure. The information bulletin should include instructions on how to install the reinforcement.
