Safety Investigation Report

Ref. AAIU-2016-AII-08

SYNOPSIS

Classification:	Accident
Level of investigation:	Standard
Date and time:	08 October 2016 at 14:36 UTC
Aircraft:	Fournier RF 47, MSN: 01
Owner:	Private
Accident location:	In a field in Oordegem (Belgium), Geographic coordinates: 50°57'58,29 – 3°53'46,59
Type of operation:	Non-commercial - Cross-Country
Phase:	En route
Persons on board:	One pilot
Injuries:	The pilot was slightly injured

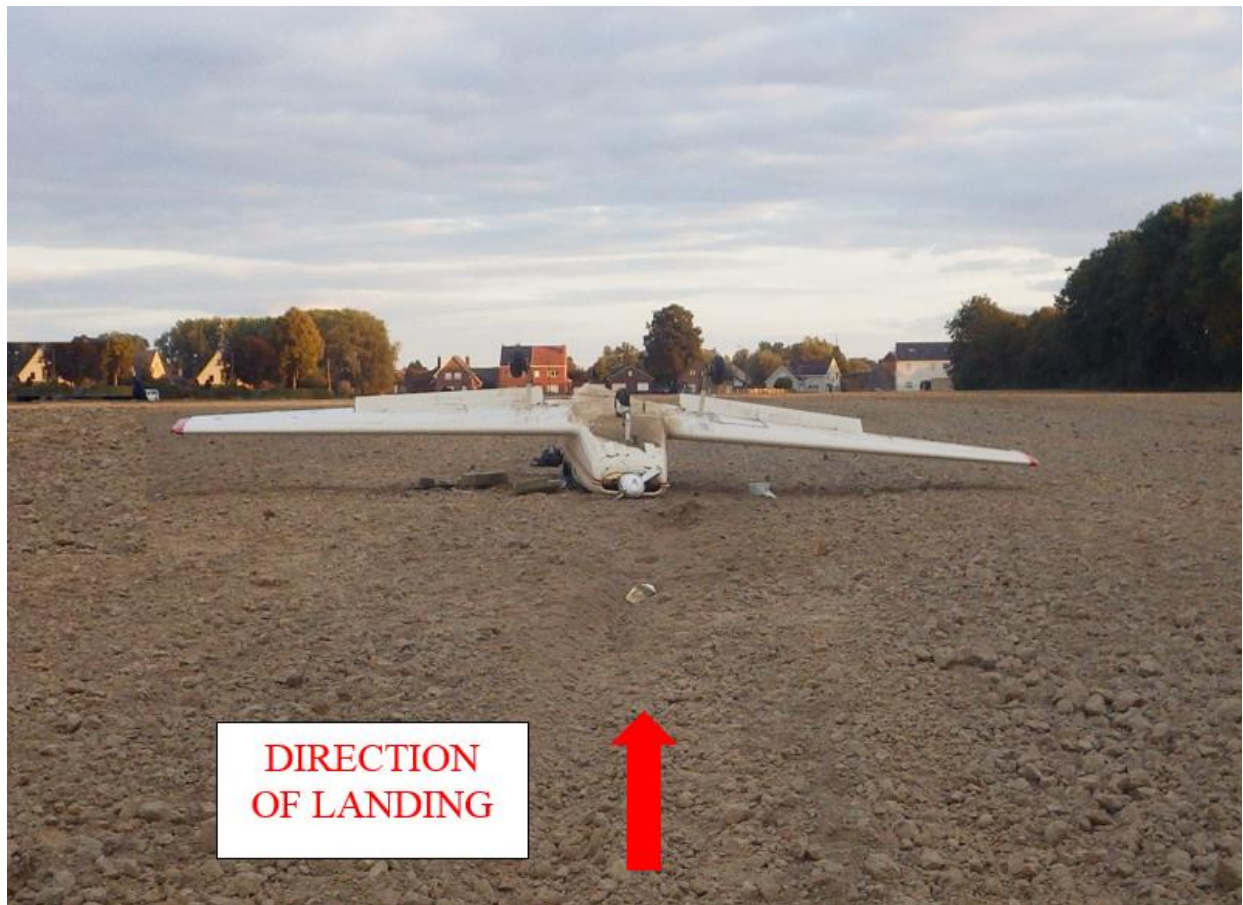
The aeroplane touched down approximately at mid-length of the field at 380 meters from the row of trees and rolled between 10 – 15 m before it became airborne again for about 10 meters. Thereafter, the aeroplane touched down again causing the nose wheel to sink into the soft ground causing a rapid deceleration. The nose landing gear strut failed rearwards and the aeroplane flipped over.

Figure 2: Rest position of the wreckage

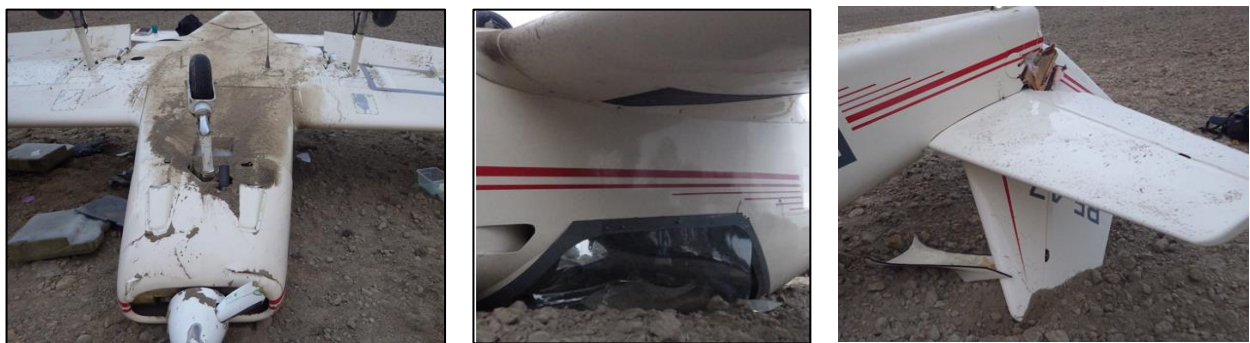
The aeroplane was significantly damaged at the nose landing gear, engine cowlings, engine mount, propeller, canopy, tail section ...

Figure 3: Detail of the damage

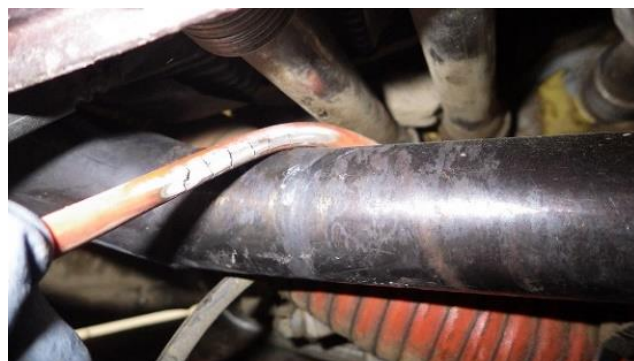
An external inspection of the engine showed that two ignition cables were damaged by an abnormal contact with an exhaust pipe, likely due to a wrong cable routing.

Figure 6: chafing of a high-tension ignition cable on an exhaust pipe.

Beyond the cause of the engine failure, the investigation determined that one high tension (HT) cable was significantly damaged by chafing onto an exhaust pipe. Guidance to avoid the chafing of high tension cables, electrical wires, flexible lines etc. is not always available in the manufacturer technical documentation in general aviation. It is common sense, experience, capacity for observation and skill that show the mechanics how to adequately organize the routing of these components.

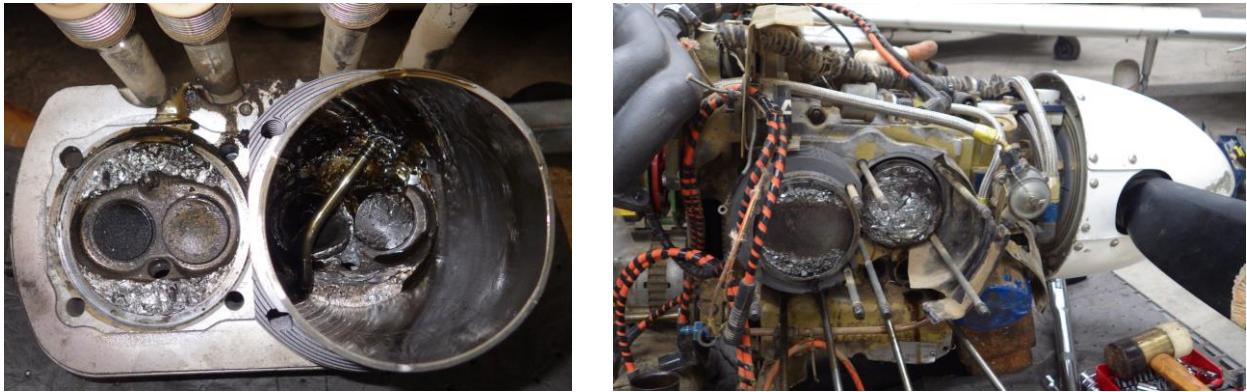
Extreme damage to both combustion chambers and pistons was found after removal of Nr 2 and Nr 4 cylinders. The remains of the Nr 2 intake valve were found pressed into the aluminium casing of the combustion chamber.

Figure 5: Cylinders and pistons Nr 2 and Nr 4

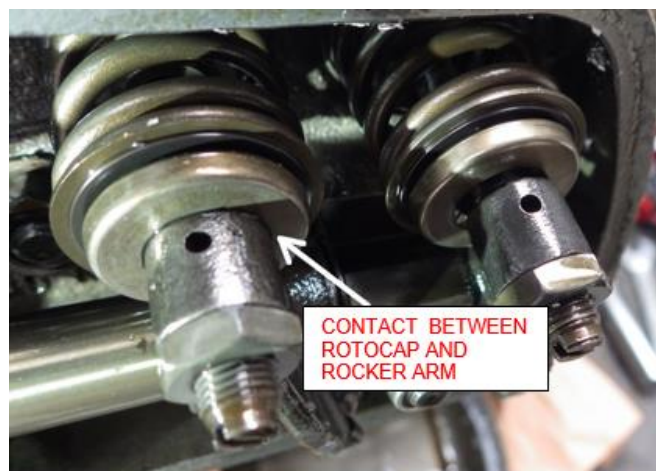
The inspection after removal of the Nr 1 and Nr 3 cylinder head cover (left-side cylinders) also showed evidence of an abnormal contact between the rotators and the intake valve rocker arms.

Figure 6: Cylinder Nr 3 lack of gap at intake valve train.

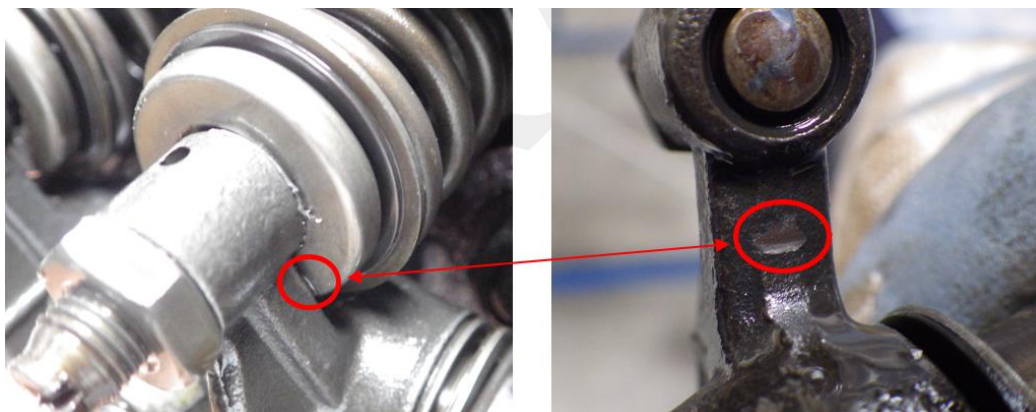
After disassembly of the rocker arm shaft, all rocker arms could be thoroughly examined. Close examination of the rocker arm of the failed valve (Nr 2 intake) showed an abnormal chafing of the rocker arm. This rocker arm was locally damaged by an abnormal contact with its rotator² (generally known as its trademark Rotocap).

Figure 7: Contact areas between the rocker arm and the rotator

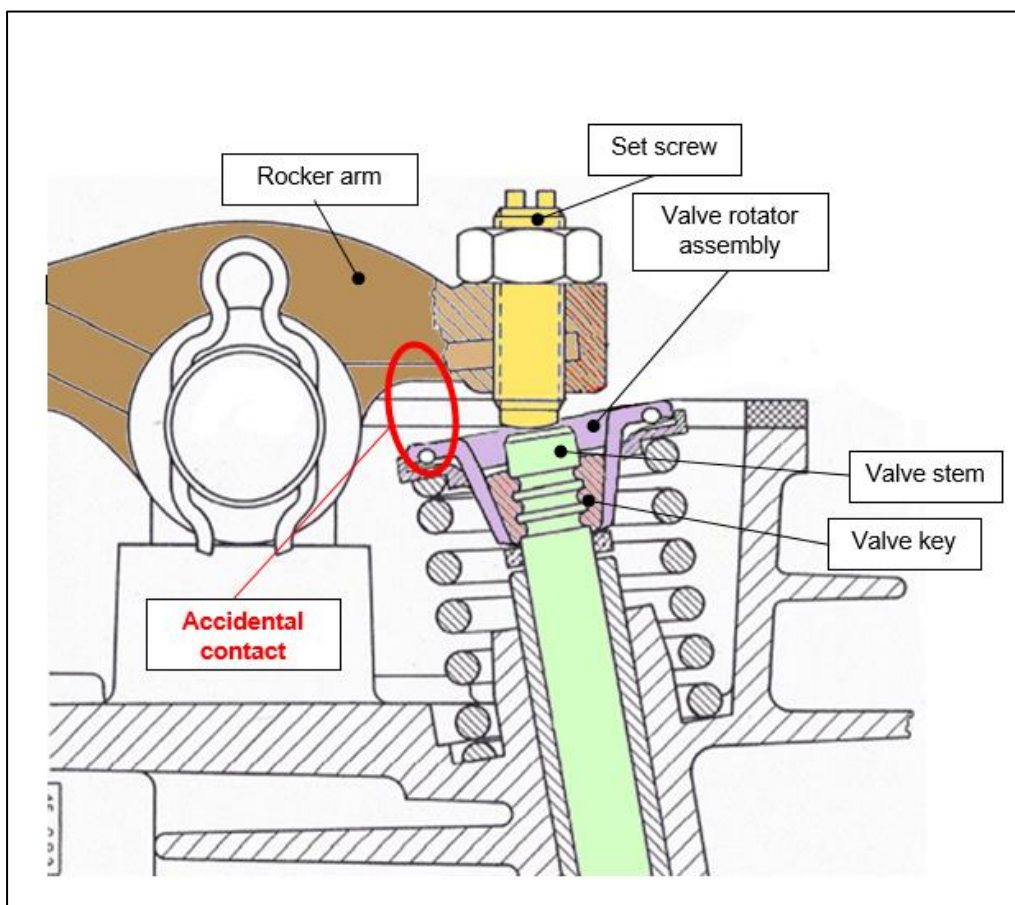
The examination of the failed engine determined that, for the intake valves only, there was a dramatic reduction of the gap between the rocker arms and the rotators. Several rocker arms and their respective rotator were even in contact when the valves were closed. However, the exhaust valves showed a sufficient clearance between the rocker arms and the rotators.

Because of the lack of gap between the rocker arm and the valve rotator, a chafing occurred between the rocker arm and the rotator, in particular when the valve was in the closed position. This caused on its turn a rapid wear of the valve keys. After a while, the worn valve keys failed to hold the valve train assembly causing the valve to be sucked inside the combustion chamber. The engine failure occurred only 2h42 after the repair.

Figure 8: components of the valve train showing the location of unwanted contacts between the rotator and the rocker arm

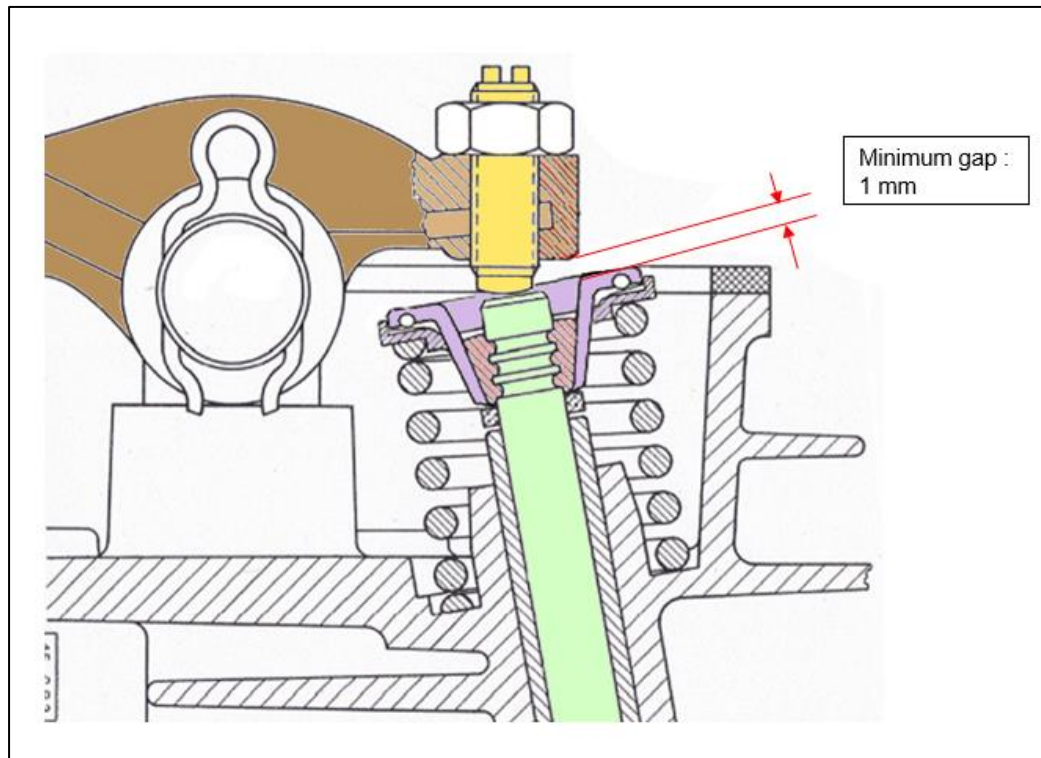
Figure 9: Minimum gap between the rocker arm and the rotator (When valve fully pushed in)

- 1) To check visually the damage through wear and tear of materials on the contact surface between the set screw and the valve stem.
- 2) To verify periodically the presence of at least 1 mm gap between the rotator and the valve-rocker when the valve is pushed in.
