Safety Investigation Report

SERIOUS INCIDENT RUNWAY INCURSION ON 5 OCTOBER 2016

EMBRAER ERJ-195 AND AIRBUS A320 AT EBBR

Ref.:
AAIU-2016-21

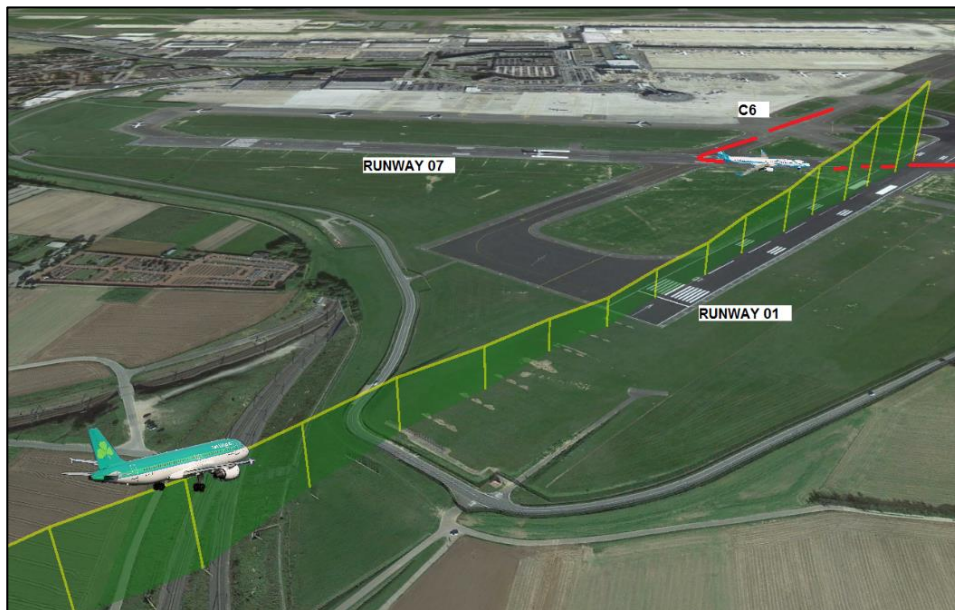
Figure 1: Situation sketch (airplane represented not in scale)

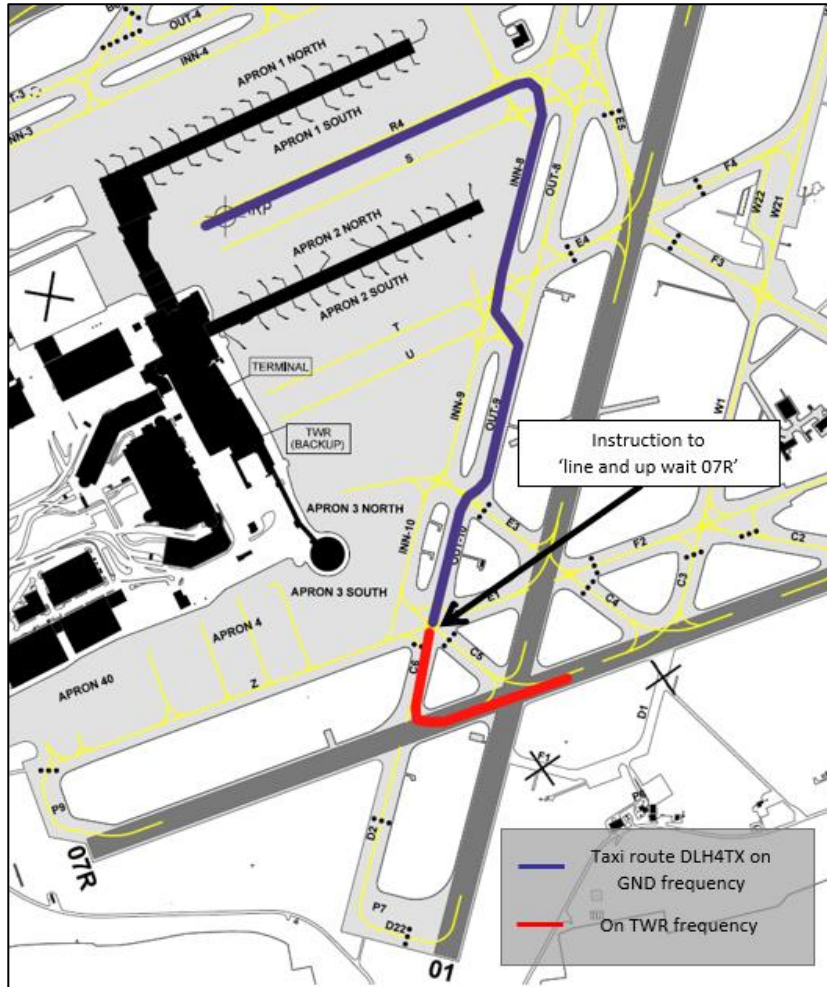
DLH4TX was slightly late and the crew, during push-back, requested to depart from the C5 intersection of Runway 07R. The Ground controller responded by giving a taxi route leading to the C6 intersection. The crew did not understand immediately the taxi route received due to the rapid speaking tempo and the crew requested clarification. The crew reported that the ground frequency was quite busy.

Figure 2 : route of DLH4TX at EBBR

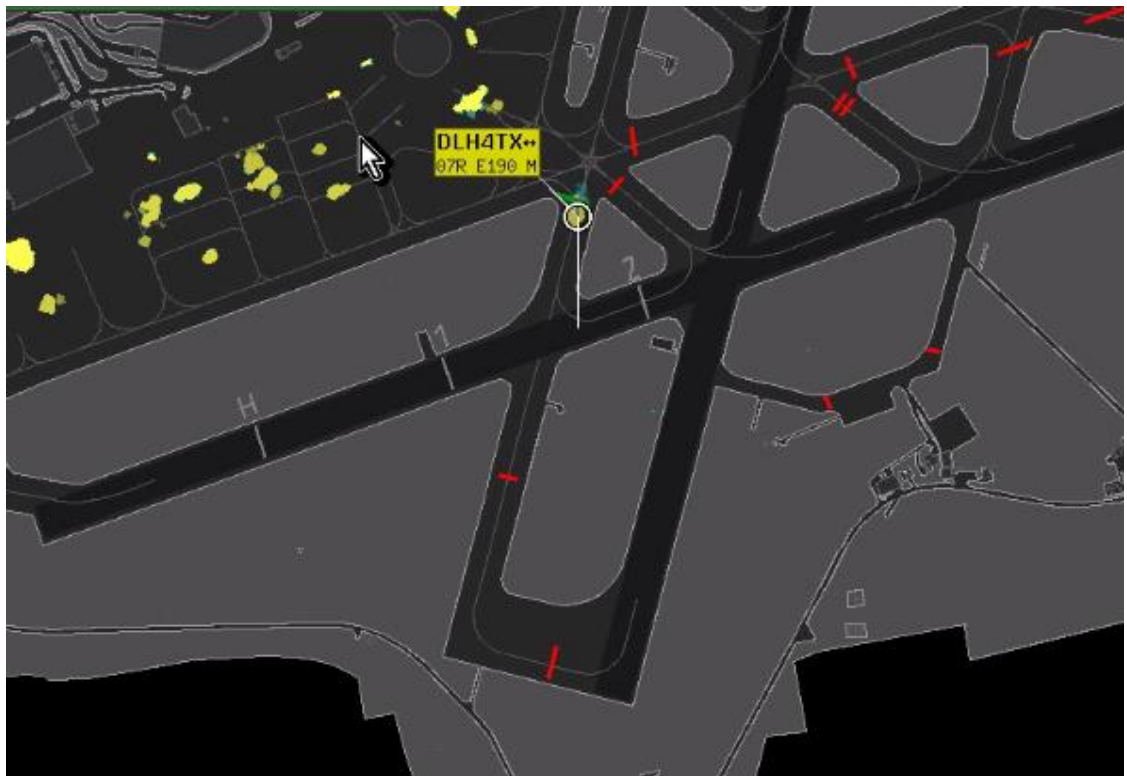
Figure 3: DLH4TX Cleared for “line up and wait” on Runway 07R, from C6 intersection.

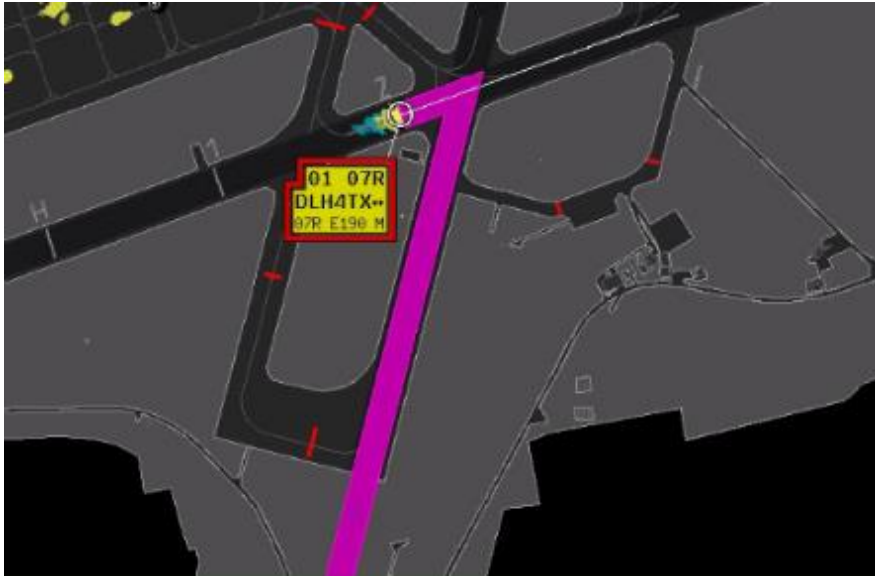
The alerting system activated when DLH4TX entered the Runway 01 protected area (90m from both sides of the runway axis); a blinking purple line appeared on the screen to visualize the conflicting flight paths (see fig.4).

Figure 4: DLH4TX initiates the take-off; visualization of the conflict with EIN368 on ATC screen (time 18:40:54)

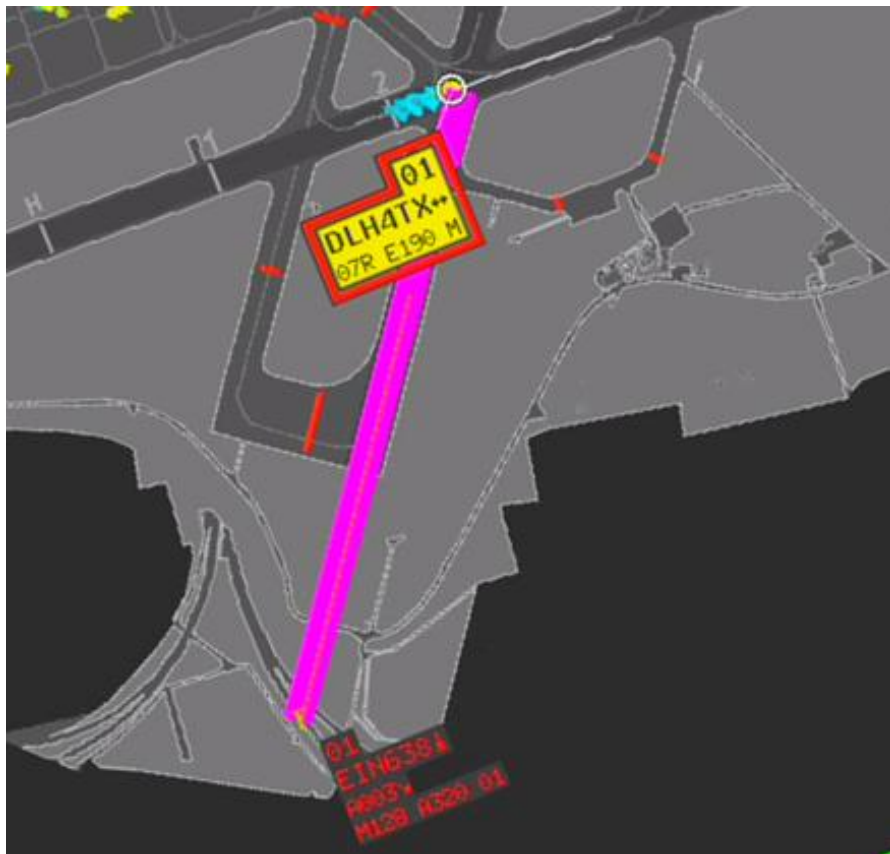
Figure 5: (time: 18:41:01) DLH4TX crosses Runway 01 with EIN638 in short final confirming the go-around

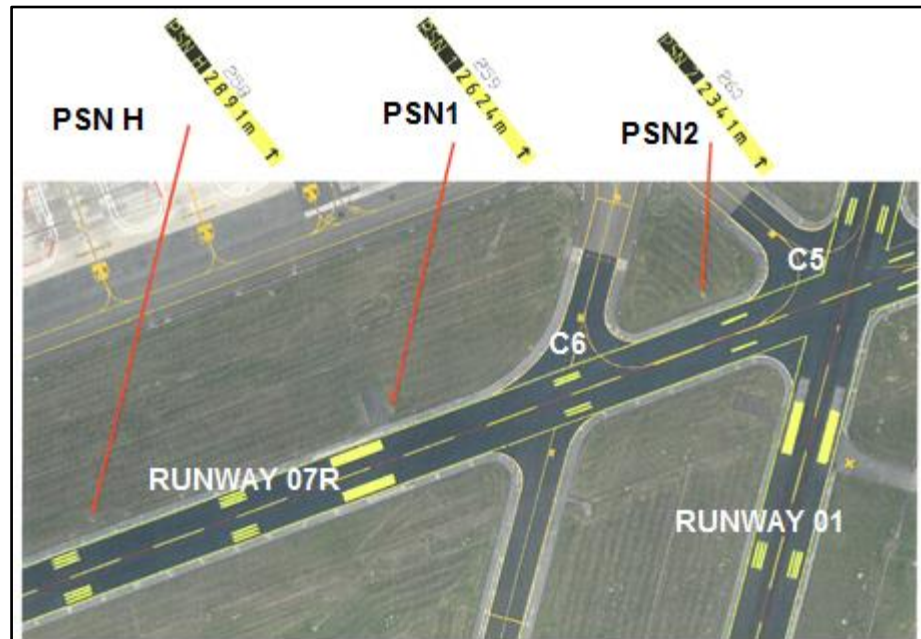
Figure 7: Location of Positions

The distance between the centreline of RWY 07R at Line up Position 2 against the axis of RWY 01/19 is 93,74m. As above stated, Runway 01 has been equipped with a CAT I Instrument Landing System (ILS). This means that the minimum distance from the runway centre line to a hold position is 90 m.

- The distance between the intersections of Taxiway C6 axis with the Runway 07R axis against the Runway 01/19 axis is more than 125m. The distance between this point and the location of Line Up position 2 looking into the RWY axis is 64m. The location of intersection TWY C6 with RWY07R lies physically in-between Line up Positions 2 and 1.
- 3 departure positions have been defined on Runway 07R for noise abatement and operational capacity reasons. All three signs are accompanied by a “Take off run available” (TORA) sign indicating the declared distances.
 - Sign “PSN H” (line-up position heavy) on the left at 194 m from THR 07R
 - Sign “PSN 1” (line-up position 1) on the left beyond the PAPI at 461.4 m from THR 07R
 - Sign “PSN 2” (line-up position 2) on the left at 743.7 m from THR 07R (BTN TWY C6 and C5)

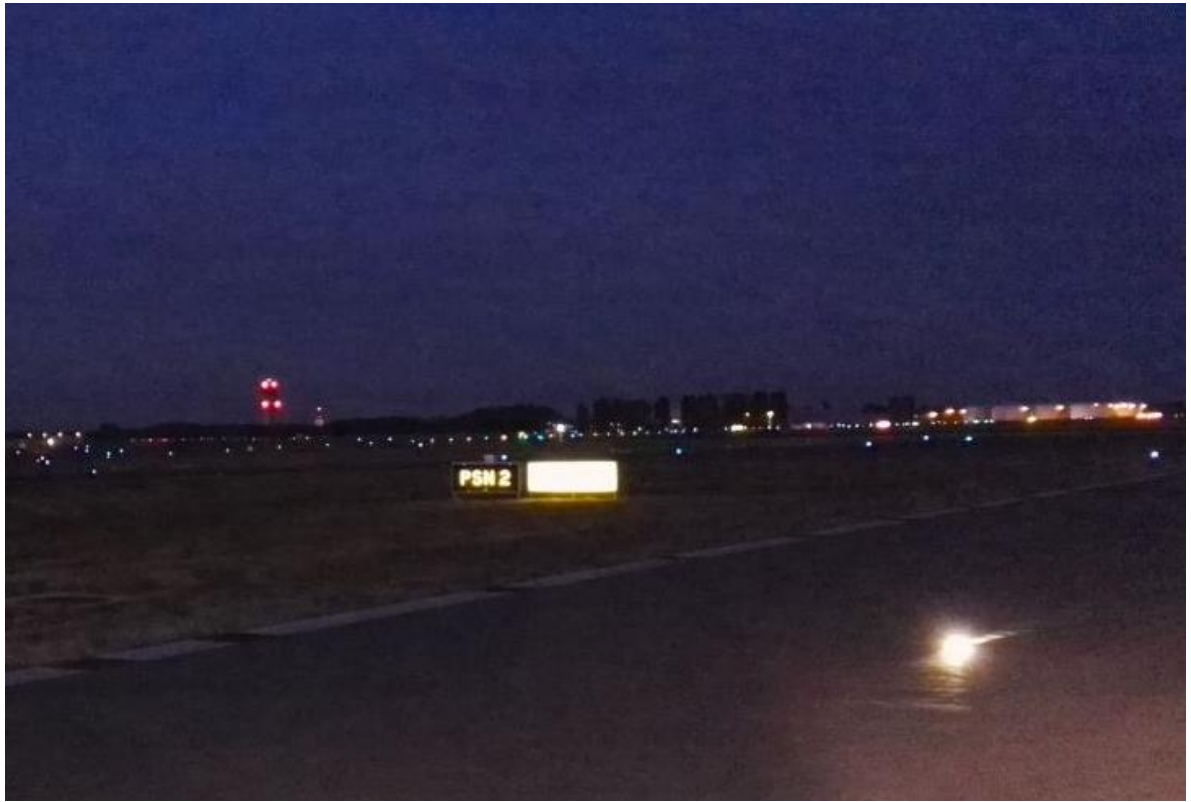
Figure 8: PSN2 sign, at night

It is recommended that Brussels Airport Company performs a study aimed to improve the indications on Runway 07R of both the presence and the status of Runway 01-19 in the vicinity of their intersection.

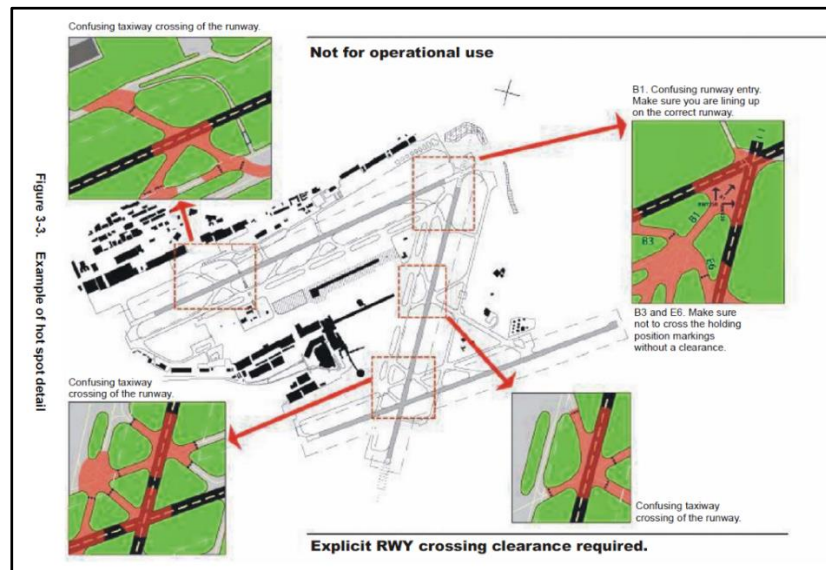
Figure 9: ICAO Doc 9870 extract

Brussels airport is taken as an example, and the C6 intersection is identified as a hot spot.

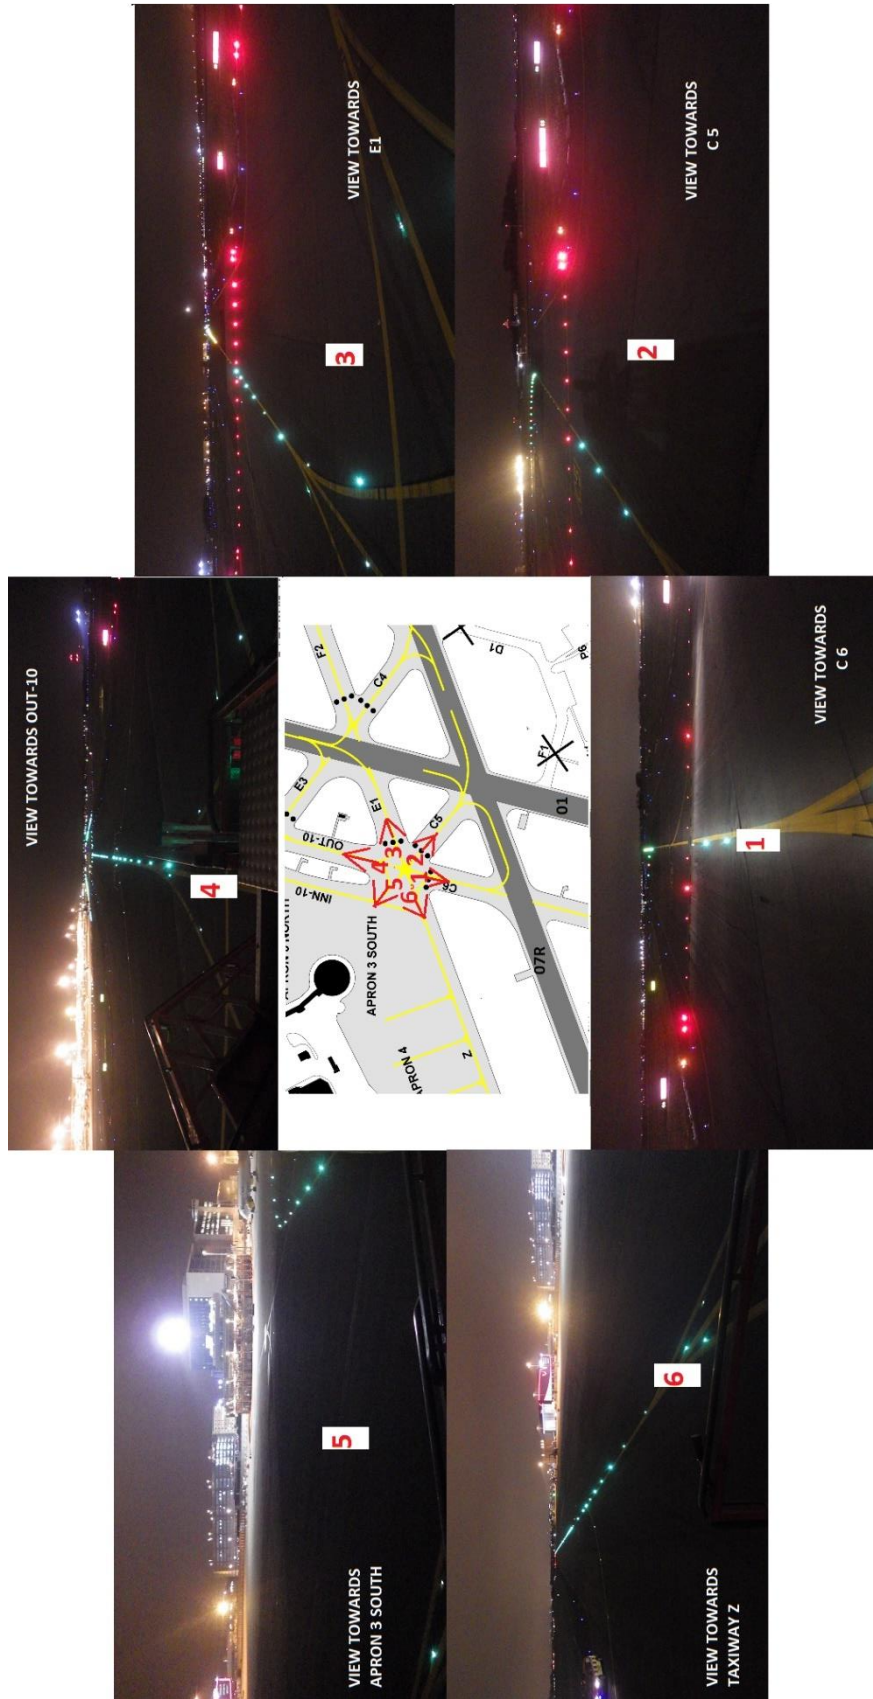
With respect to the environmental conditions, the event occurred at night. Arriving at the C6 intersection from the Outer 10 taxiway, the aircraft faces 5 possible exits (E1, C5, C6, Taxiway Z, Inner / Apron 3 South). The pictures on page 40 show the apparent complex situation.

Figure 11 : C6 intersection at night

This study should also take into account the possible replacement of taxiway C6 by a right angled entrance taxiway and the replacement of the current stop bar by a CAT I stop bar (90 m from runway centreline) as these both factors would definitely reduce the time needed to line-up on runway 07R.

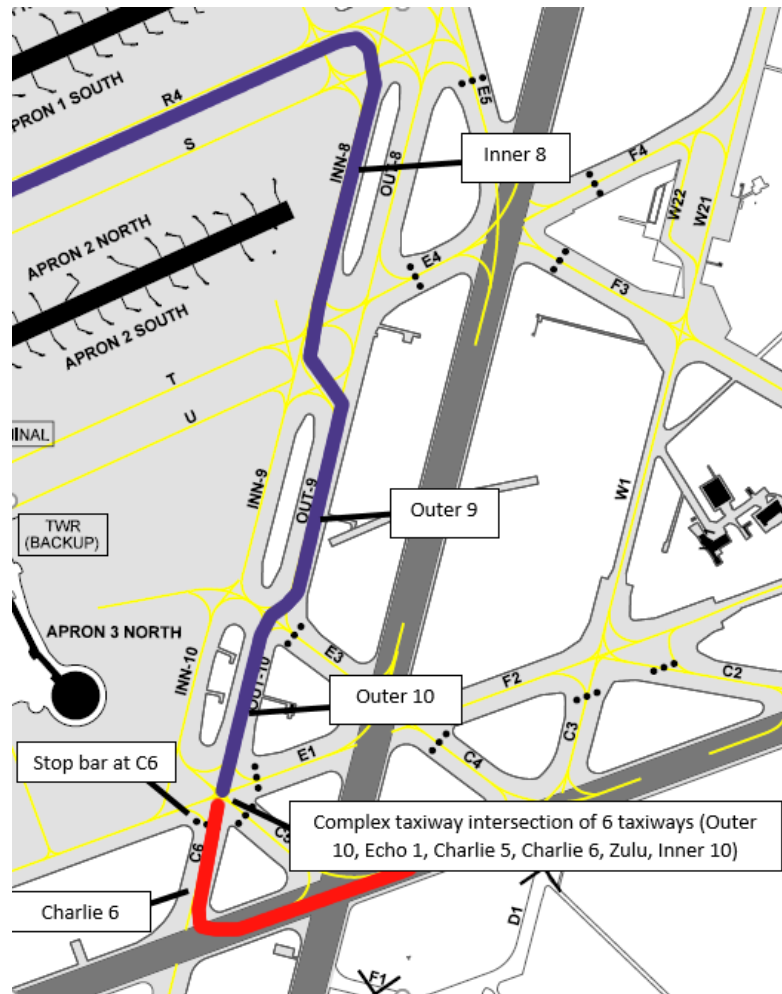
The assigned taxi-route was Romeo 4, Inner 8, continue Outer 9, C6, Holding point 07R.

Figure 12: Taxi route

However, the use of C6 via Inner might cause a possible flow obstruction. Aircraft waiting in line on the Inner for taking off on RWY07R via C6 might block the way for aircraft in need of a longer take-off distance (position H and 1 via taxiway Zulu). Therefore, aircraft taxiing to C6, once passed Outer 8, are directed to the Outer to free the taxi route to Zulu.

It is recommended that Brussels Airport Company makes a study aimed to reduce the complexity of the taxi route to the current line-up position 2.
