Safety Investigation Report

ACCIDENT TO A UAV NAVIGATION ATLANTIC /OCULUS AT DIZY-LE-GROS, FRANCE ON 29 FEBRUARY 2016

Ref.:
AAIU-2016-AII-01

Issue date:
17 March 2017

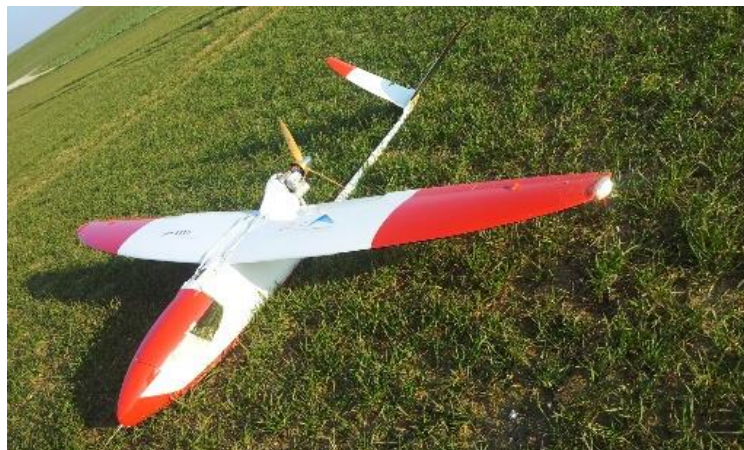
Figure 11 : Crash site

The UAV was found by the French Gendarmerie in a field, North of the village of Dizy-le-Gros, Aisne, France at coordinates 49° 38,752' N, 004° 01,224' E. The engine was not running, but the navigation lights were still on.

The impact traces show the UAV impacted the ground first on the left side. The distance between the first impact trace and the resting position of the UAV is 39,65m.

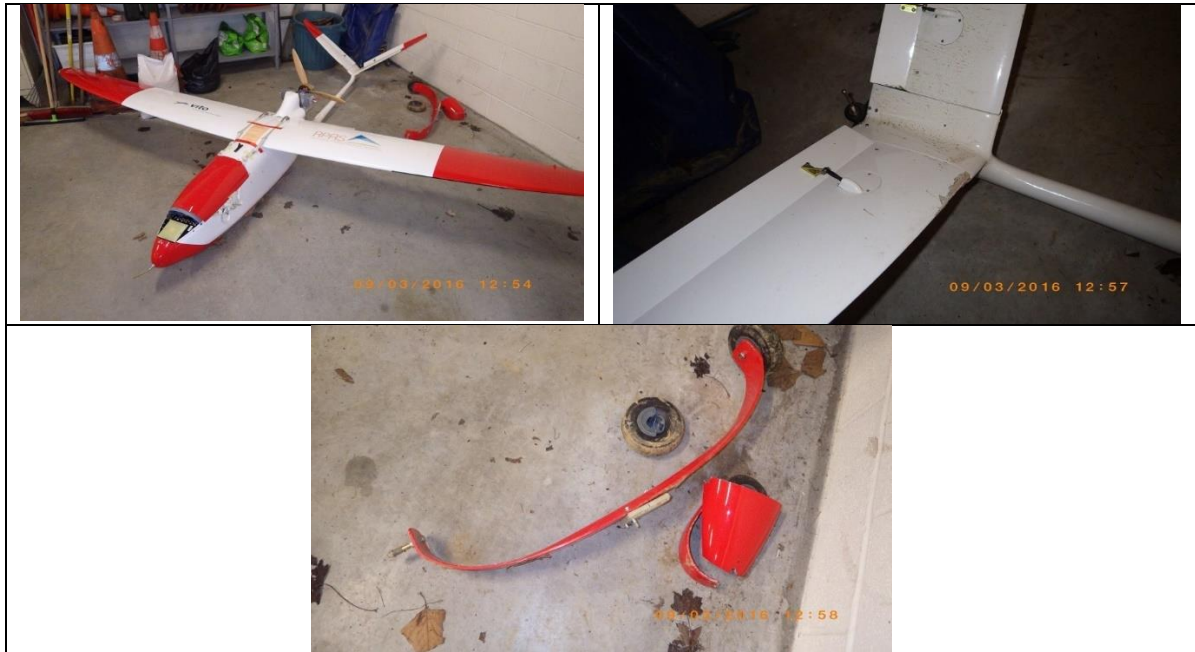
Figure 12: Damage to UAV

The UAV was first inspected on 9 March 2016. The undercarriage was ripped off. The pitot tube was bent. The left winglet was found bent inwards and there was some impact damage on the stabilizer.

Besides that, the UAV was in general good condition.

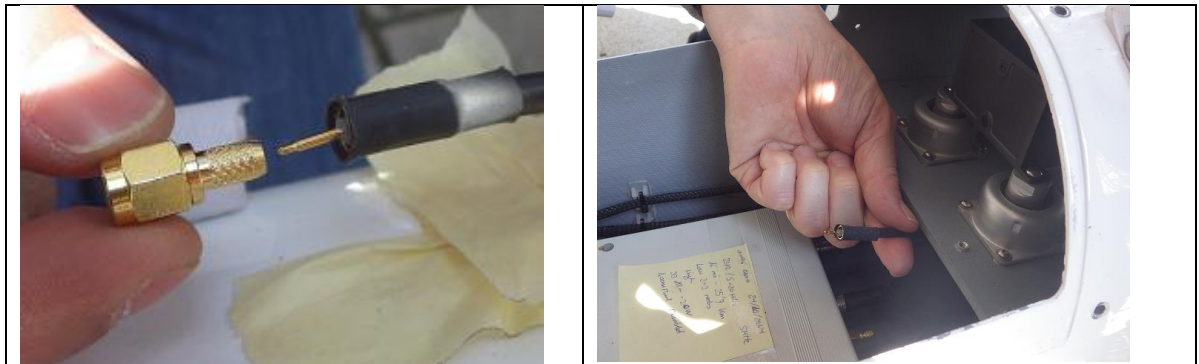
Figure 13: Disconnected antenna

When the UAV parachute cover was opened to gain access to the UAV radio box, it was found that the cable between the radio and the antenna was disconnected.

The antenna cable was removed from the Oculus A – the sister ship – and installed in Oculus B. This could determine that the radio still did not work after installation of the serviceable antenna cable. Thereafter, the radio from the Oculus A was installed in the Oculus B allowing the communication between the UAV autopilot and the ground station to be re-established. The replacement of both the radio and the antenna cable was thus necessary to restore the communication system. The radio failure was determined by UAVN engineer as being very likely created by the antenna cable disconnection. The disconnection of the antenna causes the radio to emit continuously at full power, eventually causing its failure.

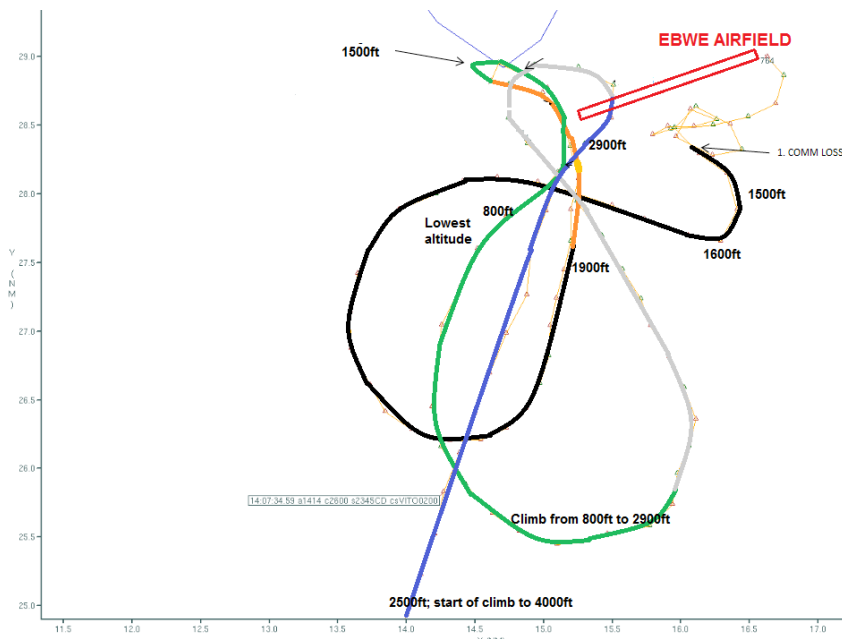
Figure 15 : UAV flight in the vicinity of EBWE

Moments after the failure, the UAV seemed to react to the SAFE mode, automatically triggered upon a LUL warning; it flew in direction of the landing area. However, although the UAV was flying above the safety altitude (1001 ft set during flight preparation), the altitude did not decrease, and even increased.

The flight deviated then from the expected pattern, and the UAV started a wide loop to the west, away from the intended landing point (black track on Figure 15 : UAV flight in the vicinity of EBWE)

The UAV then initiated a clockwise loop, but the movement was then changed to an increase of altitude, away from the landing point. This reaction was caused by an interruption of communication

From the lowest altitude reached, the UAV started to climb and entered a counterclockwise loop (green track on Figure 15), eventually coming back above the runway threshold at an altitude of 2900ft. The UAV then started a descent.

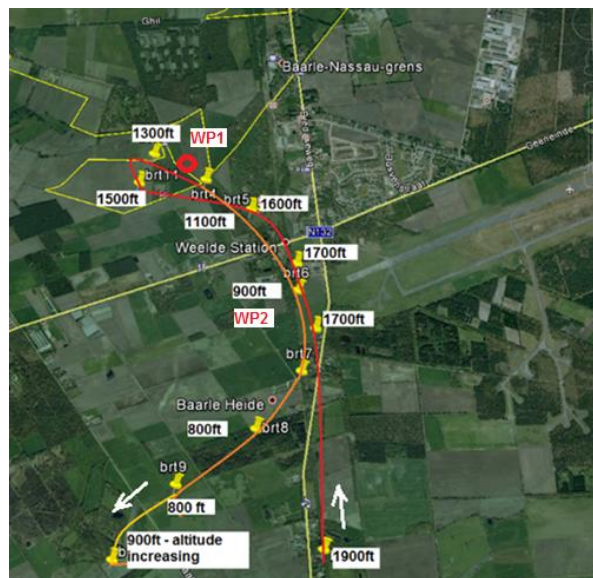
Figure 16 : UAV flight during loss of control (based on radar data)

When the UAV passed 2400ft (grey track on Figure 15), Bingo time was reached, inhibiting the LAND instruction. When this happens, the AP enters automatically in SAFE and

subsequently in LAND mode. However, when the landing is afterwards aborted (by the operator or due to a further loss of communication), the UAV will go in SAFE mode (full power, climbing) and will not enter into LAND mode again unless the BINGO time is reset. This explains why the UAV started climbing upon reaching BINGO time and continued its flight without changing its heading, holding it steady at 199 degrees..

It is recommended that UAVN reviews the BINGO time logic, as it features an inherent danger of losing control of the UAV should a communication problem arises after the landing is interrupted and the BINGO time elapsed.

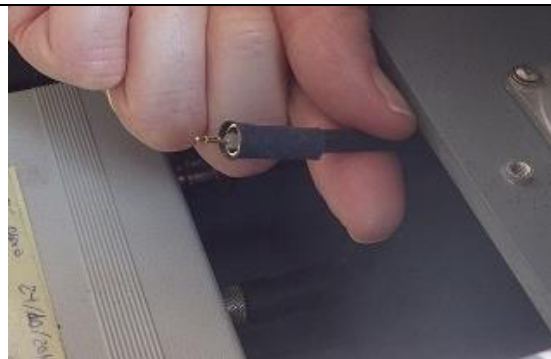
Figure 17: cable as found.

The disconnected antenna was found during the inspection of the OCULUS UAV on April 14, 2016.

- Due to a faulty workmanship, i.e. inadequate crimping of the antenna connector, the radio antenna cable of the UAV disconnected from the radio.
- The communication between the ground station and the UAV was already partially defective on the ground during pre-flight check. The procedure described in the POH was not applied by the crew.

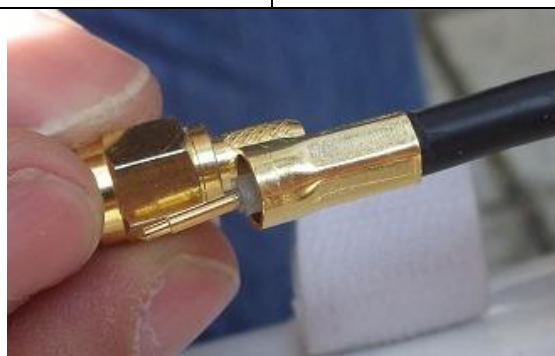
Figure 19; rubber protective sleeve removed.

The rubber protective sleeve was removed and showed that crimping of the brass sleeve occurred mostly on the far end (cable end of the connector).

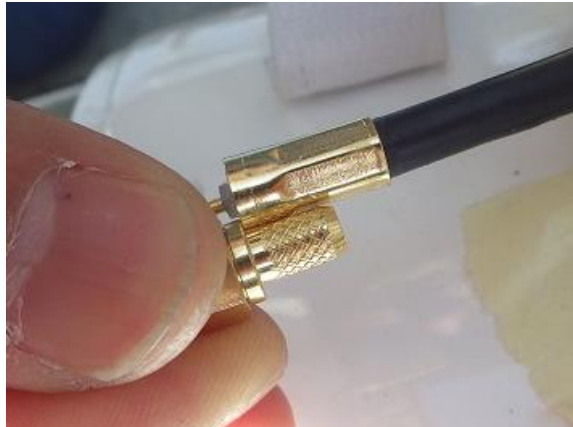
Figure 20 : connector and cable in situation showing the crimped sleeve covering a small part of the connector center.

The braid was found short so that only a small portion of the extremities of the braid was pressed between connector and sleeve.

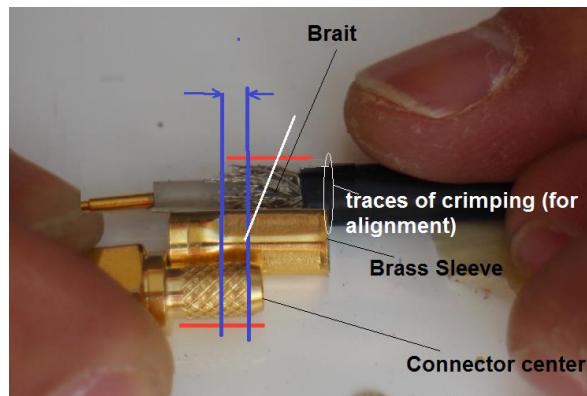
Figure 21 : cable, sleeve and connector body.

Normally, for a coax connector, the braid should be inserted up to the edge of the connector before the crimping sleeve be inserted, to ensure that the braid be pressed between the sleeve and the connector center.

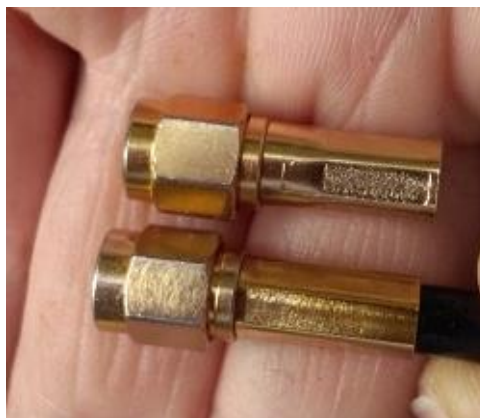
Another connection showed a correct crimping pattern (done by another tool - sleeve crimped close to the connector body – lower connection in the picture hereunder);

Figure 22 : comparison with another connection
