Safety Investigation Report

Ref. AAIU-2019-05-18-01
Issue date: 08 September 2020
Status: Final

During a field landing, the sailplane made an avoidance manoeuvre during final approach, resulting in a hard landing.

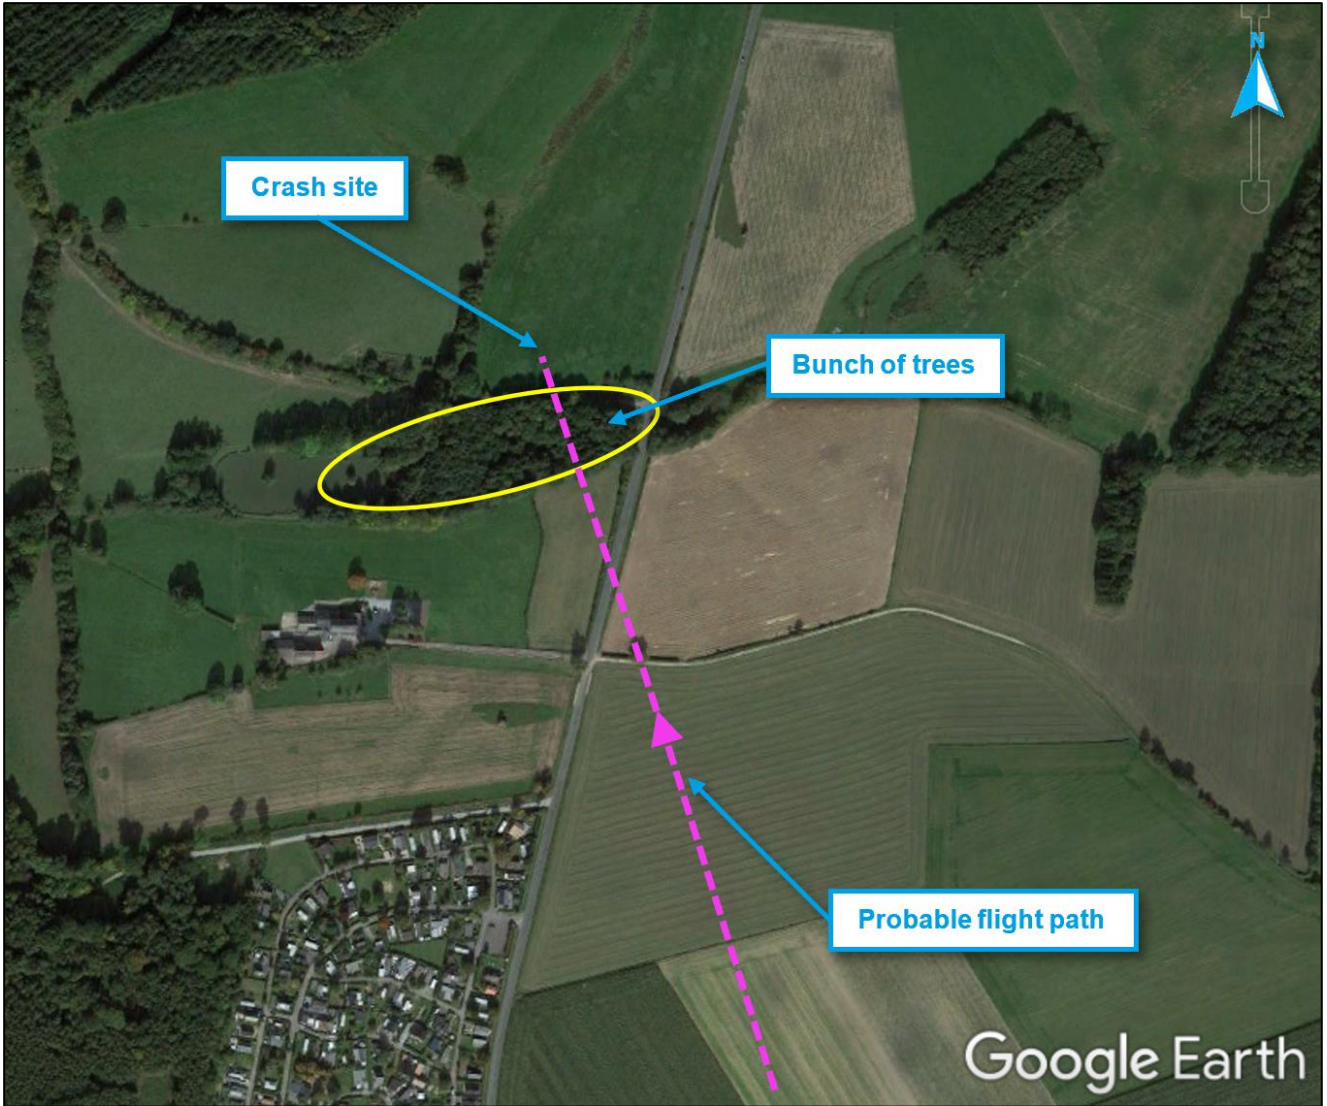
The pilot misjudged the configuration of the field and had to make an avoidance manoeuvre because of the presence of trees in the approach path.

Figure 2: landing area

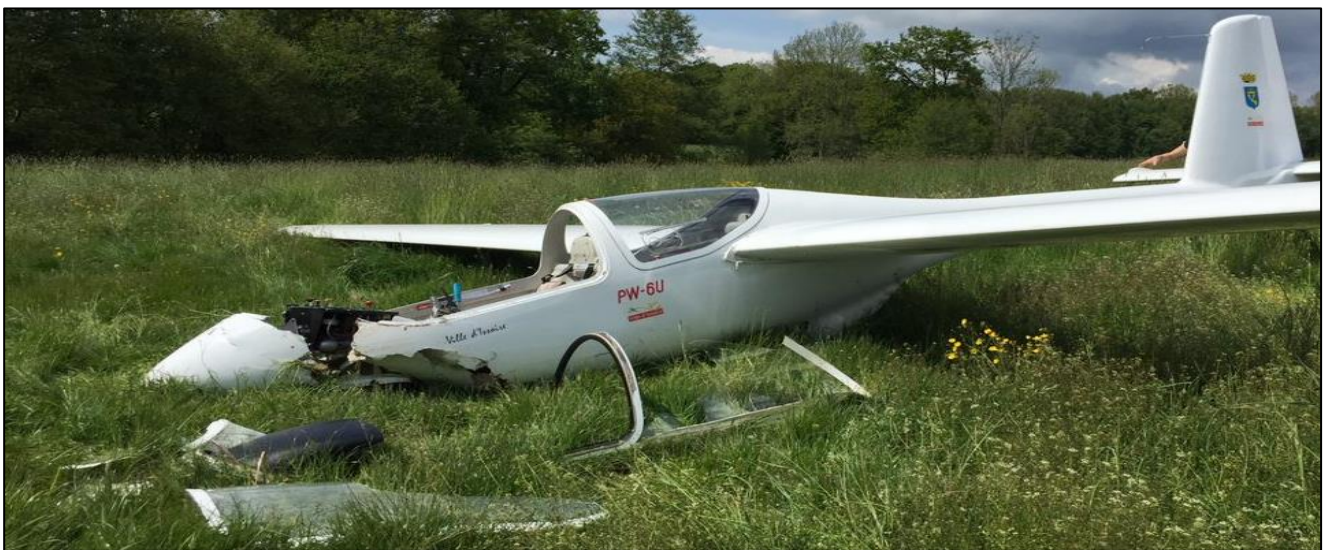
The sailplane got unbalanced and the left wing touched the ground first, the nose of the sailplane hit the ground hard. The sailplane made a ground loop.

The sailplane's nose was heavily damaged.

Figure 3: the sailplane after the landing

- Refreshing training about **VERDO** (**V**ent **E**tat de surface **R**elief **D**imensions **O**bstacles) out landing issues and associated risks (environment, altimeter settings, choice of field).
- On advice of the AAIU(Be), the FCFVV confirmed that they will
 - analyse and reduce potential risks before flying in a new environment
 - use a ‘check list before take-off’ to reduce the chance of confusion in altimeter setting QNH or QFE.
