Air Accident Investigation Unit

FINAL REPORT ON THE ACCIDENT TO ULM POLARIS FK14B (OO-F37) IN HASSELT ON JUNE 30,2007

Ref. AAIU-2007-10
Issue date: 19 November 2007
Status: Final

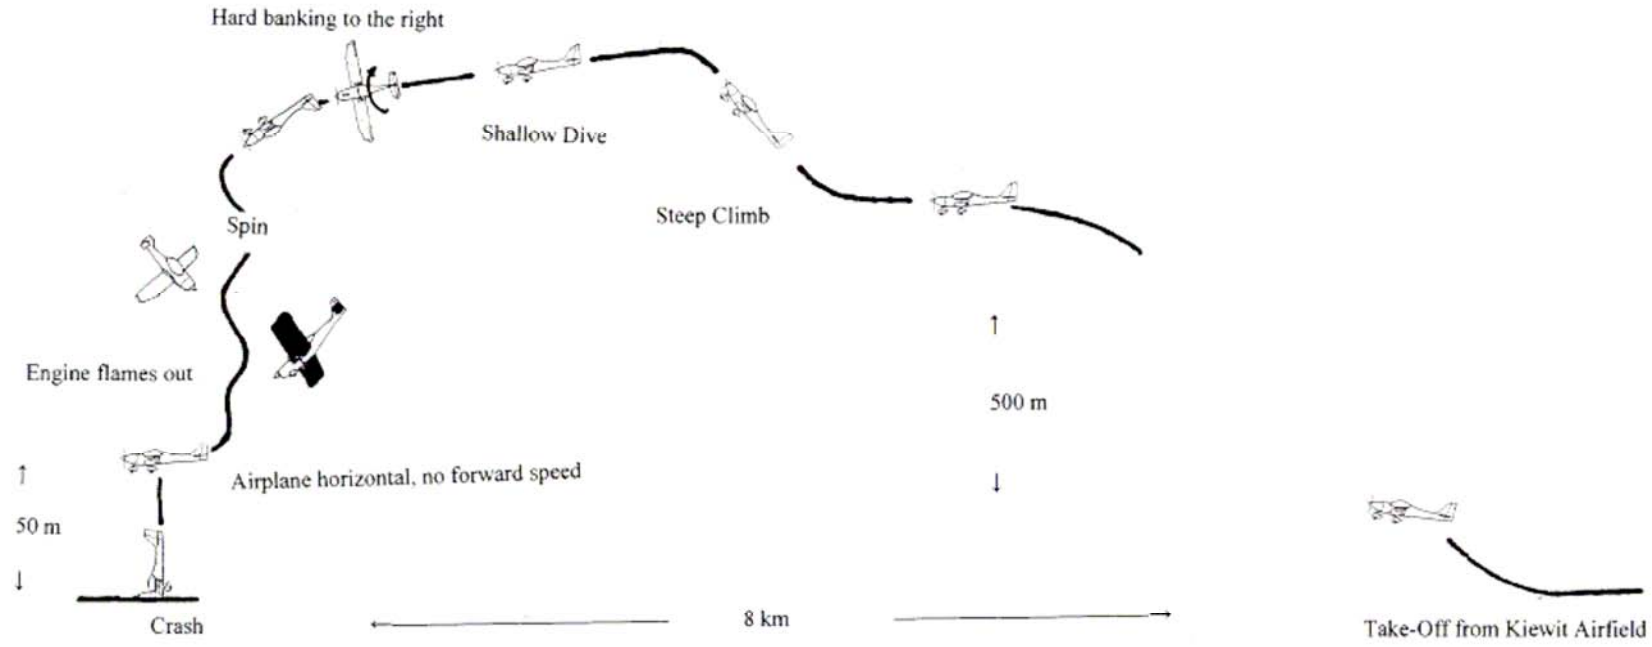
The second pilot died from a heart attack before the aircraft caught fire. The pilot suffered multiple bone fractures, and was transported to the hospital.

The aircraft was totally destroyed, leaving only the metallic structure.
