**Federal Public Service
Mobility and Transport**
Belgian Civil Aviation Authority

Air Accident Investigation Unit

FINAL REPORT ON THE ACCIDENT TO HELICOPTER BELL TEXTRON B206 REGISTERED N678LW IN MERCHTEM ON 26 DECEMBER 2007

Ref. AAIU-2007-20
Issue date: 17 JAN 2009
Status: Final

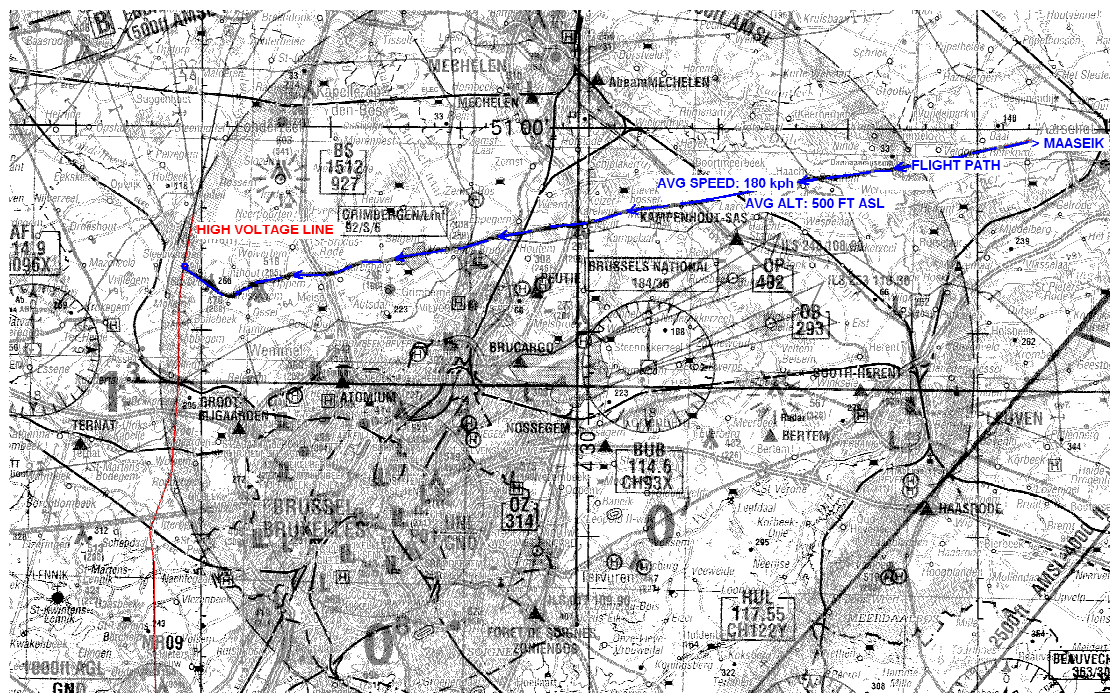
The helicopter turned to the North-West, following the terrain. The visibility conditions worsened, as mist was coming towards the helicopter flight path. the pilot lowered the altitude and reduced speed.

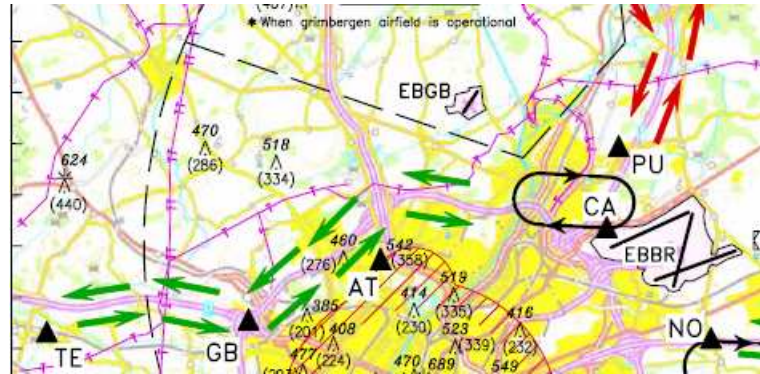
Standard routes inside the CTR of EBBR

ATC instructed the pilot of the “routing is Peutie – Groot-Bijgaarden.”, as published in the AIP. This was acknowledged by the pilot, but not performed.

This routing would have led the helicopter around Brussels, in the vicinity of the Ring Road. The helicopter would then exit the controlled airspace at the height of the Brussel-Ostend highway, 7 km South of the crash area.
