## Safety Investigation Report

# ACCIDENT TO THE ULM – RAINBOW AIRCRAFT REGISTERED OO-G29 IN HOEVENEN ON 11 DECEMBER 2011

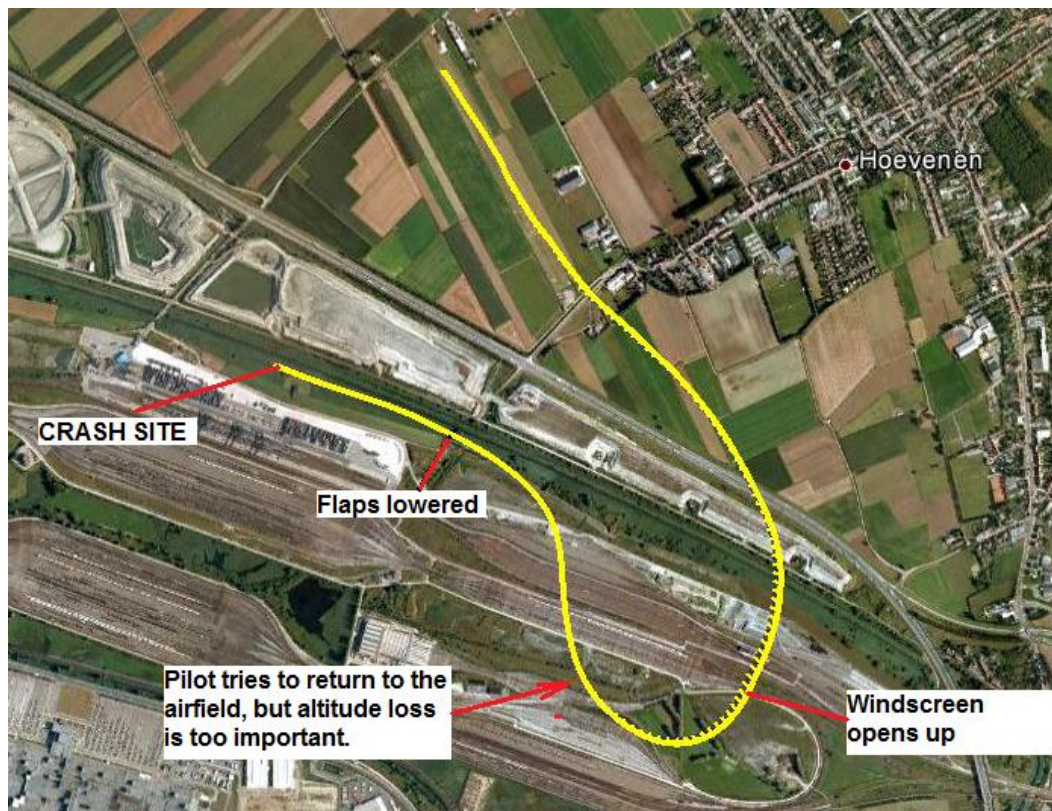
Fig.1 Flight track

He selected a suitable place to perform an emergency landing. For the last 100m, the pilot lowered the flaps. The airplane crash landed on a reed field.

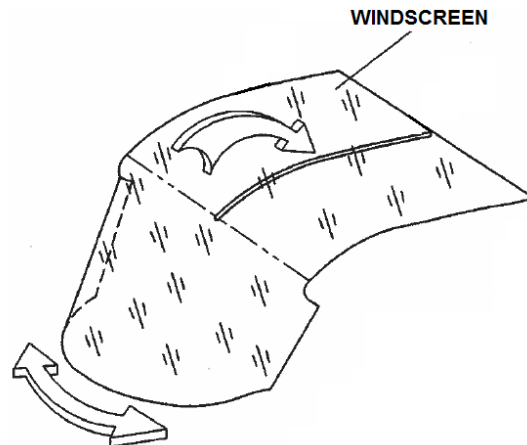
Fig. 5. Windscreen configuration

The windscreen is made of 1 piece of polycarbonate (2mm thick) attached to the roof structure of the airplane, bent downward and attached by 9 rivet nuts to the forward fairing of the cockpit, and bent sideward and attached to the side structure of the cockpit.

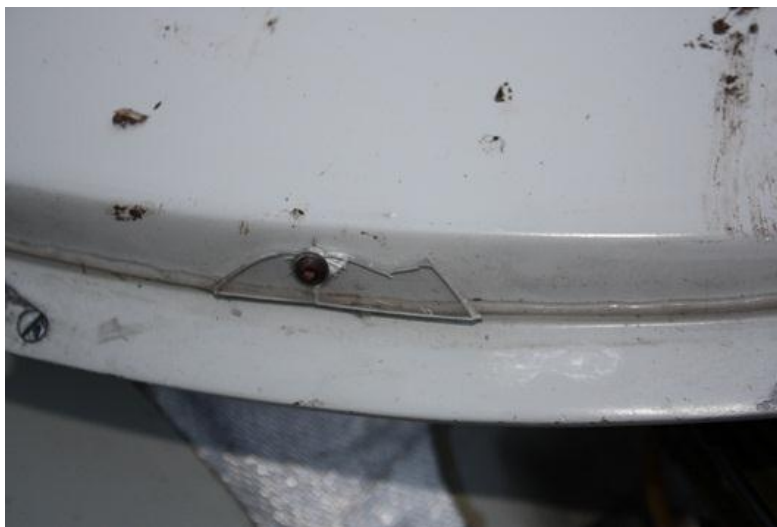
The windscreen is attached to the airplane forward fairing by rivet nuts and separated from the fairing by a rubber seal (see fig 11 hereabove)  
On OO-G29, the inspection of the windscreen revealed that the Rubber seal PP110 was not installed. A silicone sealing was added.

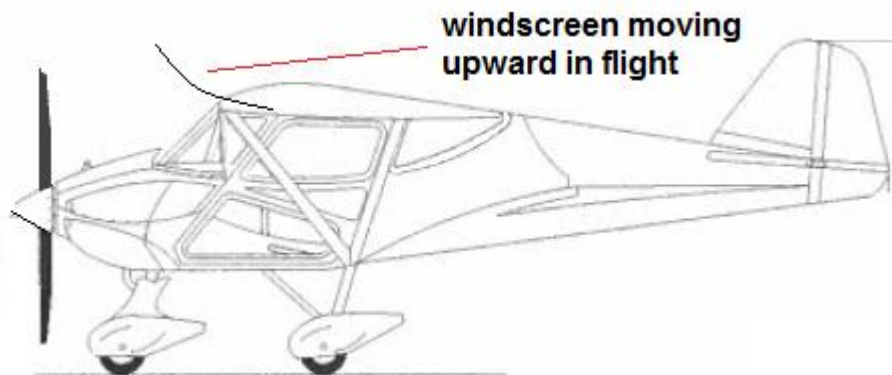
The windscreen forward portion was found in the wreckage, indicating it was not liberated in flight, and remained attached to the roof. The forward portion of the windscreen went up, pushed by the air flow (engine and airplane displacement) causing a very important aerodynamic drag, making that the airplane went irresistibly down.

The windscreen failed in flight from cracks originating from attachment point 4 and cracks between attachment point 5 and 6.

The cracks at the attachment point and at the border of the windscreen were caused by a mechanical stress coming from the relative movements of the airplane structure and the windscreen (a visible sign of this movement is given by wear traces around attachment point 4). The installation of the windscreen was not complying with the manufacturer's requirements, as it omitted to place a rubber seal between the windscreen and the forward fairing, that would normally act as a stress dampener.
