Safety Investigation Report

ACCIDENT TO
THE PZL-BIELSKO SZD-55-1
REGISTERED D-5****
IN EBNM
ON 18 MAY 2011

Ref. AAIU-2011-15-EBNM
Issue date: 10 August 2012
Status: Final

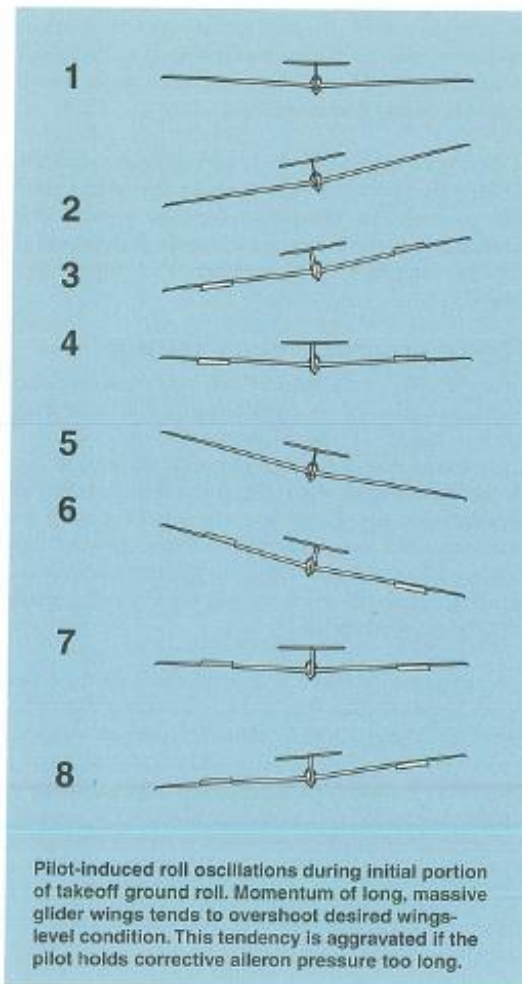
Figure 8-2. Pilot-induced roll oscillations during takeoff roll.

Pilot-induced roll oscillations occur primarily during launch, particularly via aerotow. As the tow pilot applies full throttle, the glider moves forward, balanced laterally on its main wheel. If a wingtip begins to drop toward the ground before the glider achieves significant speed, aileron control is marginal and considerable stick displacement must be applied to elicit a response from the glider. As the glider accelerates, the control response improves and the latency of response from the glider shortens. As acceleration continues, the pilot must recognize the quickening response of the glider to avoid over-controlling the glider. [Figure 8-2]

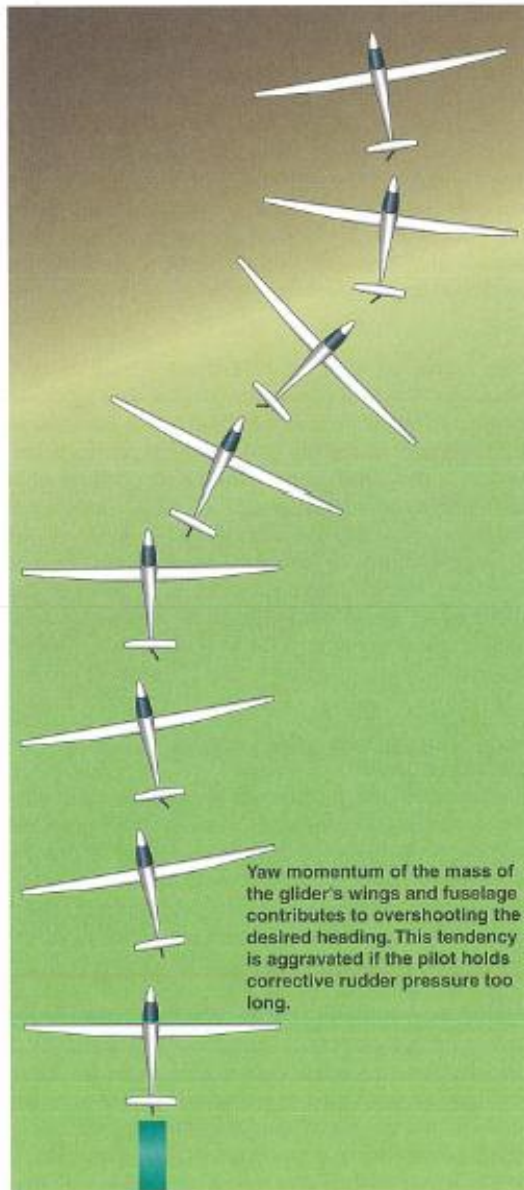
Figure 8-3. Pilot-induced yaw oscillations during takeoff roll.

Pilot-induced yaw oscillations are usually caused by overcontrolling the rudder. As with roll oscillations, the problem is the failure of the pilot to recognize that the glider is accelerating and has considerable momentum. If the glider is veering away from the towplane, rudder application in the appropriate direction helps correct the situation. If the rudder pressure is held too long, the large yaw momentum of the glider wings and fuselage results in overshooting the desired yaw position and veering off in the opposite direction. The alarmed pilot now applies considerable rudder pressure in the direction opposite from the original rudder pressure. As the glider continues to accelerate, the power of the rudder increases and the lag time decreases. In extreme cases, the glider may veer off the runway and collide with runway border markers, airport lights, parked glider, or

When a wingtip contacts the ground during takeoff roll, an uncommanded yaw results. The drag of the wingtip on the ground induces a yaw in the direction of the grounded wingtip. The yaw usually is mild if the wingtip is on smooth pavement but much more

vigorous if the wingtip is dragging through tall grass. If appropriate aileron pressure fails to raise the wingtip off the ground quickly, the only solution is to release the towline and abort the takeoff attempt before losing all control of the glider.

other obstacles. The cure for this type of yaw oscillation is to anticipate the momentum of the glider wings and fuselage about the vertical axis and reduce rudder pedal pressure when the nose of the glider begins to yaw in the desired direction in response to rudder inputs. [Figure 8-3]
