Safety Investigation Report

ACCIDENT TO VAN'S AIRCRAFT RV-8A REGISTERED OY-L** AT GRIMBERGEN ON 30 APRIL 2011

Ref. AAIU-2011-6-Grimbergen-OY-L**
Issue date: 10 July 2012
Status: Final

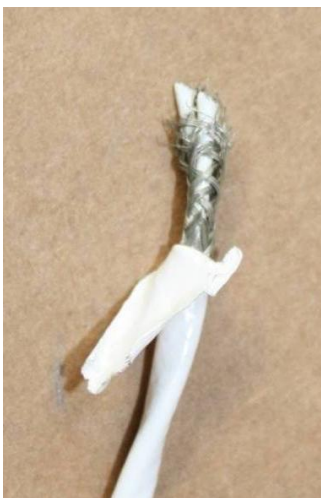
Figure 3: example of shielded wire

During the investigation, “Spark Engines” explained that normally the ECU box and the entire ECU loom were shielded to avoid possible perturbations of the working of the ECU caused by interference coming from the ignition system (or from any interference source).

By looking in detail at the ECU loom of OY-L**, we noticed that the both plus and minus feeding wires of the ECU were not shielded.
