FINAL REPORT ON THE ACCIDENT TO PIPER PA-28 REGISTERED OO-TMI AT EBZH ON 08 FEBRUARI 2011

Ref. AAIU-2011-01
Issue date: 08 April 2011
Status: FINAL

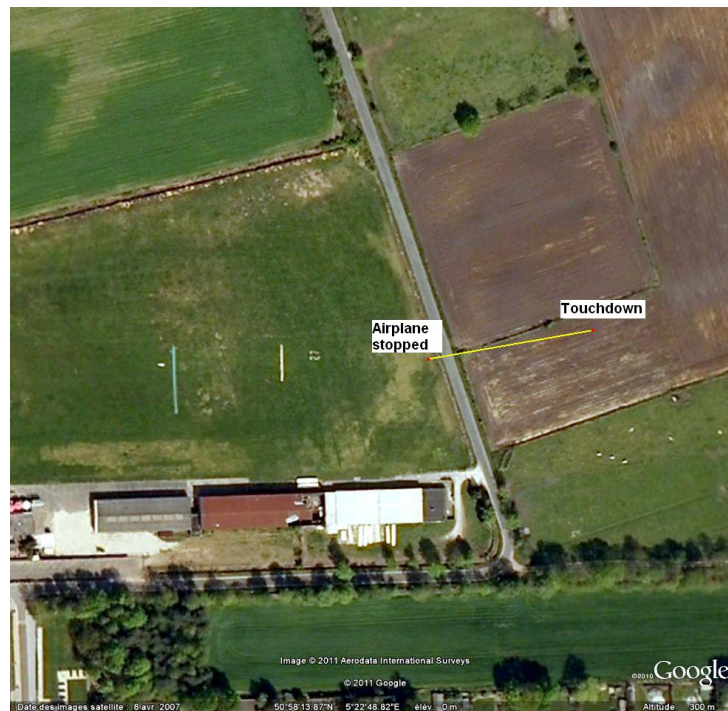
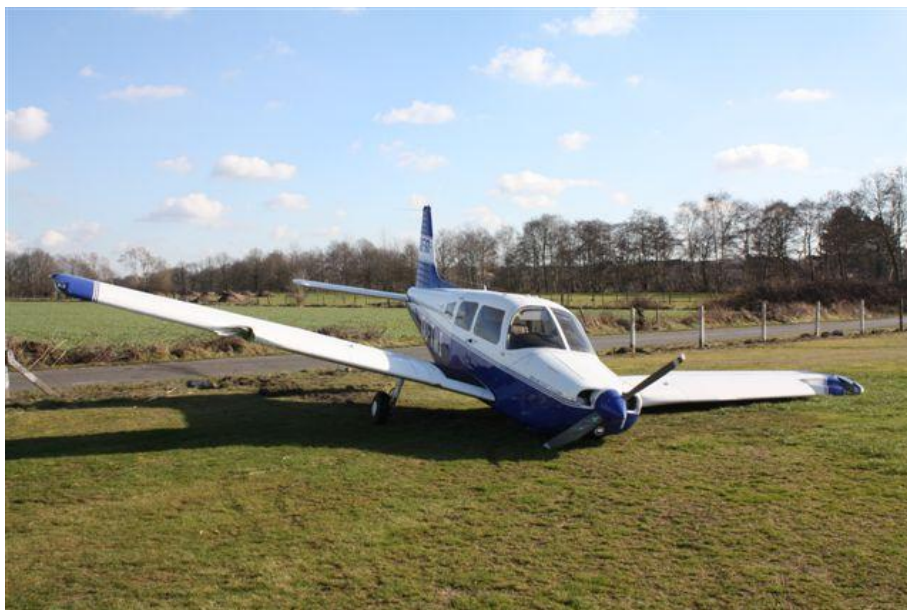
Both propeller blades were bent backwards, one blade showing more damage than the other.

The carburetor heat box was found crushed by impact; the valve was found 2/3 in the 'cold' position.

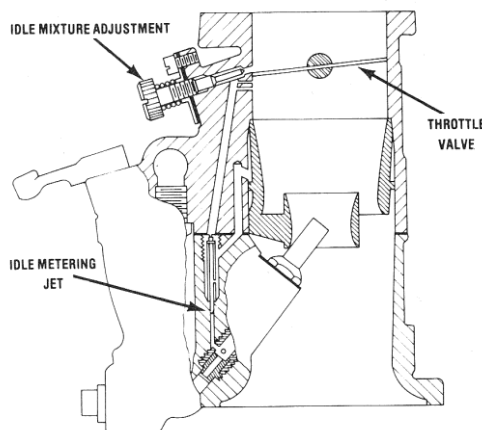
Carburetor cut-away (typical)

At idle power, fuel is drawn from the float bowl of the carburetor through an internal channel in the carburetor body, and air is mixed with this fuel, and discharged through a hole located downstream of the throttle Valve.

The Throttle Valve is almost closed when the engine is idling, and all of the air that flows into the engine must pass around its edges. Because of this restriction, the air has a high velocity, and the pressure at the edge of the valve is low, pulling the fuel out into the air as a spray through the discharge hole.
