Federal Public Service
Mobility and Transport
Air Accident Investigation Unit

Safety Investigation Report

ACCIDENT TO PIPER PA-18-95 SUPER CUB REGISTERED OO-KKK IN THEUX ON 16 OCTOBER 2011

Ref. AAIU-2011-25
Issue date: 2012
Status: Final R1

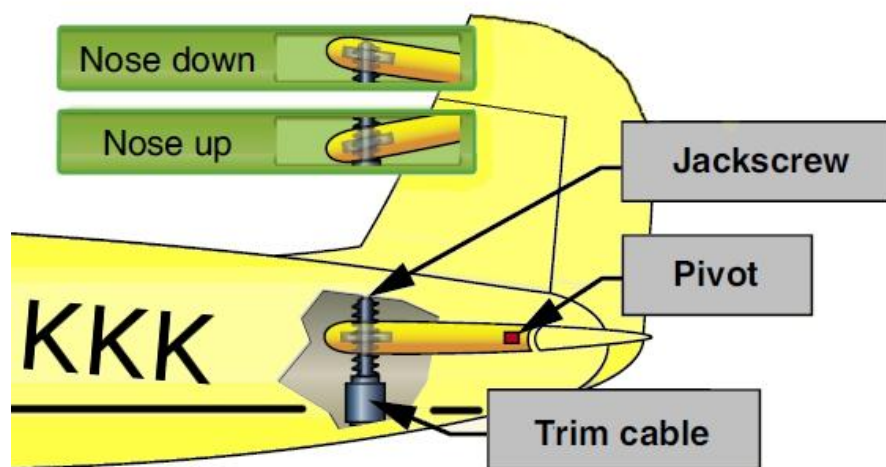
Figure 4: Adjustable stabilizer

The aircraft is fitted with an adjustable stabilizer having the same function and effect as a moveable trim tab. Linkages pivot the horizontal stabilizer about its rear spar. This is accomplished by use of a jackscrew mounted on the leading edge of the stabilizer. This jackscrew is cable operated with a trim control in the cockpit. Turning the control NOSE UP lowers the leading edge of the stabilizer and generates a downward force on it, causing the aircraft to pitch up. Turning the control NOSE DOWN raises the leading edge of the stabilizer and generates an upward force on the stabilizer, causing the aircraft to pitch down.

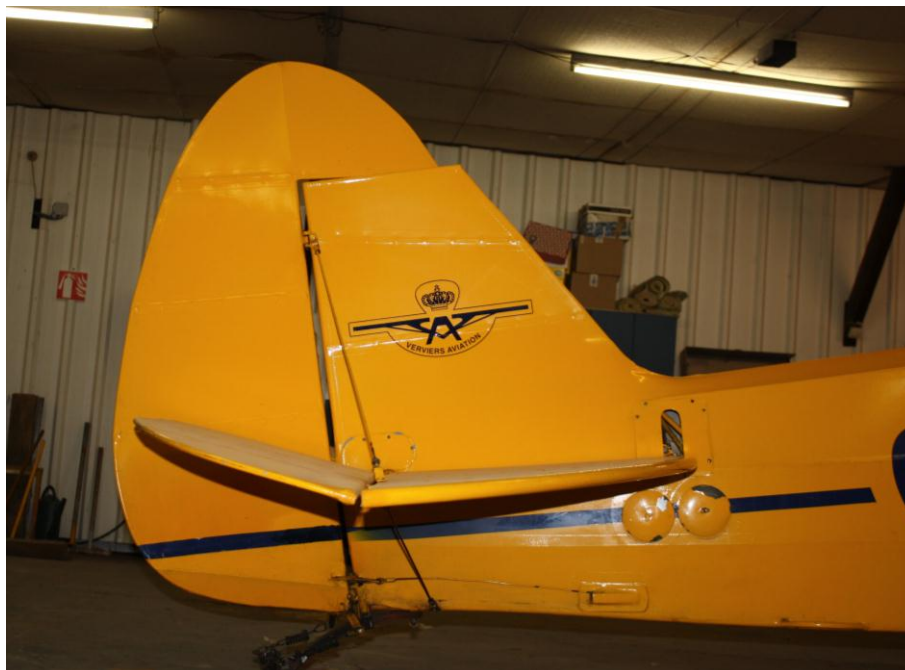
Figure 5: Example of a stabilizer in full nose up position. Notice the up-position of the elevator

The stabiliser trim jack screw was found in the full nose up position (leading edge of stabilizer down).

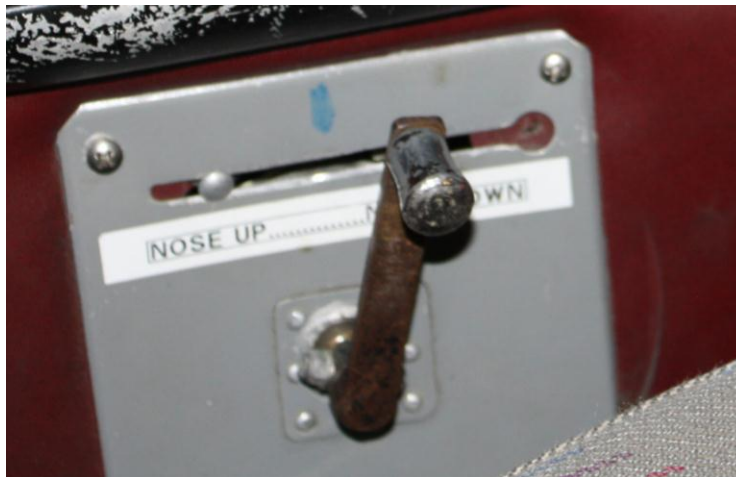
The stabilizer trim control is mounted on the left side wall at the lower rear of the front seat from where it is also reachable from the back seat. A stabilizer position indicator in the mounting plate of the control indicates the nose attitude of the airplane.

Figure 6: Stabilizer trim control of another PA-18

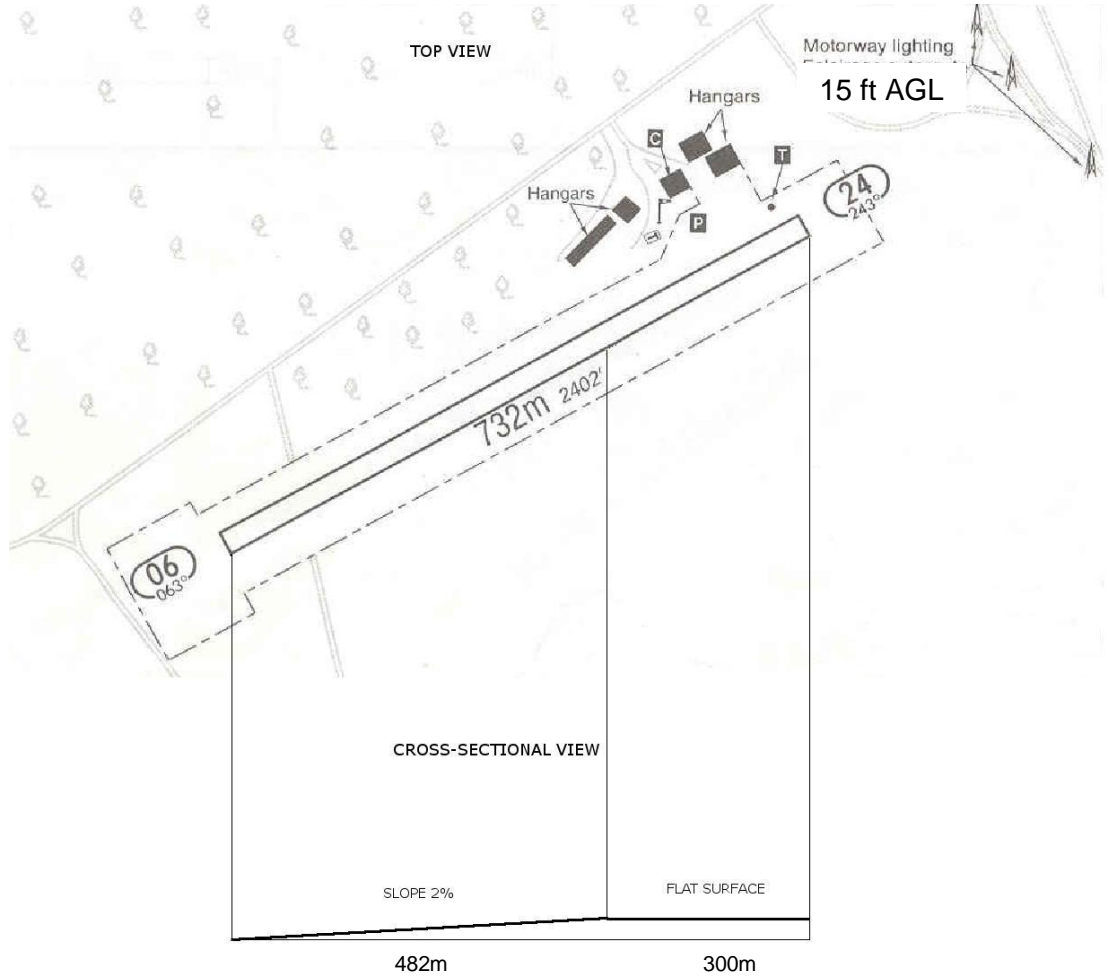
Figure 7: Layout of aerodrome

- Mixed activity (airplanes and gliders).
- Jet aircraft operations not allowed
- Motorway lighting 300m from the end of RWY 06, **locally lowered to 15 ft AGL**
- High voltage line 650m from the end of RWY 06, 200 ft AGL
