Safety Investigation Report

FINAL REPORT ON THE SERIOUS INCIDENT TO APEX AIRCRAFT DR400/120 REGISTERED OO-C AT POTTES ON 2 AUGUST 2011**

Ref. AAIU-2011-20-Pottes-OO-C**

Issue date: 7 September 2012

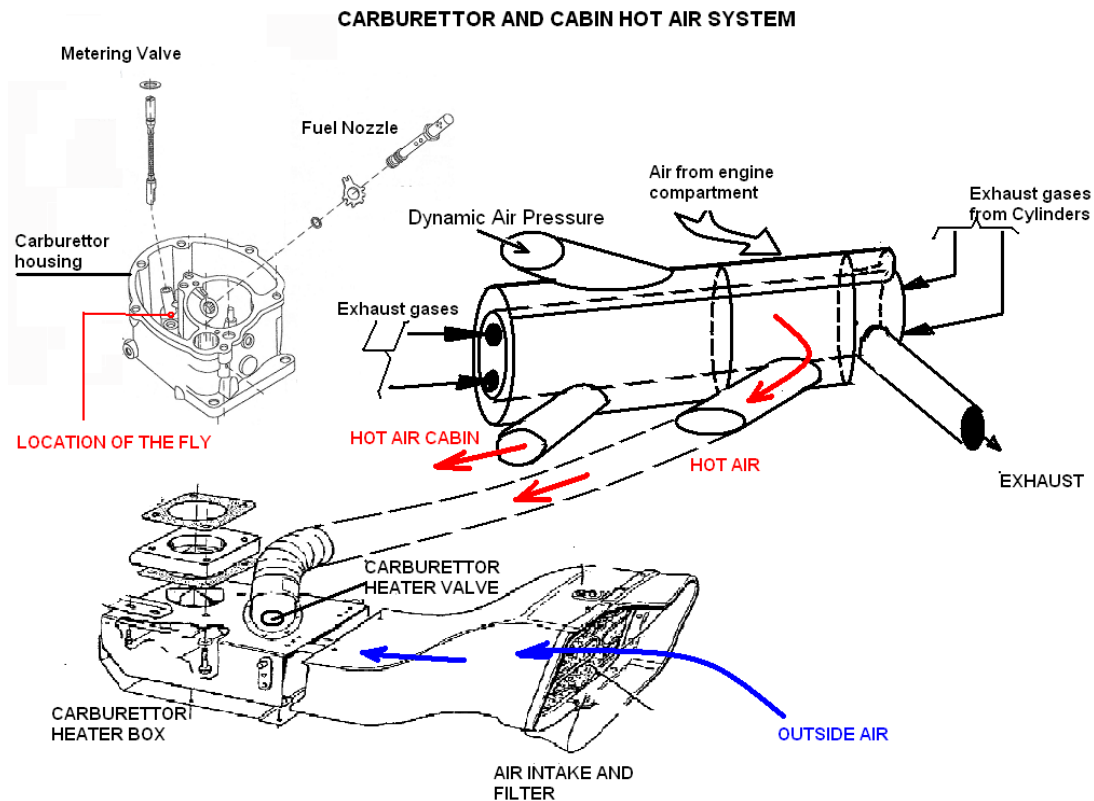
Figure 4: carburettor and cabin heater system

- The cold air intake, featuring an air filter and a duct leading to the carburettor heater box.
- The hot air intake:
When the carburettor heater control valve is set to ON, air is drawn from inside the engine cowl in a heat exchanger. The heat exchanger consists of a chamber located between the exhaust shroud and the exhaust muffler. The air entering the heat exchanger is filtered by a screen filter (wire mesh) before being heated by contact with the hot exhaust muffler.

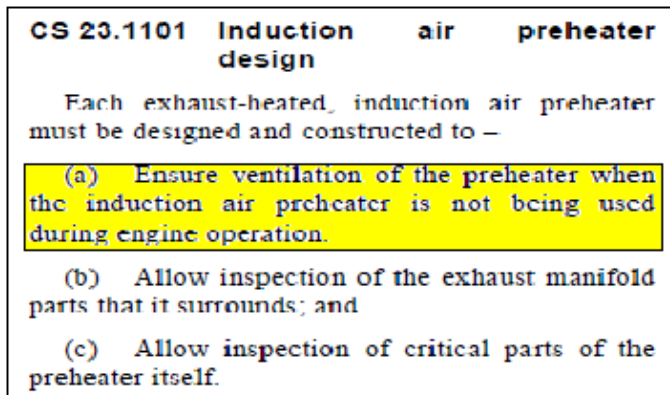
Figure 14: extract of CS 23 regulation

The design requirements of the carburettor heater are to be found in CS 23.1101.

CS 23.1101 does not define the actual reason behind the ventilation.

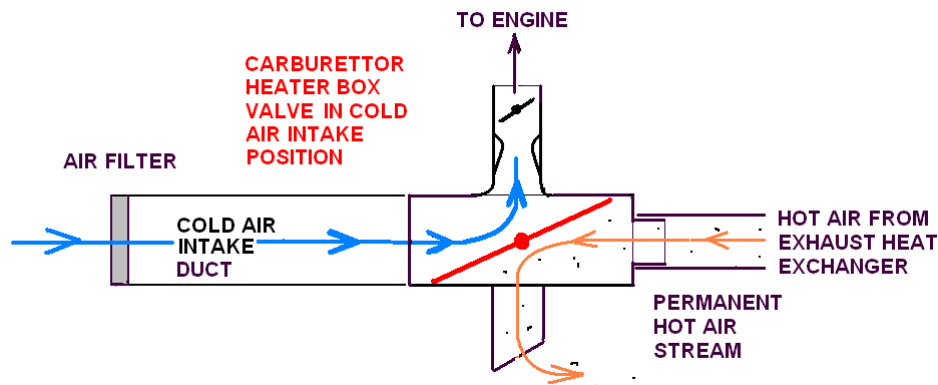
Figure 16: Typical vented carburettor heater box

By contrast, a typical vented carburettor heat box eliminates permanently the possible contaminants that could have entered the system. Ventilation is achieved by both suction of the ram air (as seen above) or by the pressurization of the carburettor heater system by total air pressure (Dynamic + static).
