Safety Investigation Report

Ref. AAIU-2013-16
Issue date: 1st April 2016
Status: Final

Classification:	Accident
Level of investigation:	Standard
Date and time:	Sunday 02 June 2013 at 13:59 UTC
Aeroplane:	Apex aircraft DR 400/140 B (former Robin). The aircraft was registered in Belgium and held a Certificate of Airworthiness and a valid Airworthiness Review Certificate (ARC).
Owner:	Noordzee Vliegclub VZW, a flying club based in EBOS
Total flight time:	1255:20 FH
Engine:	One Thielert TAE 125-02-99 SN: 02-02-03166
Accident location:	Ostend airport (ICAO: EBOS)
Type of flight:	General Aviation - Cross-country
Phase:	Landing
Persons on board:	4
Injuries:	None

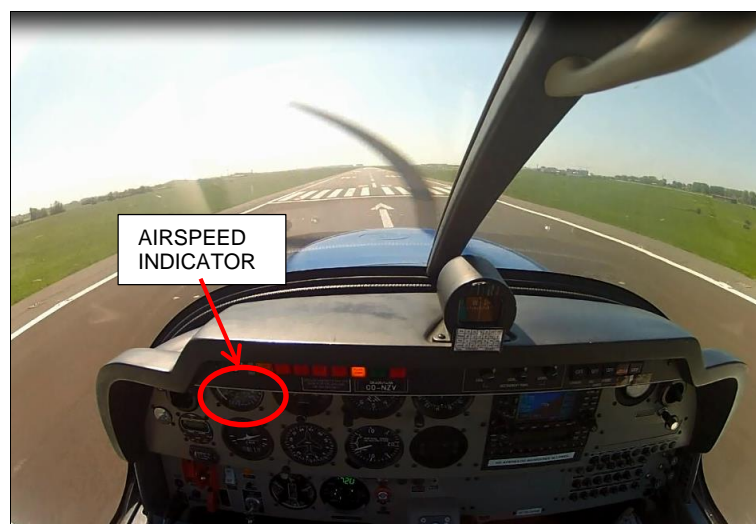
Figure 3: Aeroplane in flight – The airspeed needle is not yet visible

An action camera installed in the aeroplane by the pilot recorded the runway excursion. Snapshot views of interesting phases of the landing were selected and timed starting from the touchdown. The recorded sound of the touchdown could determine that the nose landing gear touched the ground almost immediately after the main landing gear (less than 1 second).

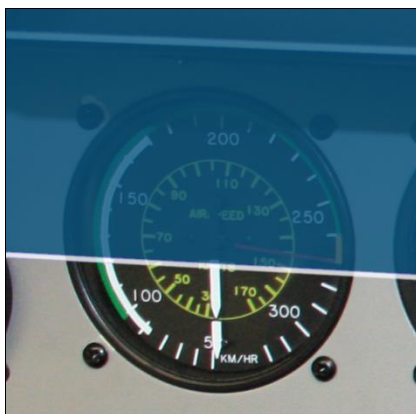
Figure 14: airspeed indicator

The analogue airspeed indicator has both a scale in km/h (outer scale) and a scale in kt (inner).

The needle moves clockwise if the speed is increasing. At rest, the needle is in the 6 o' clock position on the stop of 50 km/h (+- 27 kt).

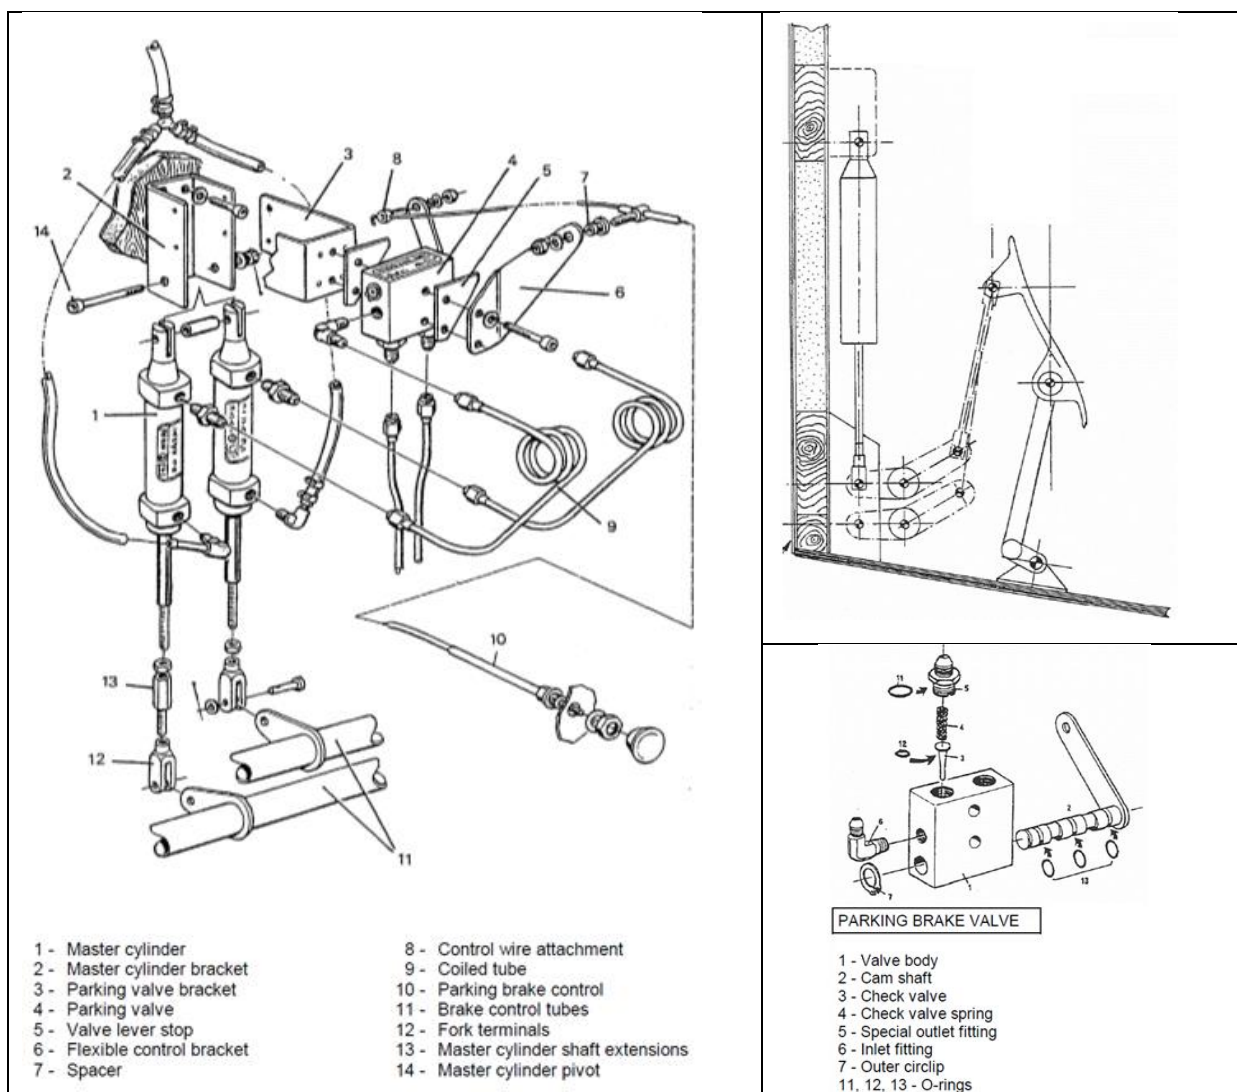
Figure 18: Extract of the parts catalogue showing the brake system.

The aeroplane was first moved several times back and forth which showed that there was no friction caused by the brakes. Inspection of both brake discs and brake callipers didn't show any abnormality. The brake pedals and their associated torque tubes and linkages were also externally examined as well as the master cylinders. The parking brake system was tested by pushing on the brake pedals and closing the parking brake valve. After opening the parking brake valve again, no particular friction remained between the discs and the brake pads. No anomaly was found in the brake system.

Although no evidence of malfunction was found during the aeroplane's inspection, possible malfunction of the parking brake system was investigated by studying the operating principle and the construction of the brake system.

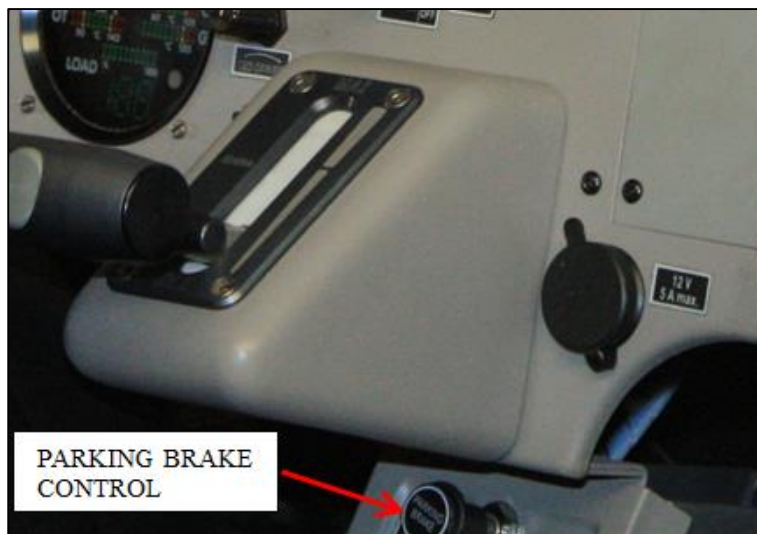
Figure 19: location of parking brake control

It has to be noted that the parking brake must be set during the 'Before take-off' checks, but no subsequent release of the parking brake (push on the control), or check that the parking brake is properly released, was required by the checklist at the time of the accident.

To set the parking brakes on, the pilot must press on both pedals and keep pressure on while pulling the parking brake control. Just after that, the pressure on the pedals is released but the parking brake control must remain in pulled position. To set the parking brake off, the pilot must push the parking brake control in.

The parking brake control is located on the centre console, under the throttle control pedestal, see .

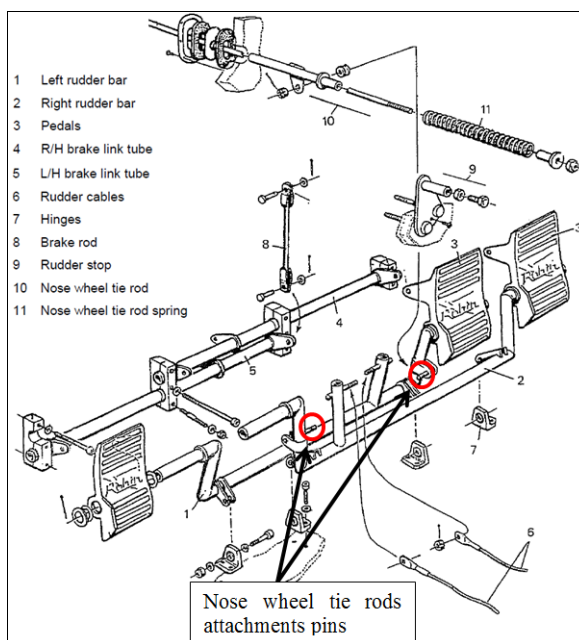
Figure 20: nose wheel steering system and rudder control cables (n°6 on the drawing).

In flight, the 3 landing gear oleo struts remain extended. The expansion of the nose landing gear strut acts on the nose wheel lock rod and forces the nose wheel to position itself in line with the centreline of the fuselage. When the pilot applies pressure on the rudder pedals, it rotates the rudder bars, causing the rudder to move as wanted, while the nose wheel steering remains in position.

From the moment the aeroplane touches the ground, the oleo strut is pushed inward causing the lock rod to move upward and allowing it to rotate freely in its guidance.

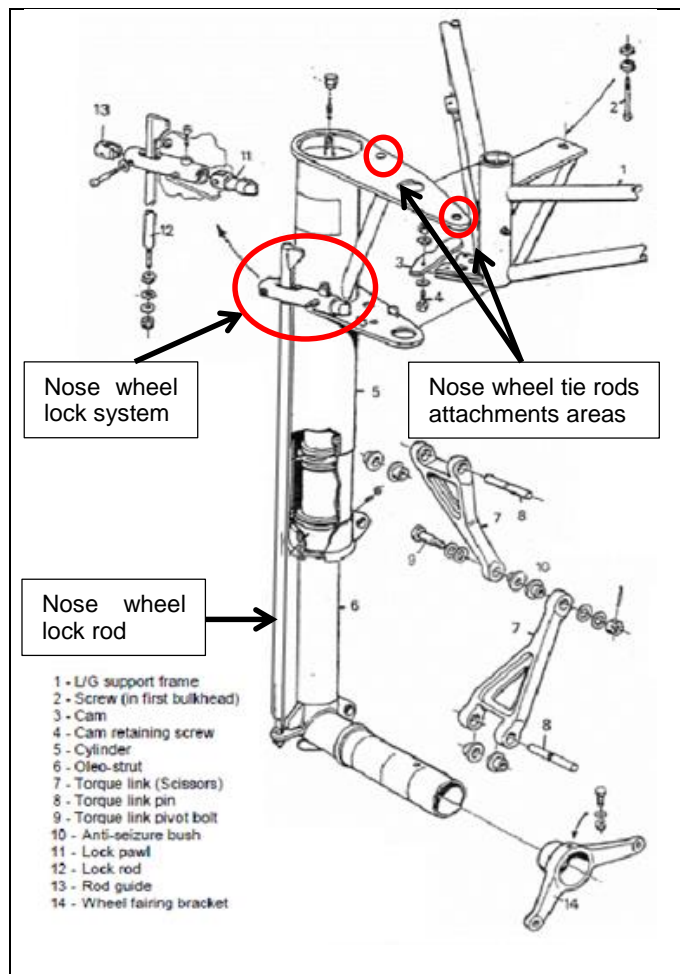
Figure 21: nose wheel steering system.

The nose wheel steering was also carefully examined and tested. No anomaly was found in the steering system. The test performed a few days after the accident, first with the aeroplane standing on the ground and later with the nose oleo-strut extended (aeroplane nose jacked up – as in flight position), showed the nose wheel steering system was working properly.

On the same way, it was determined that the nose wheel steering rod positively locked the nose wheel parallel to the fuselage centreline when the nose oleo-strut was extended, as in flight position.

No anomaly was found in the directional control system. The test performed a few days after the accident, first with the aeroplane standing on the ground and later with the nose oleo-strut extended (aeroplane nose jacked up – as in flight position), showed the nose wheel steering system was working without anomalies.

In the same way, it was determined that the nose wheel steering rod positively locked the nose wheel, parallel to the fuselage centreline, when the nose oleo-strut was extended, as in flight position. Therefore a locked nose wheel rod can be excluded as the cause of the initial swerve to the right.
