Safety Investigation Report

Ref. AAIU-2013-01-EBHN

Aircraft: Robinson R-22 Beta II, msn 4133. The helicopter was registered in Belgium and held a Certificate of Airworthiness and a valid Airworthiness Review Certificate (ARC)

Accident location: On EBHN airfield

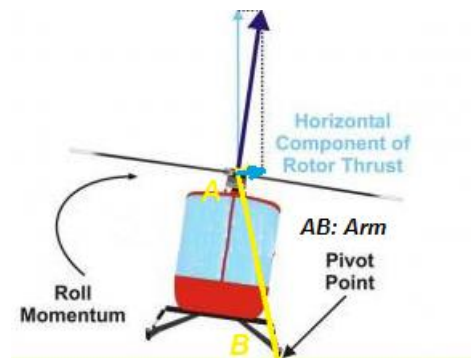
Fig. 10: Dynamic rollover

Three conditions are necessary for dynamic rollover to occur;

1. There must be main rotor thrust sufficient to lift the helicopter.
2. The helicopter must be restrained to the ground or in contact with the ground.
3. There must be a roll rate about the ground contact point (pivot).

The bank angle or side drift can place the helicopter in a situation where it is pivoting about a skid/wheel which is still in contact with the ground. When this happens, lateral cyclic control response becomes more sluggish and less effective than for a free hovering helicopter. Consequently, if a roll rate is permitted to develop, a critical bank angle (the angle between the helicopter and the horizon) may be reached where roll cannot be corrected, even with full lateral cyclic input and the helicopter will roll over its side. (FAA AC90-87).

The video taken and the traces on the ground show that the three conditions mentioned here-above were met.
