Safety Investigation Report

Ref. AAIU-2016-AII-08

SYNOPSIS

Classification:	Accident
Level of investigation:	Standard
Date and time:	08 October 2016 at 14:36 UTC
Aircraft:	Fournier RF 47, MSN: 01
Owner:	Private
Accident location:	In a field in Oordegem (Belgium), Geographic coordinates: 50°57'58,29 – 3°53'46,59
Type of operation:	Non-commercial - Cross-Country
Phase:	En route
Persons on board:	One pilot
Injuries:	The pilot was slightly injured

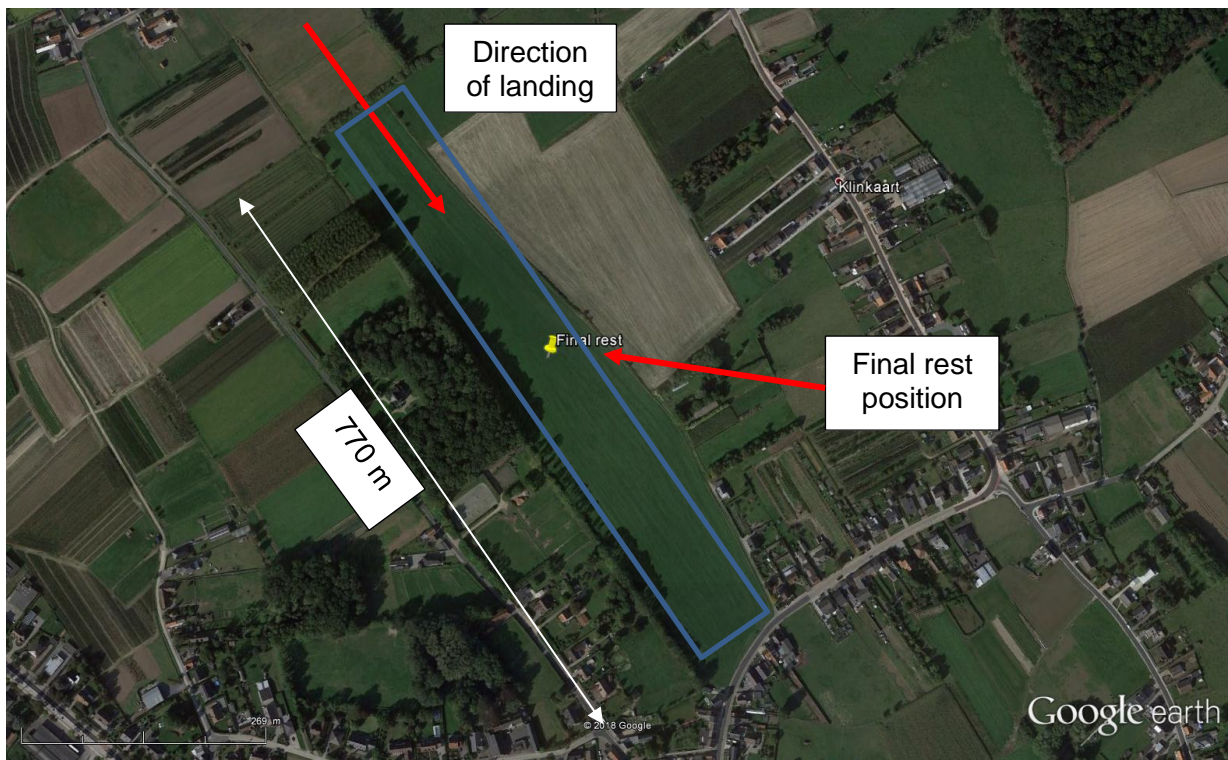
The aeroplane touched down approximately at mid-length of the field at 380 meters from the row of trees and rolled between 10 – 15 m before it became airborne again for about 10 meters. Thereafter, the aeroplane touched down again causing the nose wheel to sink into the soft ground causing a rapid deceleration. The nose landing gear strut failed rearwards and the aeroplane flipped over.

Figure 1: Aerial view of the landing field

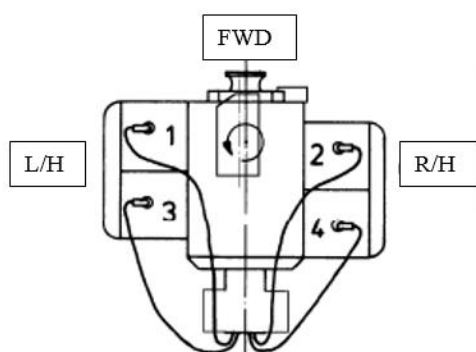
Figure 5: Cylinder sequence numbering

Traces of engine oil were present inside the exhaust pipe common to cylinder Nr 2 and Nr 4 (Exhaust of the cylinders located at the right side).
