Safety Investigation Report

ACCIDENT TO A UAV NAVIGATION ATLANTIC /OCULUS AT DIZY-LE-GROS, FRANCE ON 29 FEBRUARY 2016

Ref.:
AAIU-2016-AII-01

Issue date:
17 March 2017

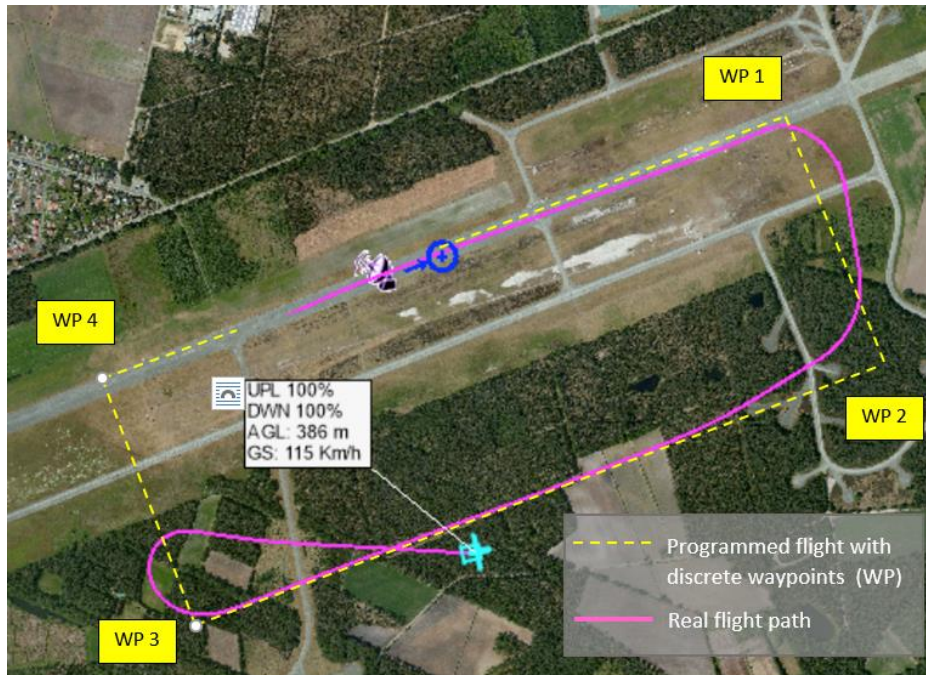
Figure 1 : Flight Path

At 13:46, the aircraft took-off in AUTO mode. Above its first waypoint (WP 1) there was a short alarm of a communication failure. The aircraft continued on its programmed flight path by making a turn to the right. However, above waypoint 3, the communication failure warning re-appeared.

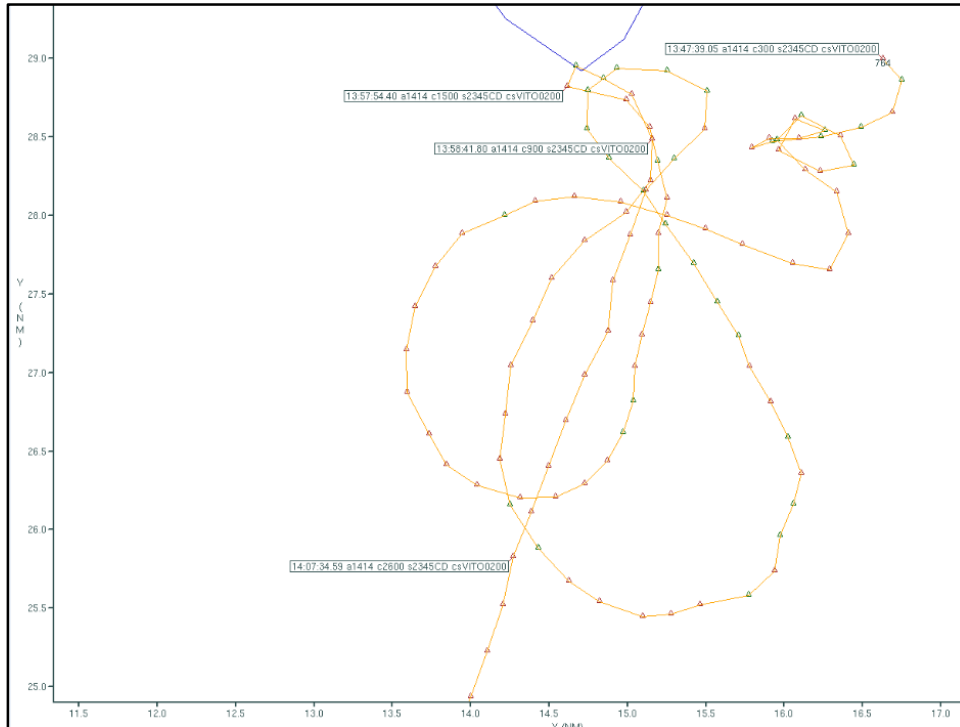
Figure 8 : Radar track of the first phase

1. First phase;
Take-off and loss of control in the vicinity of the airfield

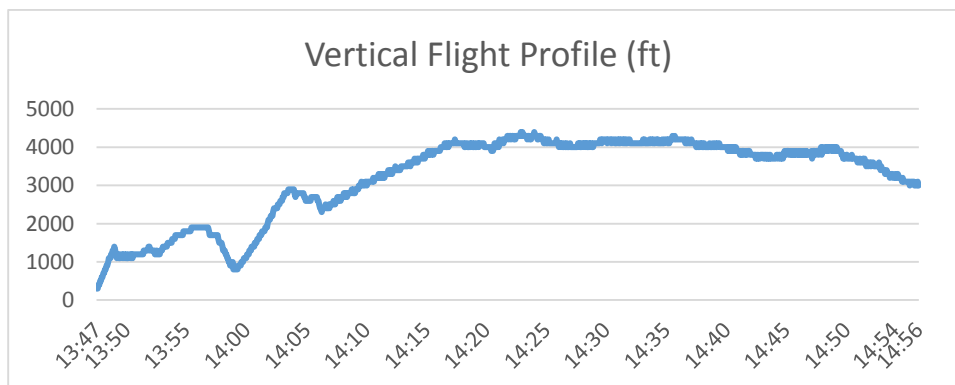
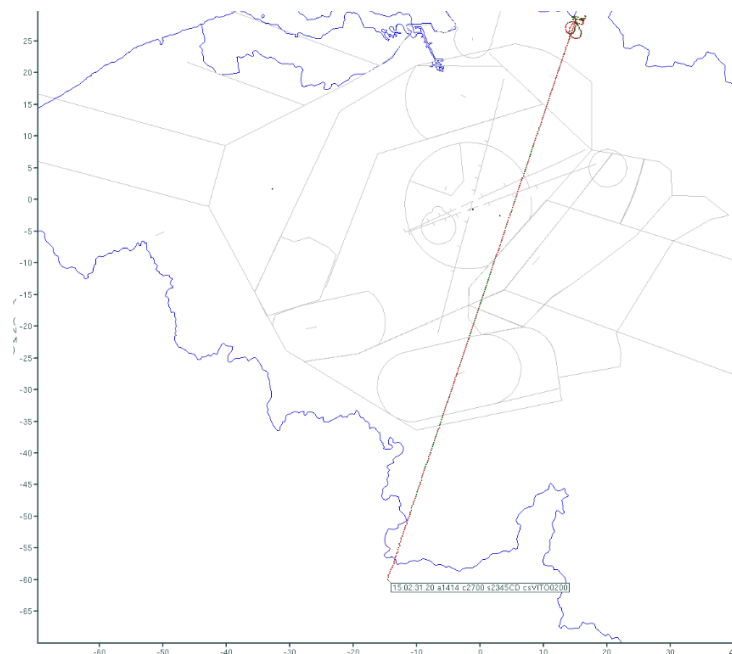
Figure 9 : Radar track – complete flight

2. Second phase:
From 14:07, out of TSA and climb from 2300 ft to 4100 ft in 10 minutes – 180 ft/min. Thereafter, straight flight of 23 minutes at 4100 ft with slight variations, up to 14:39:24. Flight at 199 degrees up to 15:02 in the vicinity of Vervins, France.

The UAV flew during 55:21 minutes at a ground speed of 183 km/h. Taking into account the wind at 5000 ft (40 degrees, 25 kts), the drone flew at an approximate airspeed of 140 km/h – 75,6 kts.

The airplane went down somewhat, then climbed back to 4000 ft up to 14:49, before going down at 140 ft/min. Crash landing at about 15:02.

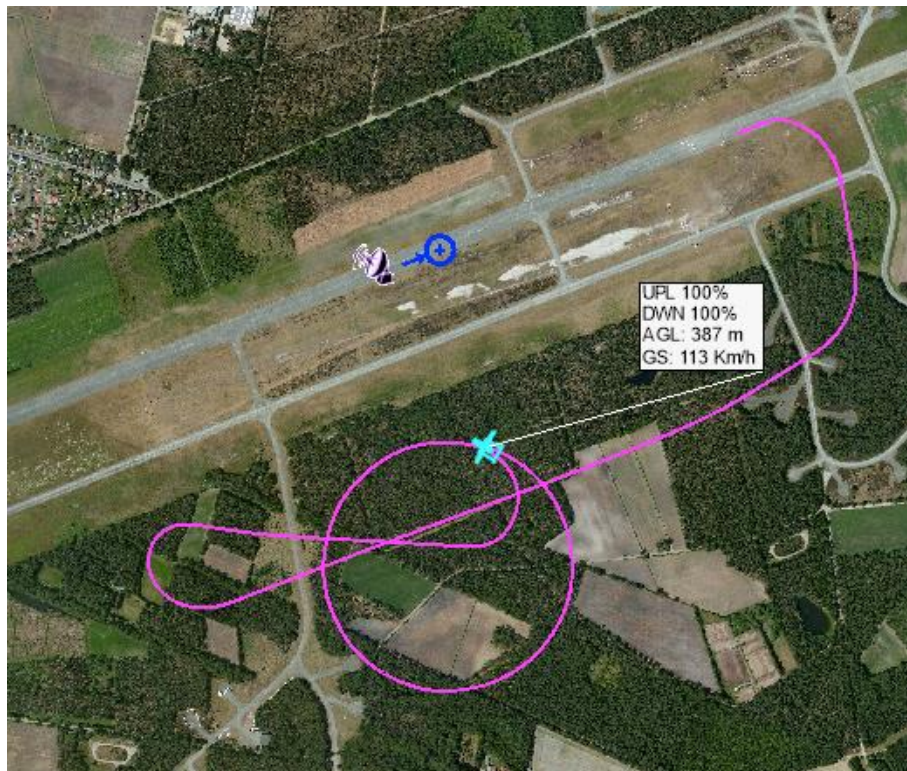
Figure 14 : Initial flight evolution

The UAV took off at 13:46:45 from Runway 07 of EBWE. During the initial climb, the system reports 4 Short Uplink Losses (SUL) warning. The crew decided to interrupt the planned flight and instructed the UAV to circle around a pre-determined point (HOLD mode). The UAV reverted course, and entered a counterclockwise turn, executed perfectly.

When the UAV was about to complete 1 ½ turn, the system reported a Long Uplink Loss (LUL). The UAV was flying at an altitude of 1500ft.

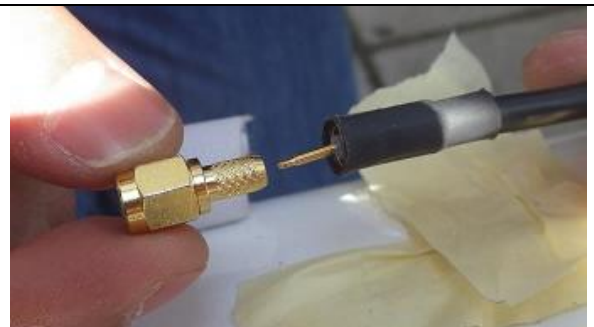
When the UAV parachute cover was opened to gain access to the UAV radio box, it was found that the cable between the radio and the antenna was disconnected.

Figure 18: cable with protective sleeve and connector.
